Technical Notes

Analysis of the Results of the Network Seismic Risk and Vulnerability Functions Evaluation Performed by the Costa Rican Institute of Aqueducts and Sewers

RESULTS OF SEISMIC RISK ASSESSMENT FOR WATER AND SANITATION INFRASTRUCTURE IN COSTA RICA

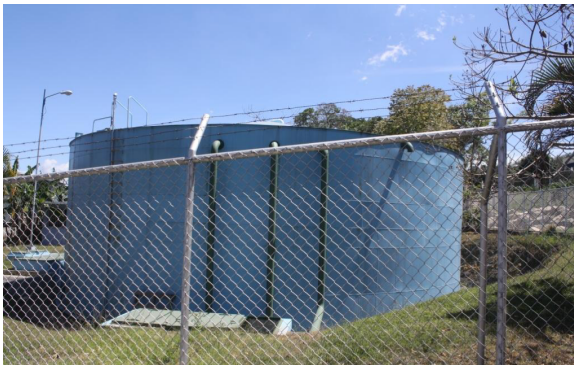
The Naranjal tank is a steel tank seated on a concrete platform located in an area with a number of slopes. The general appearance of the tank is good, there are no obvious cracks or instabilities of the walls, and as such, no loss of content is appreciated. The welded joints seem healthy and show no signs of fatigue damage, and at first sight seem to be of good quality without the presence of any rust or traces of bubbles (Figures 2, 3, 4, and 5). For this tank, risk assessment indicates an ALE of 39.58%, which does not adequately represent the tank’s situation.

Figure 2 View from the outside of the metal Naranjal tank. At first glance it looks in good condition, with no visible areas of corrosion nor any loss of content.

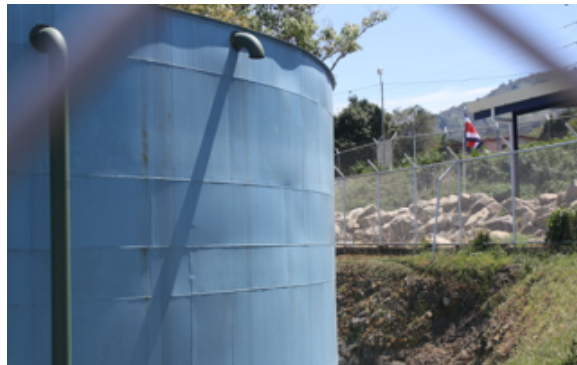
Figure 3 Detail of the metal walls of the Naranjal tank. The sheets forming the tank wall can be seen, as well as the welded seams, and the ripples which occur naturally in these kinds of welded joints.

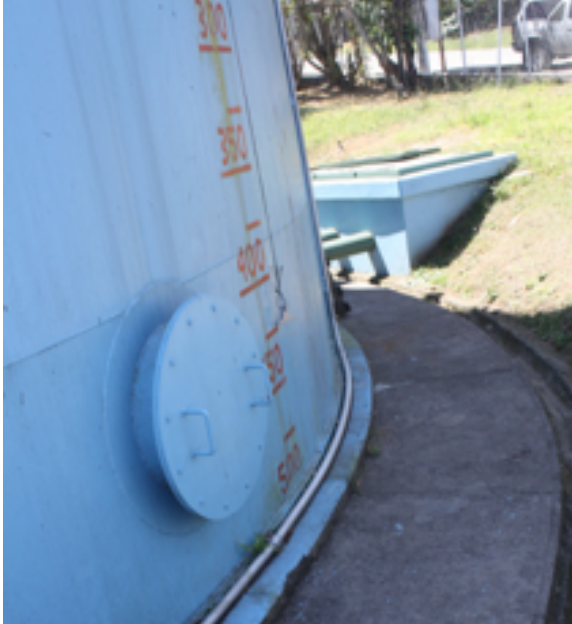
Figure 4 The Naranjal tank sits on a base of reinforced concrete, with no apparent anchor. At the time of inspection, the tank was almost full, and no loss of content could be seen at any point of the tank.

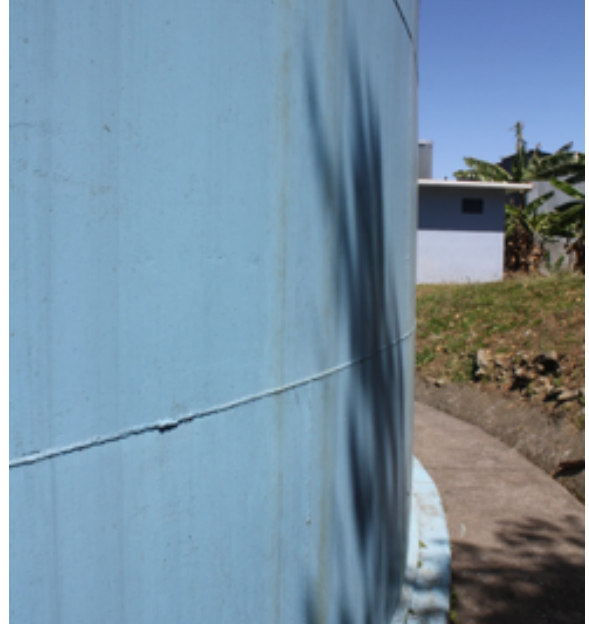
Figure 5 To the naked eye, the welded joints seem to be in good condition, although it is always possible to find some flaws in the welding work, which are, nonetheless, not serious.

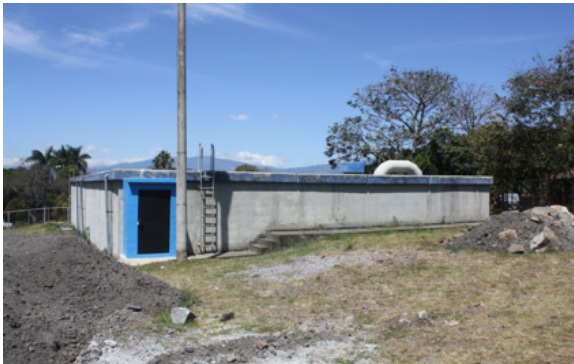
Figure 6 Side view of the Escazú Cemetery concrete tank

The other tank visited was at Escazú Cemetery (known as “Red Cross”), made up of reinforced concrete, rectangular in shape, and with a lid. Several construction problems were found in this tank, mainly related to activities of filling compaction, which had created relative movements along the sidewalks with respect to the tank itself—that, however, have not affected it—and that have only shown up as problems with the pipe connections. Besides, in the tank roof there is evidence of the inadequate application of coating, and on the walls there are traces of leaks. According to AyA, the construction of this tank was carried out by a company that made several errors and incurred in construction deficiencies which were repaired later. The tank is fully operational.

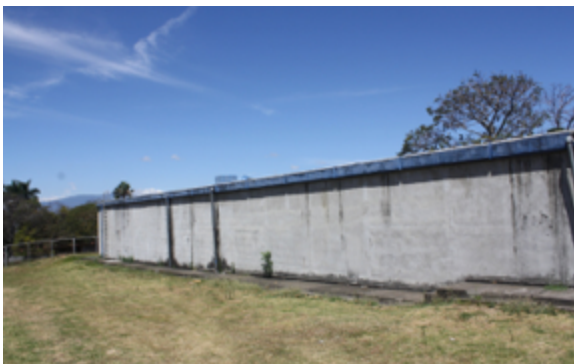
Figure 7 Another side view of the Escazú Cemetery concrete tank. Note the stains left by leaks on the wall.

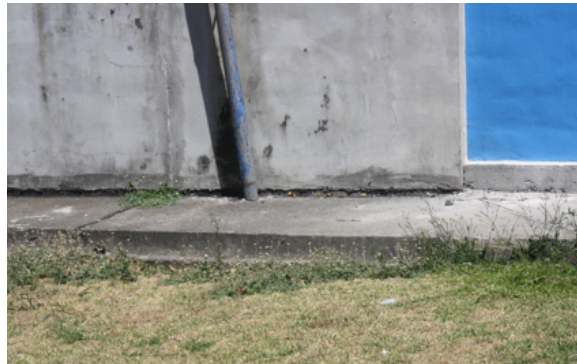
Figure 8 Evidence of compaction problems in the neighborhood of the Escazú Cemetery concrete tank

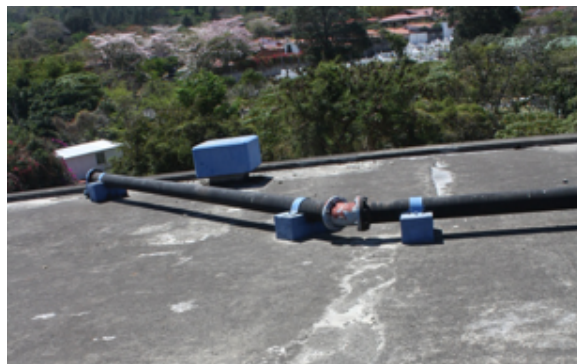
Figure 9 Picture of the Escazú Cemetery tank roof. Repairs are visible in well-defined areas.

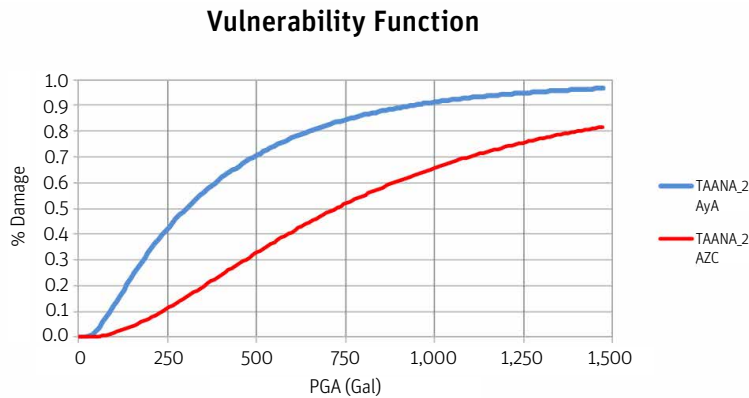
Figure 18 Vulnerability functions for seated unanchored metal tanks proposed by AyA (blue), and for this report (red)

The blue curve is the one originally used by AyA, while the red curve plots the relative damage values proposed for this report. This modification generates a curve which, in general, uses lower relative damage values than the original, although the steepness of the curve is maintained in some sectors, which means that the fault mode shares the same essential behavior. It can be seen that when the intensity of the event is small (say less than 490 Gal), the values of the modified curve are significantly lower than those of the original, and, in particular, when the values are less than 250 Gal in intensity, this difference may be considerable. Since the ALE is a weighted calculation of losses that can be caused by all events, considering their annual occurrence frequency, then it is very likely that these small but very frequent events will have an important influence on the final risk premium estimate, which explains the very high value of losses in the estimates of the AyA, which are unrelated to the actual condition of these tanks.

To confirm this, we proceeded to make an assessment of all GAM tanks, using, for the Naranjal tank (inspected metal tank), a vulnerability function such as that shown in Figure 18. The ALE of this tank was found to be 8.65%, which is probably closer to the real condition of threat and vulnerability.

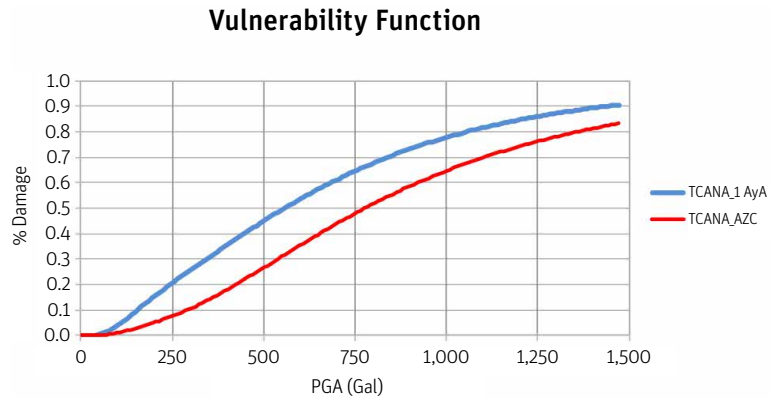
Figure 19 Vulnerability functions for seated unanchored reinforced concrete tanks proposed by AyA (blue), and for this report (red)

As in the case above, there is a slight reduction in the relative loss values obtained with the new function with respect to the one originally employed by AyA. The use of this vulnerability function leads to an ALE of 5.93%.
