KNOWLEDGE NOTE 1-2

CLUSTER 1: Structural Measures

Building Performance

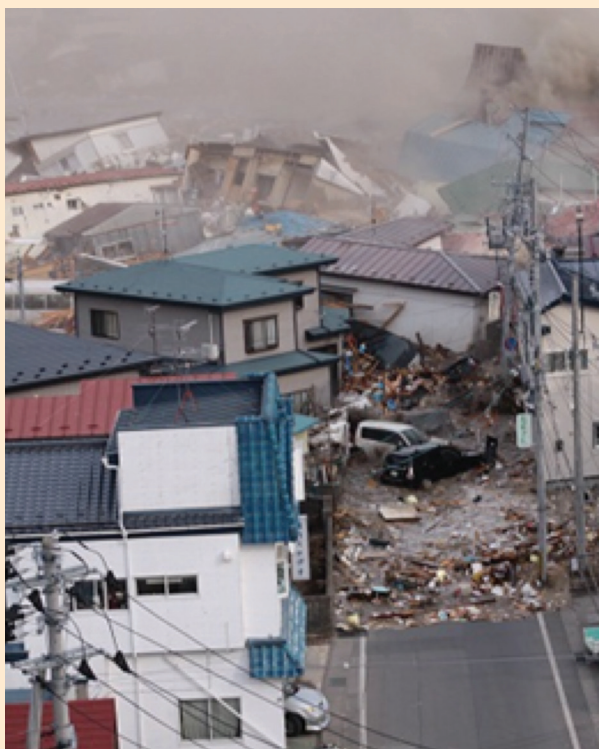
FIGURE 2: **Houses and cars were washed away by the tsunami**

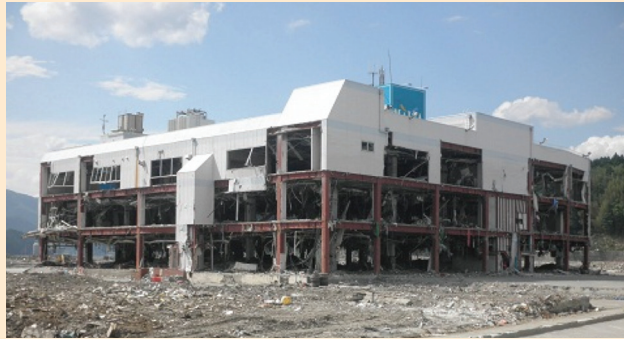
FIGURE 3 (top): **The tsunami destroyed the outer walls of steel structures**

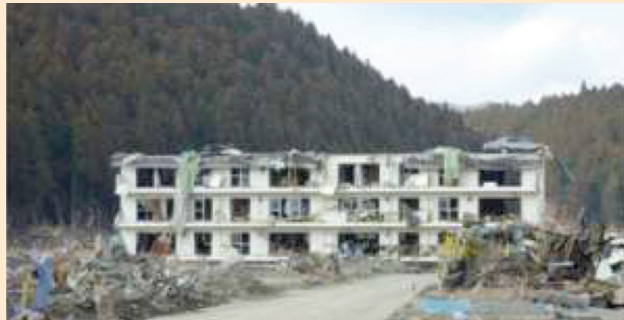
FIGURE 4 (bottom): **Reinforced concrete buildings withstood the tsunami even though it was submerged. Note the car on the roof.**

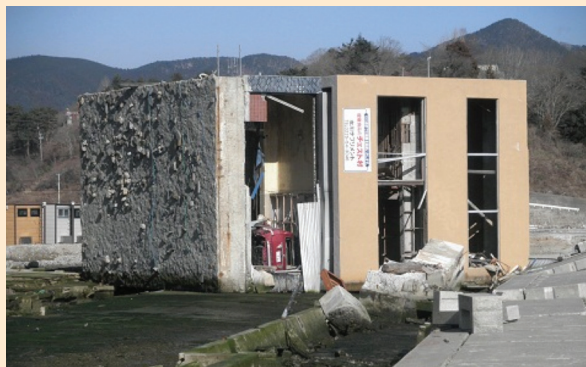
FIGURE 5 (top): **Reinforced concrete building damaged by scouring**

areas were washed away or totally destroyed (figure 2). Many steel structures were also severely damaged (figure 3). By contrast, buildings of reinforced concrete performed well against the tsunami. Although many were completely submerged, they did not suffer structural damage (figure 4). Those reinforced concrete buildings that were damaged tended to be small and without a pile foundation (figures 5 and 6). Figure 7 shows a damaged building where the probable causes of the damage were a combination of weak connections between piles and footings, strong water pressure from the tsunami current, and liquefaction.*

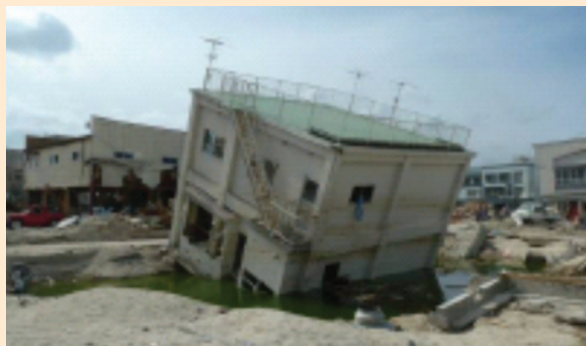
FIGURE 6 (middle): **Reinforced concrete building damaged by liquefaction**

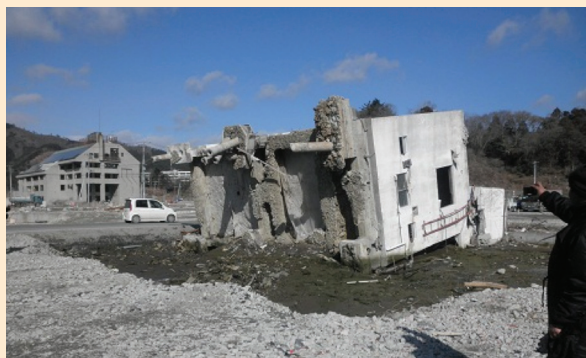
FIGURE 7 (bottom): **Overtured building of reinforced concrete with pile foundation**

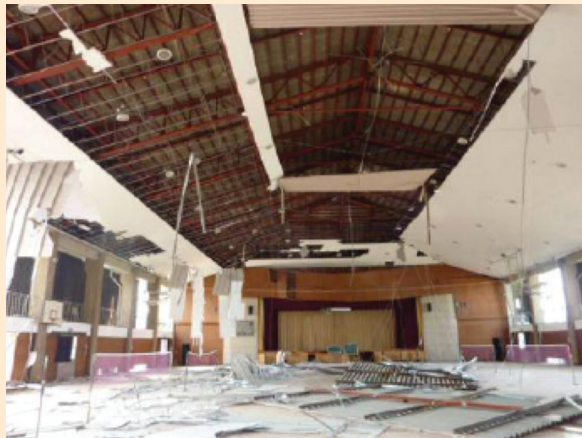
Damage to nonstructural building components. Much of the damage observed in buildings following the GEJE involved nonstructural components attached to structures, such as ceiling panels, nonstructural walls and finishing materials (figure 8). To date, no guidelines or codes cover the wide variety of materials and designs used on nonstructural components. In Japan, few engineers have devoted attention to the matter.

FIGURE 8 (top): **Fallen ceiling panels in school gymnasium**

Safety of nonstructural building components. The GEJE demonstrated the importance of considering nonstructural elements when thinking about earthquake safety. The materials, design, and construction of nonstructural components vary greatly. Technical guidelines are needed to ensure that such components are earthquake-resistant.

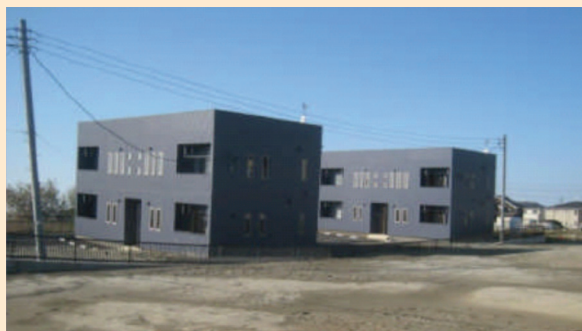
FIGURE 9 (bottom): **Subsidence of houses from liquefaction.**

Liquefaction. Liquefaction occurred on reclaimed lands and river banks over a wide area. Small buildings without pile foundations built on plots that had not been treated for liquefaction were affected (figure 9). Existing building codes cover countermeasures against liquefaction for reinforced concrete and other buildings, but not for the detached wooden houses owned by most ordinary people. The Ministry of Land, Infrastructure, Transport and Tourism has now produced technical guidelines to fill these gaps. Some local governments have provided liquefaction risk maps to encourage building owners to take countermeasures.

Liquefaction and landslides. Countermeasures against liquefaction and landslides need to be enhanced in Japan. Following the GEJE, the Japanese government has reviewed the method of assessing the risk of liquefaction. Developing more effective and affordable anti-liquefaction treatments is needed. The government is considering a requirement that home buyers be notified of the risk from liquefaction. The government is also providing subsidies for projects to stabilize slopes with landslide potential near houses.

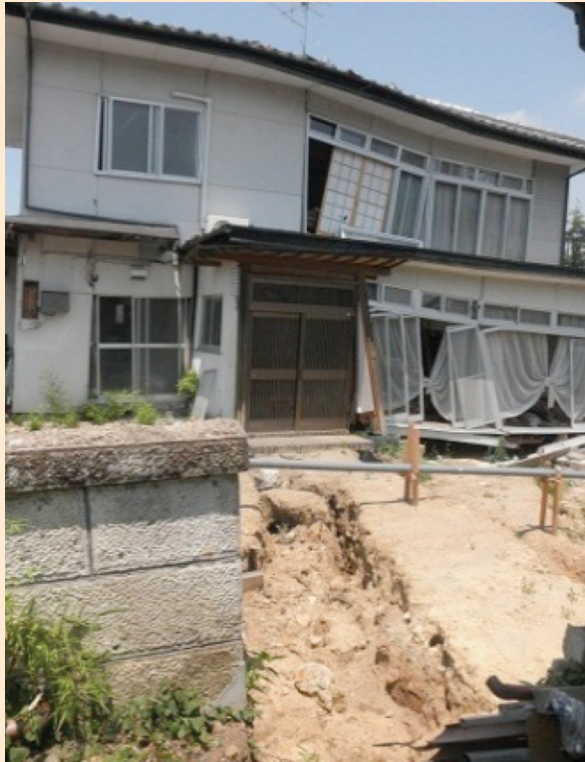
Damage from failure of retaining walls. In Sendai City, more than 4,000 houses were damaged by landslides caused by the strong ground shaking (figure 10). Since 1961, to prevent landslide disasters the city government has regulated housing in hilly areas under the Act on the Regulation of Housing Land Development. Most locations that experienced

FIGURE 10: Houses damaged by landslides

landslides following the GEJE were developed before the act came into effect. In 2009, in response to landslides caused by earthquakes since 2000, the central government established a subsidy mechanism whereby local governments were tasked to carry out geotechnical work to stabilize the ground for large-scale housing projects in high-risk areas. However, stabilization work had not started by the time the March 2011 disaster struck.

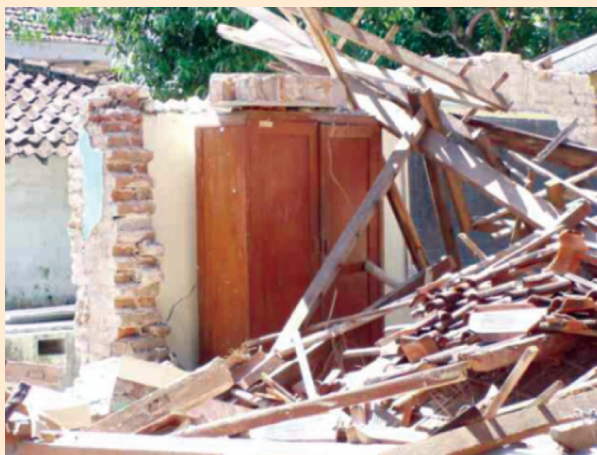
Seismic resilience of buildings is the most effective risk mitigation measure. One of the most basic and effective measure to mitigate risks from earthquakes is to build structures that are resilient to ground shaking. Many buildings in developing countries are extremely vulnerable to collapse (figure 12).

FIGURE 12: Revised design load requirements against tsunamis (Yogyakarta province, following Central Java Earthquake, 2006)
