# Multi-Hazard Risk Assessment for the Schools Sector in Mozambique

1230818-002

Client	Project	Reference	Pages
World Bank/GFDRR	1230818-002	1230818-002-ZKS-0008	89

Safe schools, earthquakes, coastal flooding, river flooding, cyclones, landslides, risk assessment, retrofitting options, awareness raising

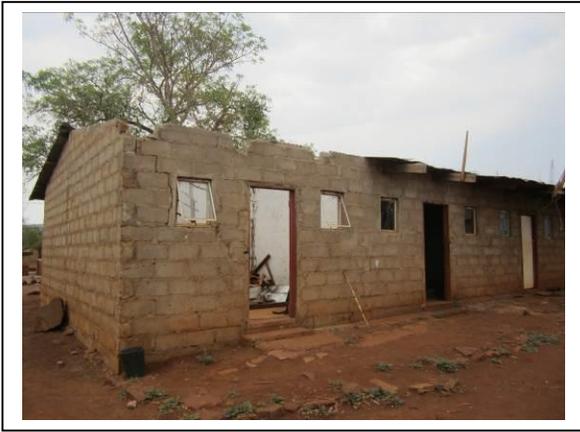
Observation: Roof damaged

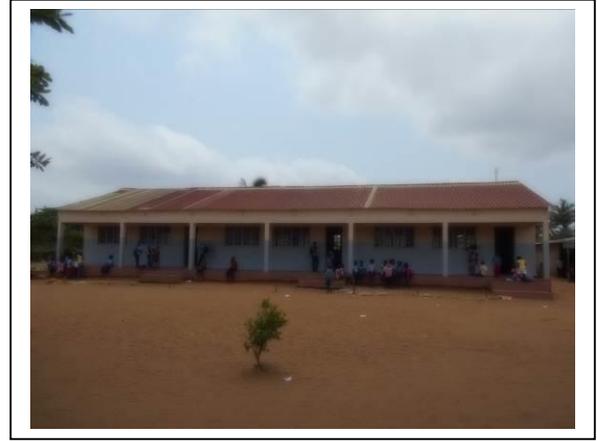
Observation: A classroom block with roof repairs

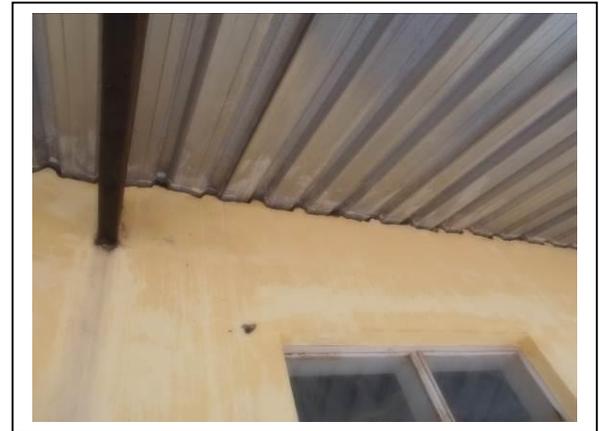
Observation: cracking between the wall and roof sheet due the effect of wind

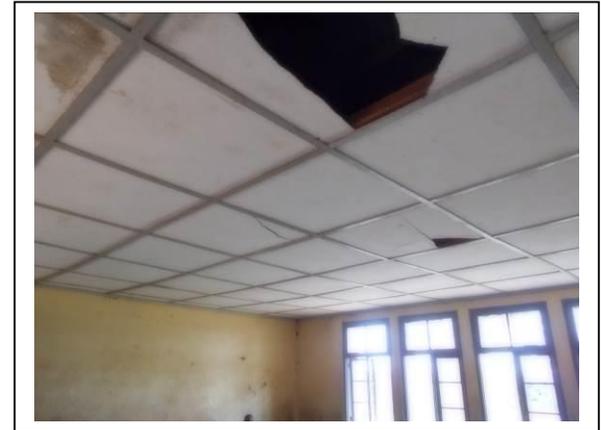
Observation: Ceiling in advanced state of degradation

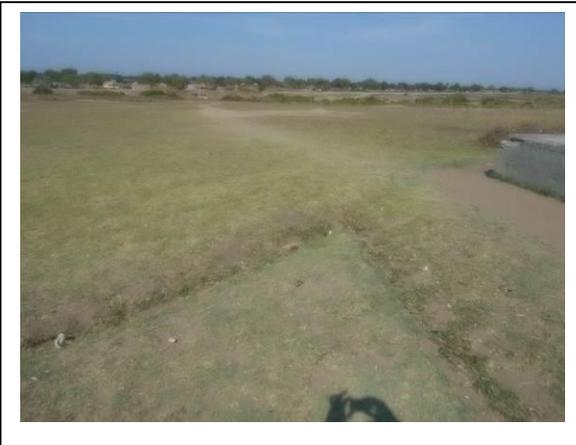
Observation: school access without gate

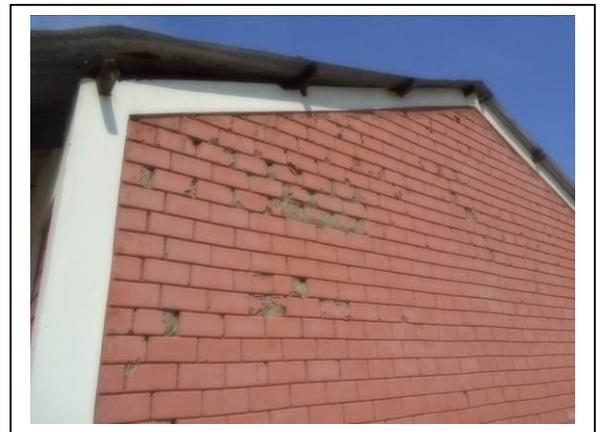
Observation: Blocks in an advanced state of degradation

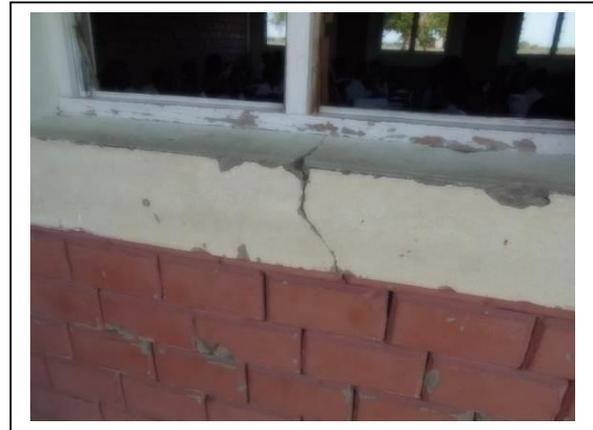
Observation: Crack at the edge of the window

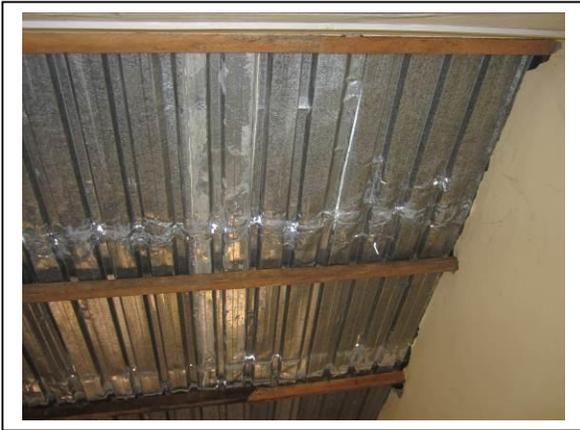
Observation: Detail of damaged roof sheet

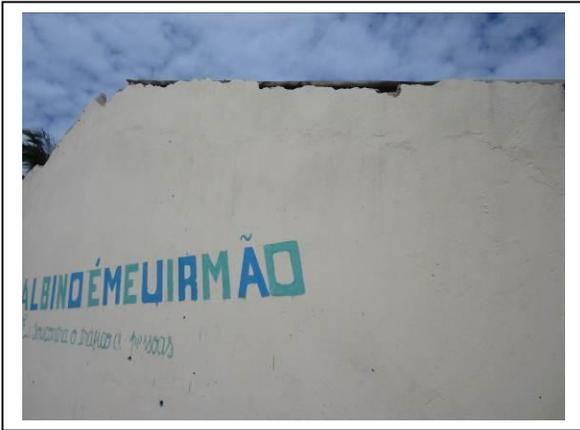
Observation: External wall cracks

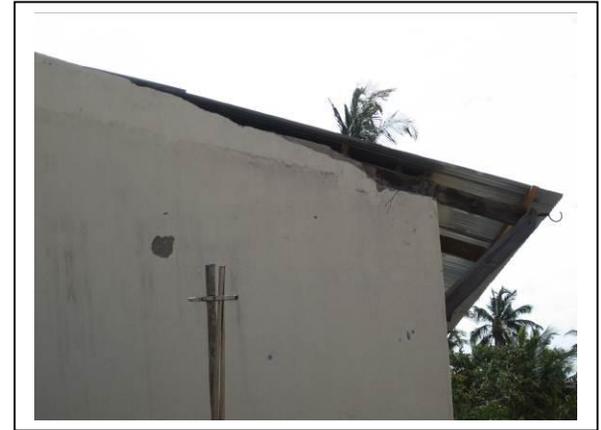
Observation: Cracks between wall and roof

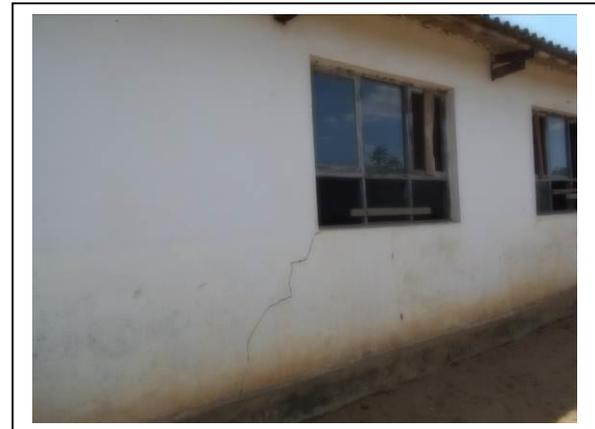
Observation: cracks are supposed to be caused by an earthquake in the old building

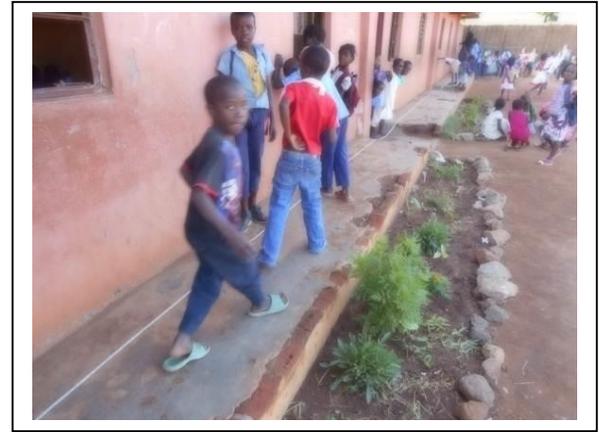
Observation: poor condition of the veranda floor

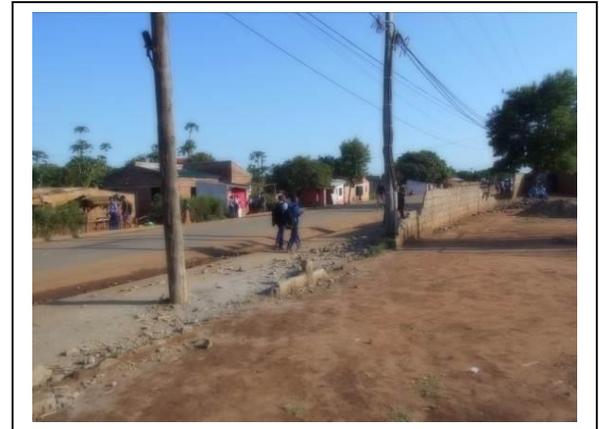
Observation: Fence wall destroyed by the effect of wind
