TBILISI DISASTER NEEDS ASSESSMENT 2015

FINAL DRAFT
2 September, 2015

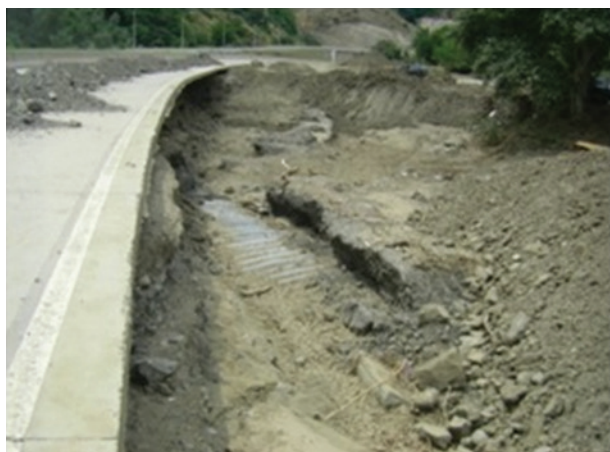
Damage of this kind has been observed along segments of the Amirejibi Highway where it runs adjacent to or above the Vere River tunnels (see Figure 3).

Figure 3: Damage to the Amirejibi Highway close to Vere River tunnel no. 5

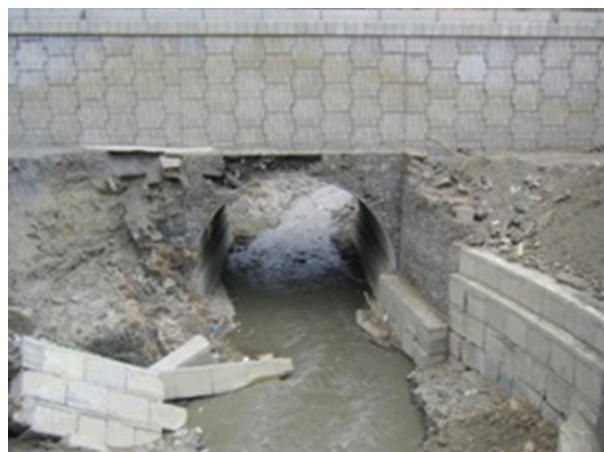
Figure 4: Damage to the gabion and concrete inlet protection walls of Vere River tunnel no. 5

This type of damage, caused by fast-flowing flood waters and debris, also affected the gabion or concrete protective walls of the Vere River tunnel inlets and outlets (see Figure 4).

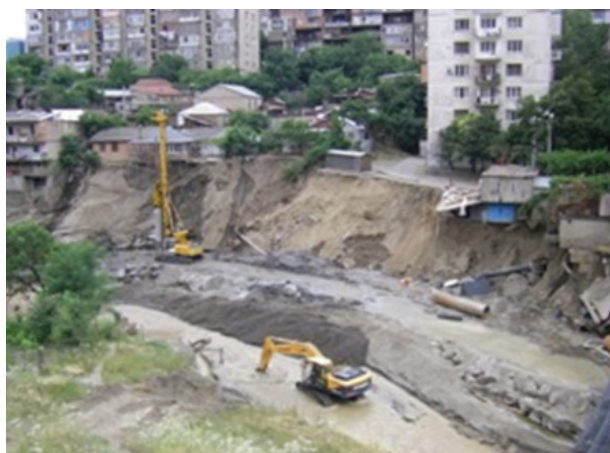
Figure 5: Eroded riverbank downstream from Vere River tunnel no. 1

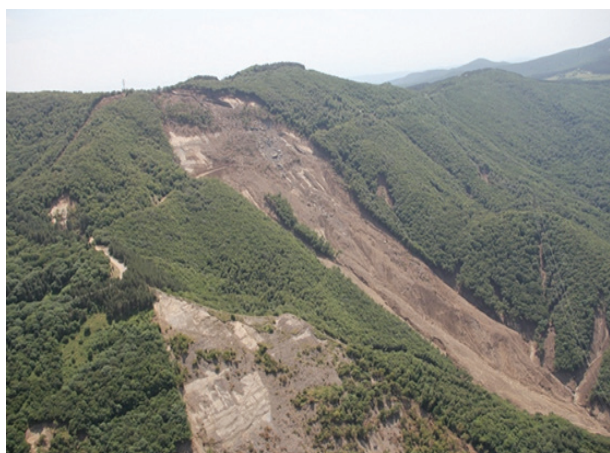
The largest landslide, near the village of Akhaldaba, affected around 32 hectares, displacing 1.3 km of ground to the junction with the Vere River and releasing around 1 million cubic metres of debris. It also destroyed around a section 600 metres long of the road to Akhaldaba (see Figure 7). This landslide was caused by extreme levels of rainfall, which resulted in high pore pressures in the landslide mass, which apparently fell in a translational “infinite slope” type of movement.

Figure 7: Akhaldaba landslide and destroyed road. The effects of an older large landslide are visible in the foreground.

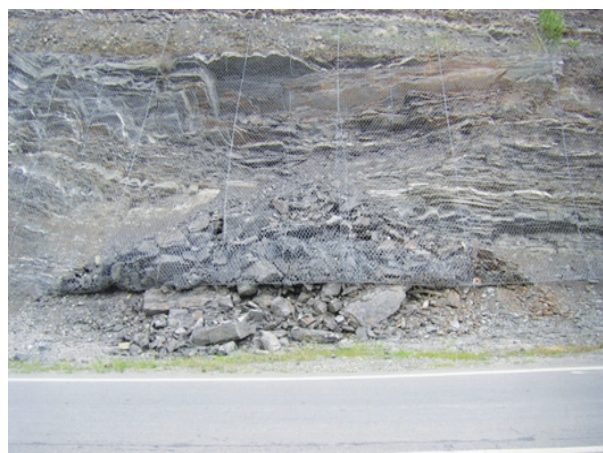
Other types of cut slope failures have also been observed along the Amirejibi Highway (see Figure 8)—and indeed on many other similar slopes in Tbilisi—where existing curtain netting protection is too weak to retain large blocks of rock and debris which could potentially fall into the Vere River. This is typical of sedimentary rocks such as the sandstone/siltstone flysch rock which predominates in Tbilisi.

Figure 8: Cut rock slope failure along the Amirejibi Highway. Stronger netting is required.

In these situations stronger and sufficiently anchored netting is required in order to retain potentially unstable blocks of rock in place.

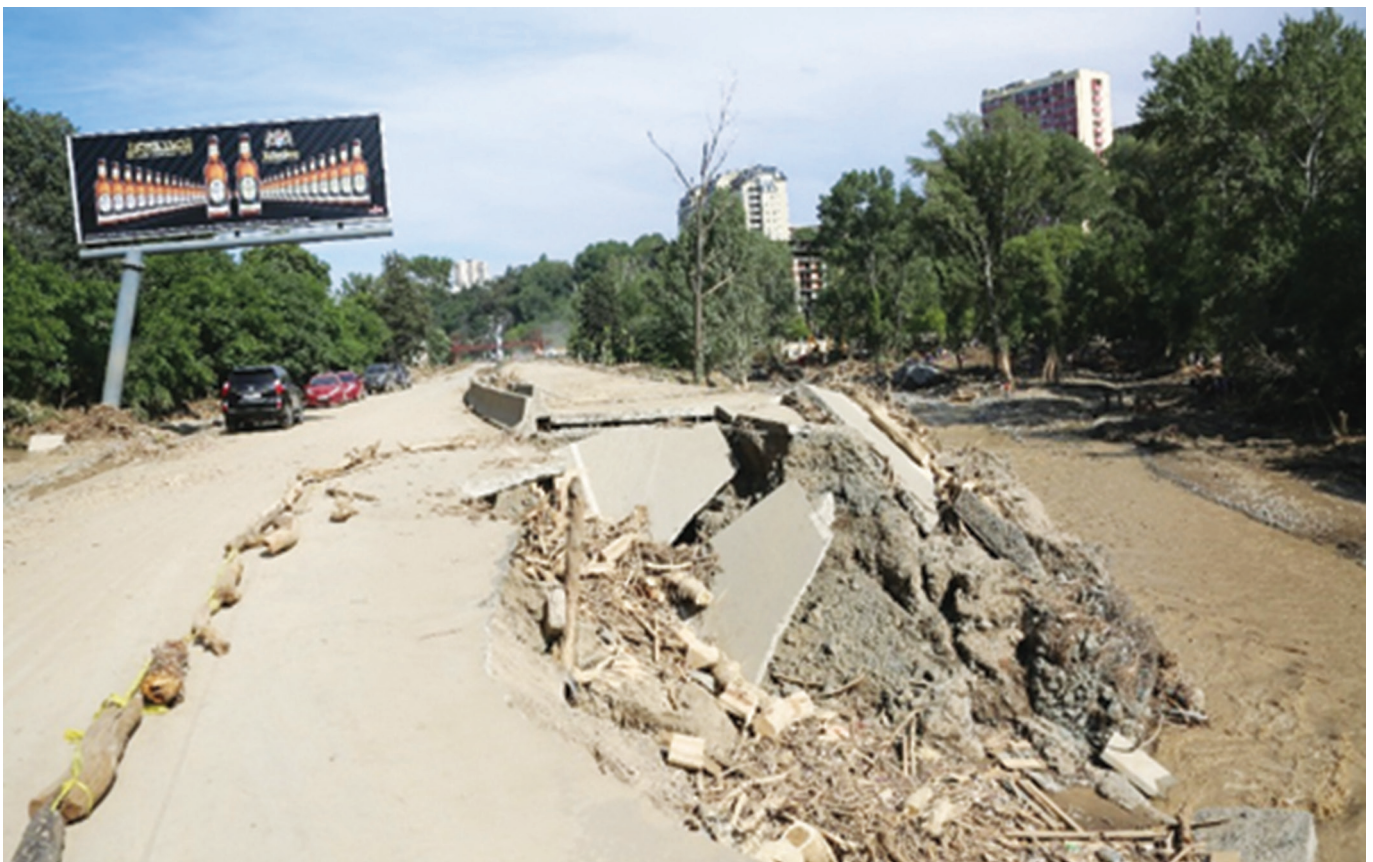
The most serious damage to transportation in Tbilisi which the floods of the 13th of June caused was the partial collapse of the Amirejibi Highway—one of the major arteries between the city’s Vake and Saburtalo neighbourhoods (see Figure 9). This has caused congestion elsewhere around the city, and has resulted in increased driver costs in terms of longer and slower trips between the western part of Tbilisi and the city centre.

Figure 9: A collapsed section of the Amirejibi Highway.

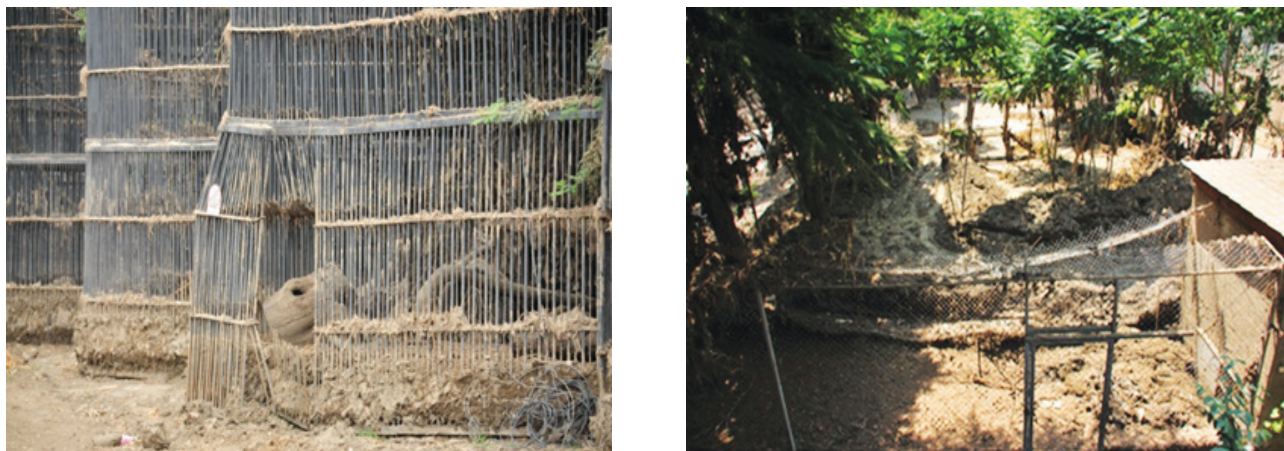
Figure 13. Destroyed Animal Enclosures

Buildings in the lower section of the Zoo were either partially damaged or completely destroyed by the floods. The damage noted in this section includes, but is not limited to, severe damage to the Zoo's utilities infrastructure (sewage, water, electricity and gas lines). Moreover, the main administrative building was half-submerged, resulting in the loss of all the administrative files—both electronic and on paper.¹⁴

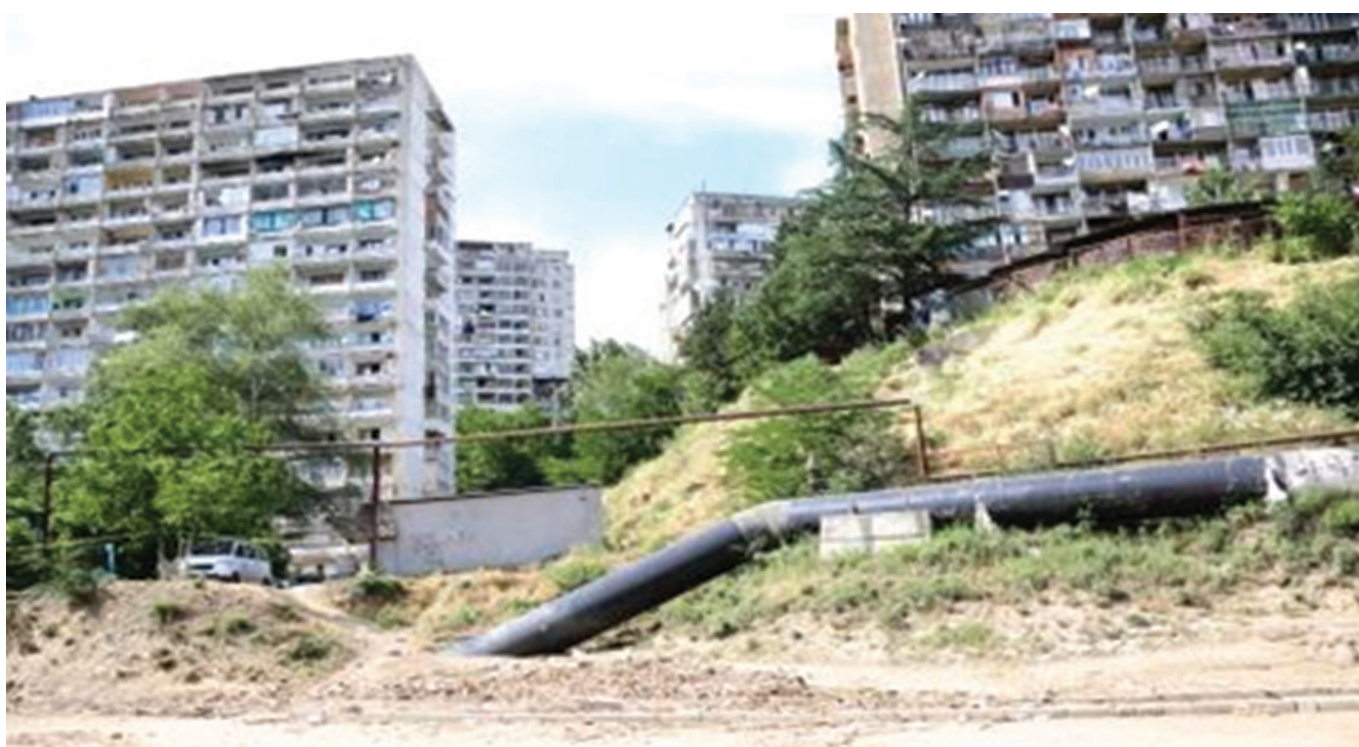
Figure 11. The 800 mm. high-pressure main water pipe

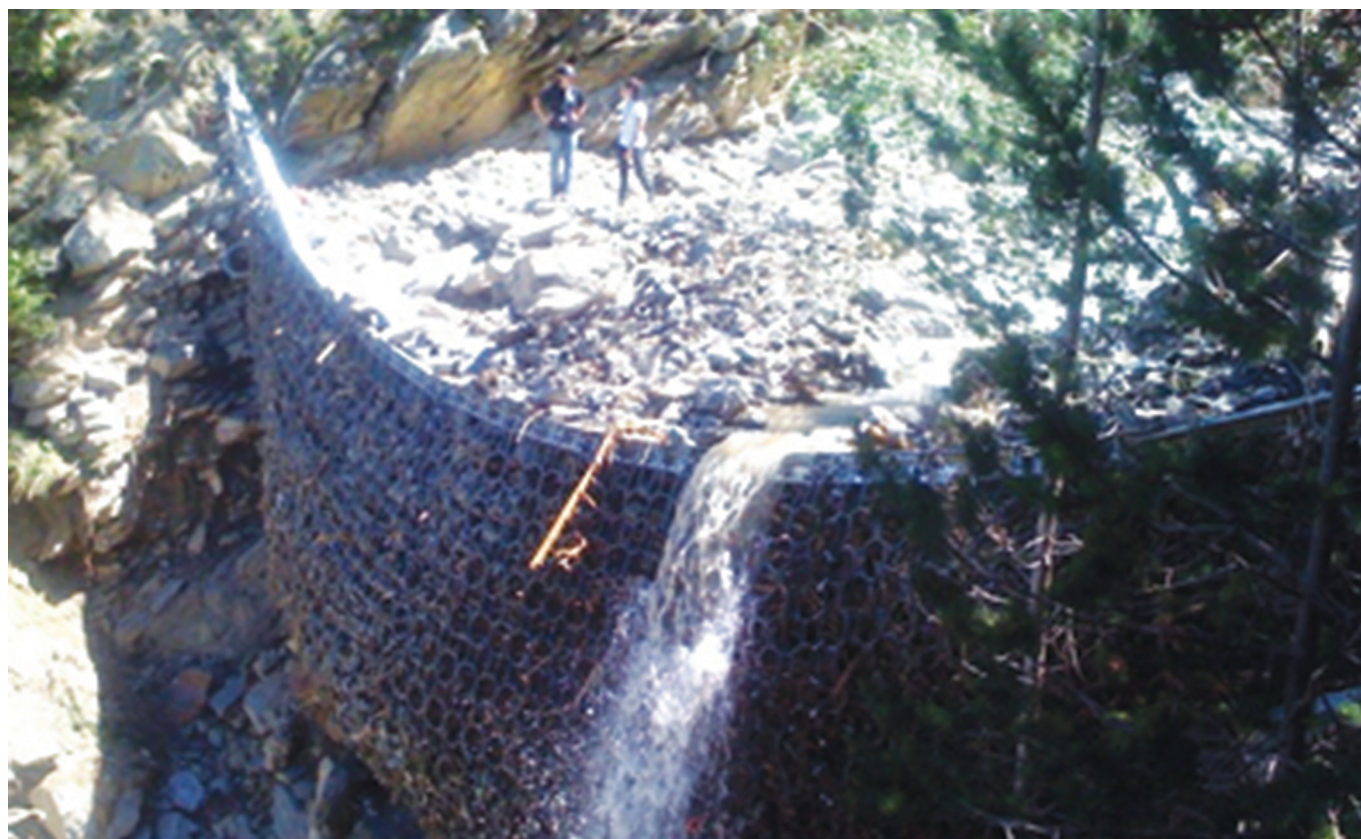
Figure 15: High-capacity debris flow steel nets

It is advisable that, following appropriate design preparation and based up on meteorological, geological and hydraulic data, the installation of debris barriers such as flexible high-strength steel nets (see Figure 15) will be considered in critical locations along the course of the Vere River and its tributaries.

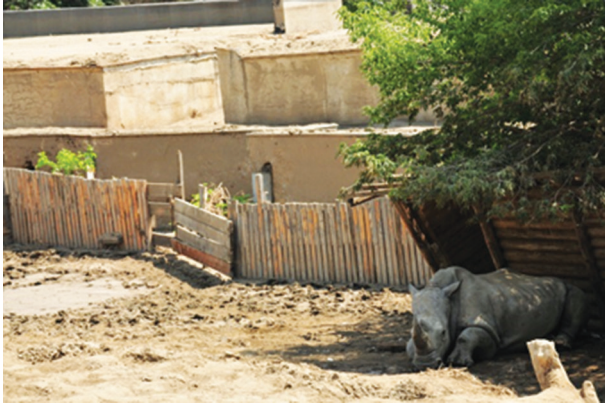
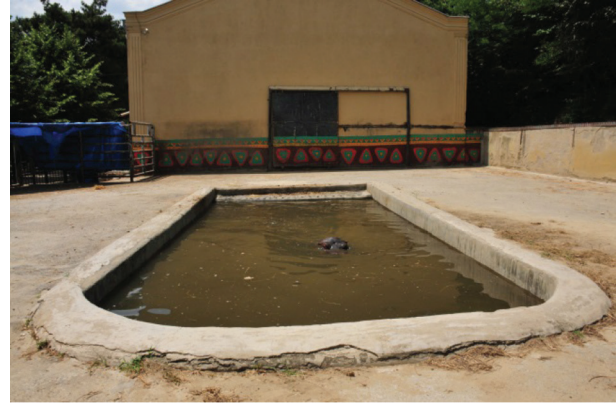
Figure 16. Damaged Animal Enclosures

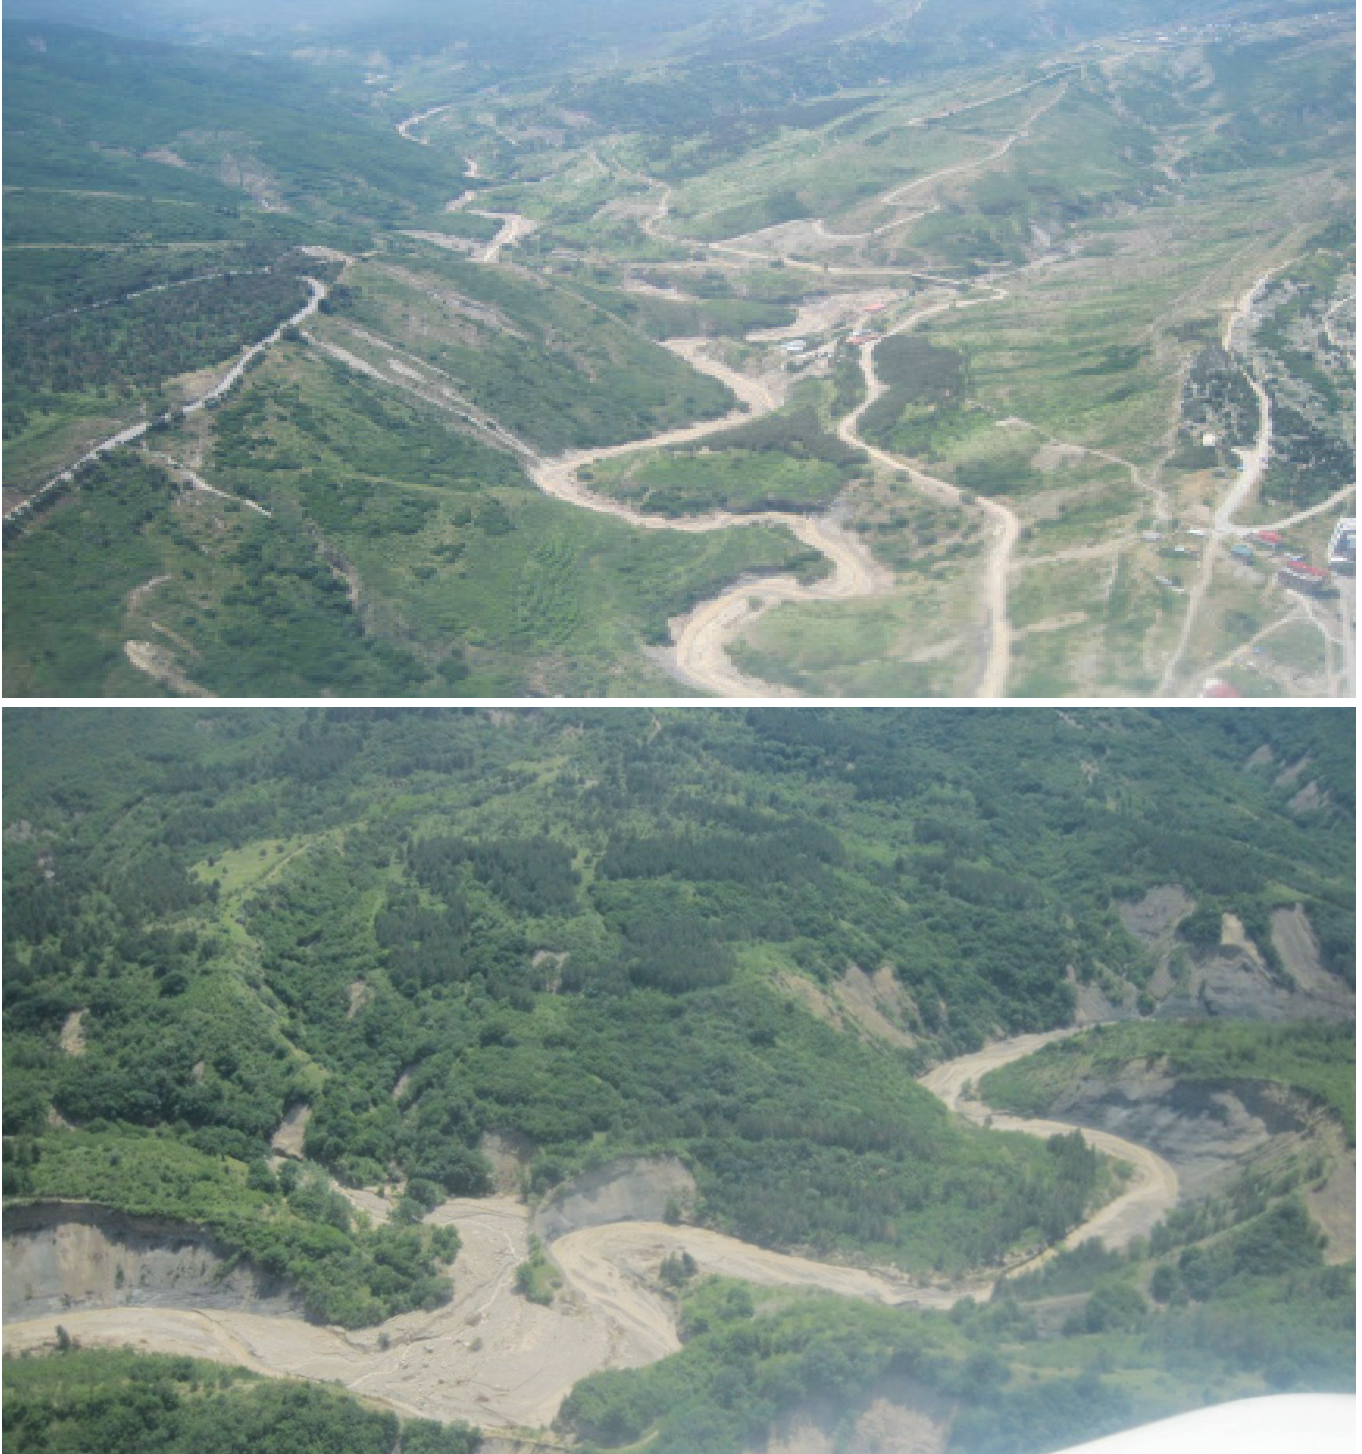
The Vere River upstream from Tbilisi city is confined by quite steep gorges and rock outcrops that permit some meandering but which are controlled by the outcrops (Figure 4).

Figure 4. Vere River Upstream from Tbilisi - Possible locations for some River Training.

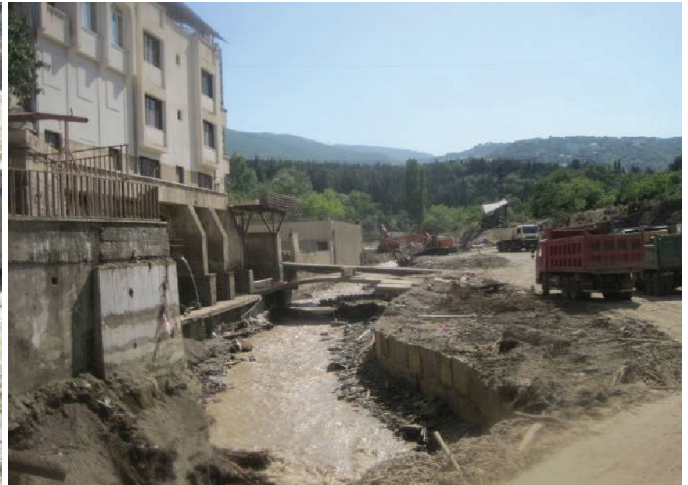
Photo 3.2 River Encroachment u/s from 1958 Tunnel

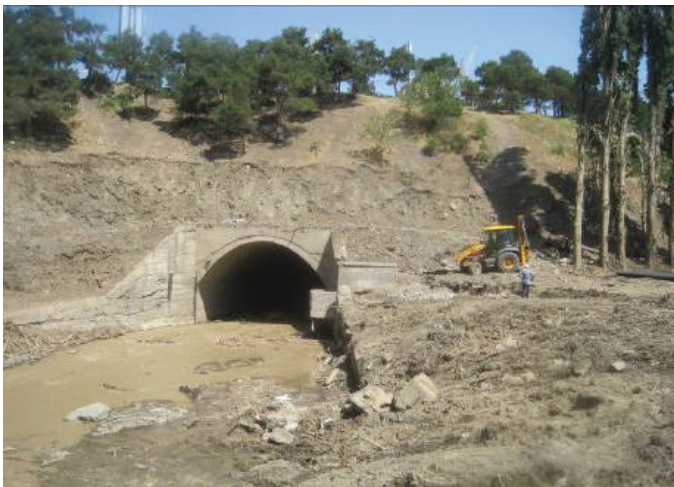
Photo 3.3 Inlet to 1958 Tunnel Cleared After Flood

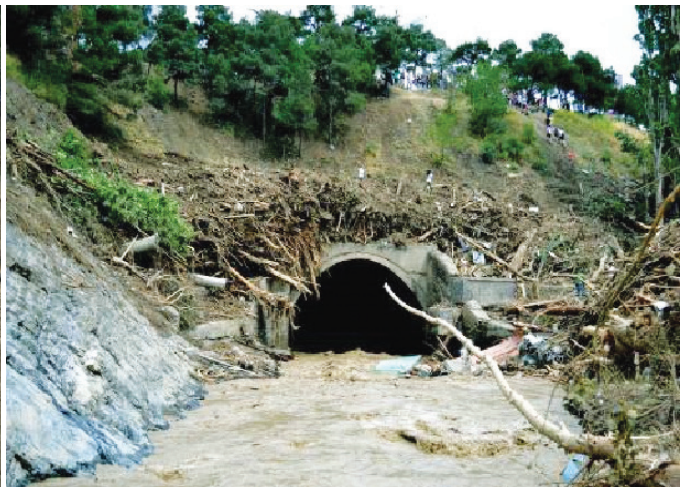
It was then impossible for debris laden flood waters to pass unhindered through the tunnel and this caused the water level upstream from the tunnel to rise between 5 and 10 metres (Photos 3.3 & 3.4) and caused flooding of Svanidze Street and neighbouring buildings.

Photo 3.4 Inlet to 1958 Tunnel after Flood

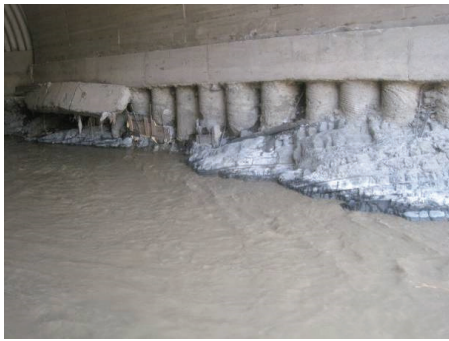
Eventually, the high head of water (10m = 1 atmosphere) was sufficient to create an hydraulic explosion that cleared the blockage. Unfortunately this created a surge flow down the entire tunnel system that had such a high velocity (>5m/sec.) that not only brought much of the deposited sediment back into suspension, but also caused considerable damage to other tunnels, downstream river banks undermining buildings and anything in the flood flow path.

Photo 3.5 Outlet from Tunnel 6 showing extent of Scouring of Bed

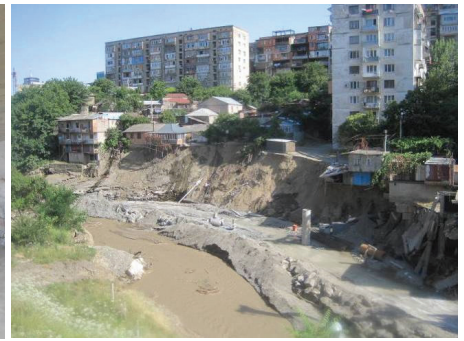
Photo 3.7 Flood Scoured RB of Vere River d/s from Tunnel 6 showing undermining of Buildings

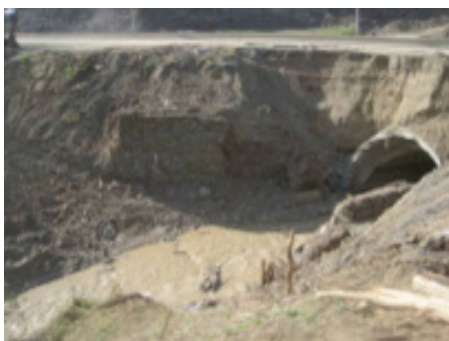
Additional debris and material (wooden houses; retaining walls; etc) were washed down the river together with newly eroded river bank material. This initially blocked the entrance to Tunnel 5, and caused the water head over the inlet of the Tunnel to increase encouraging a repeat of the process that affected tunnel 6 and caused overland flow until the hydraulic pressure again removed the blockage “explosively”. This sudden release created more hydraulic surges, shock waves and high velocities of flow as the flood discharge passed further downstream. With the series of tunnels/culverts separated by open channel sections, the elevated velocities created in the confined tunnel sections decreased once the flow reached the open flow sections and this in turn resulted in greater water depths and deposition of suspended sediment.

Photo 3.8 Flood Damaged Entrance to Tunnel 5

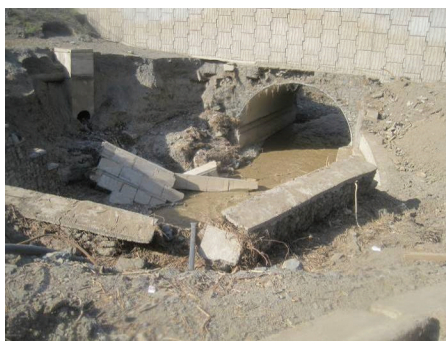
Photo 3.9 Flood Damage to 2nd Part of Tunnel 5

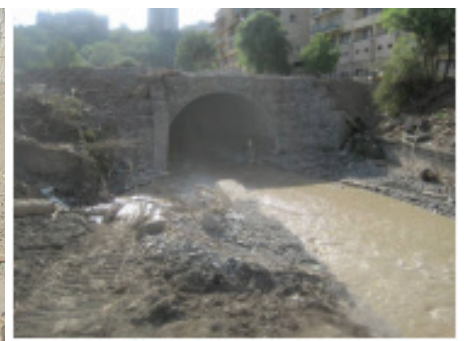
Photo 3.10 Flood Damaged Exit to Tunnel 4

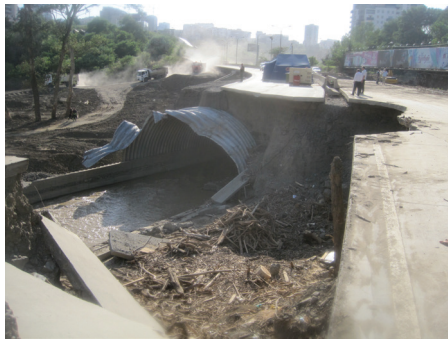
The whole process was repeated down the tunnel system. This is evidenced by the considerable material distortion at the entrance and outlets of subsequent tunnels and downstream damage (Photos 3.5 to 3.13). At the exit to Tunnel 2, the excessive velocities washed away the last 10 to 15 metres of the culvert, undermined the two carriageway highway that crossed over it and caused deep flooding and sedimentation in the Mziuri Park on the right bank.

Photo 3.12 Flood Damaged Exit to Tunnel 2

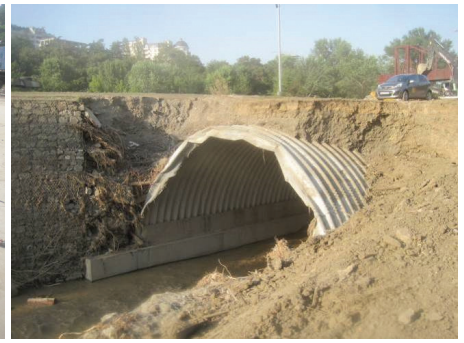
Photo 3.13 Flood Damaged Entrance to Tunnel 1

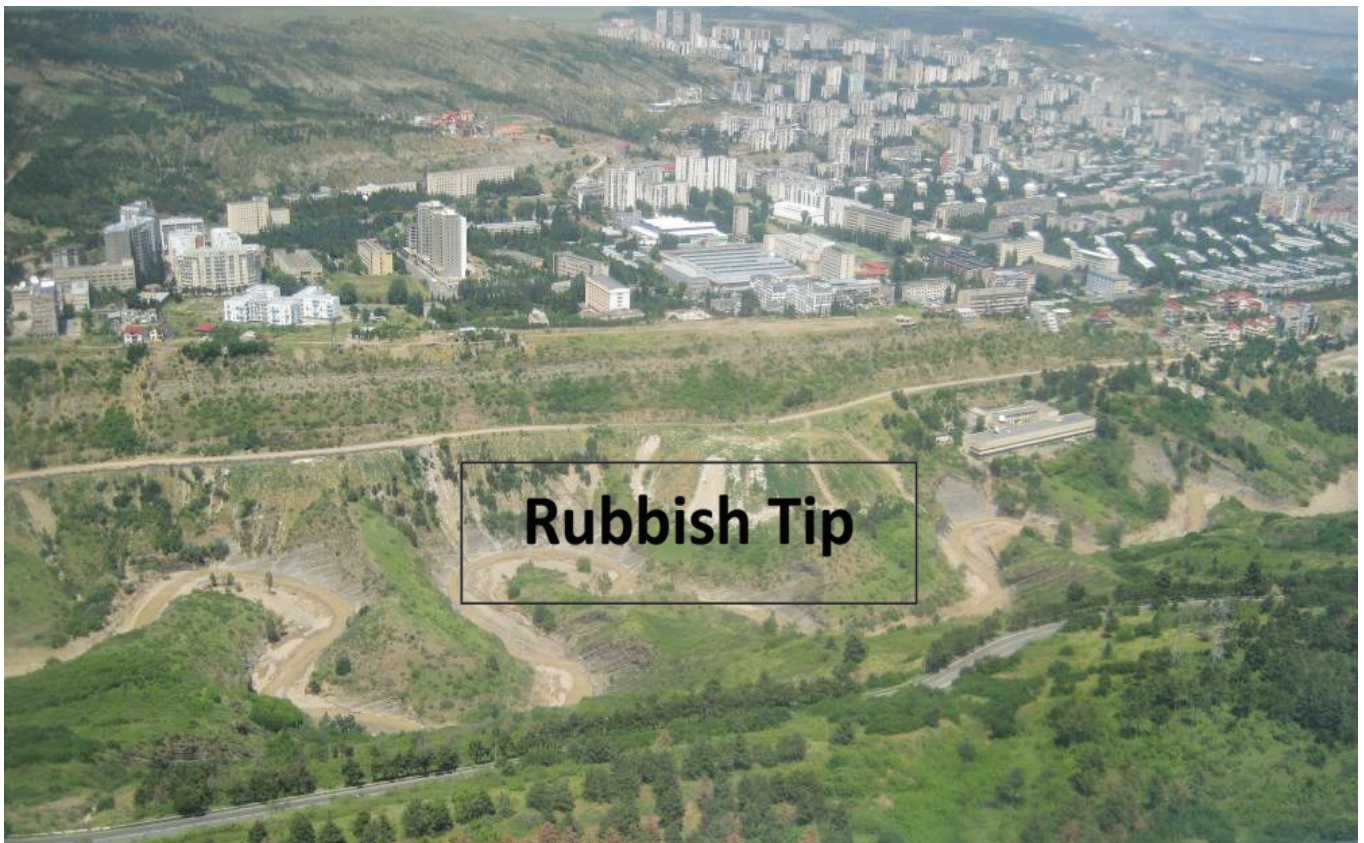
Photo D.7 Proximity of Rubbish Tips to Tbilisi and Vere River as it Approaches the City

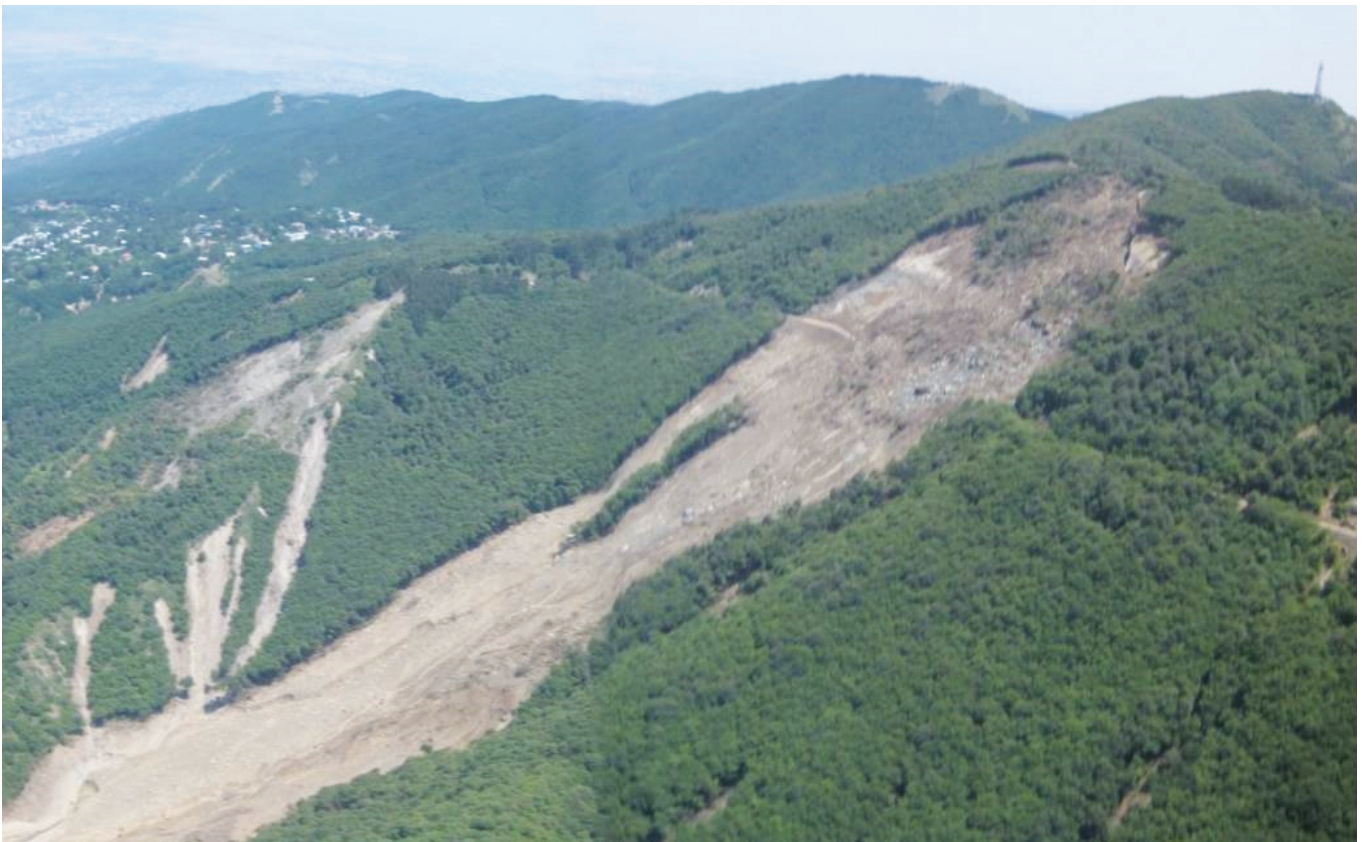
Photo E. 3. Largest landslide settled towards Akhaldaba village.

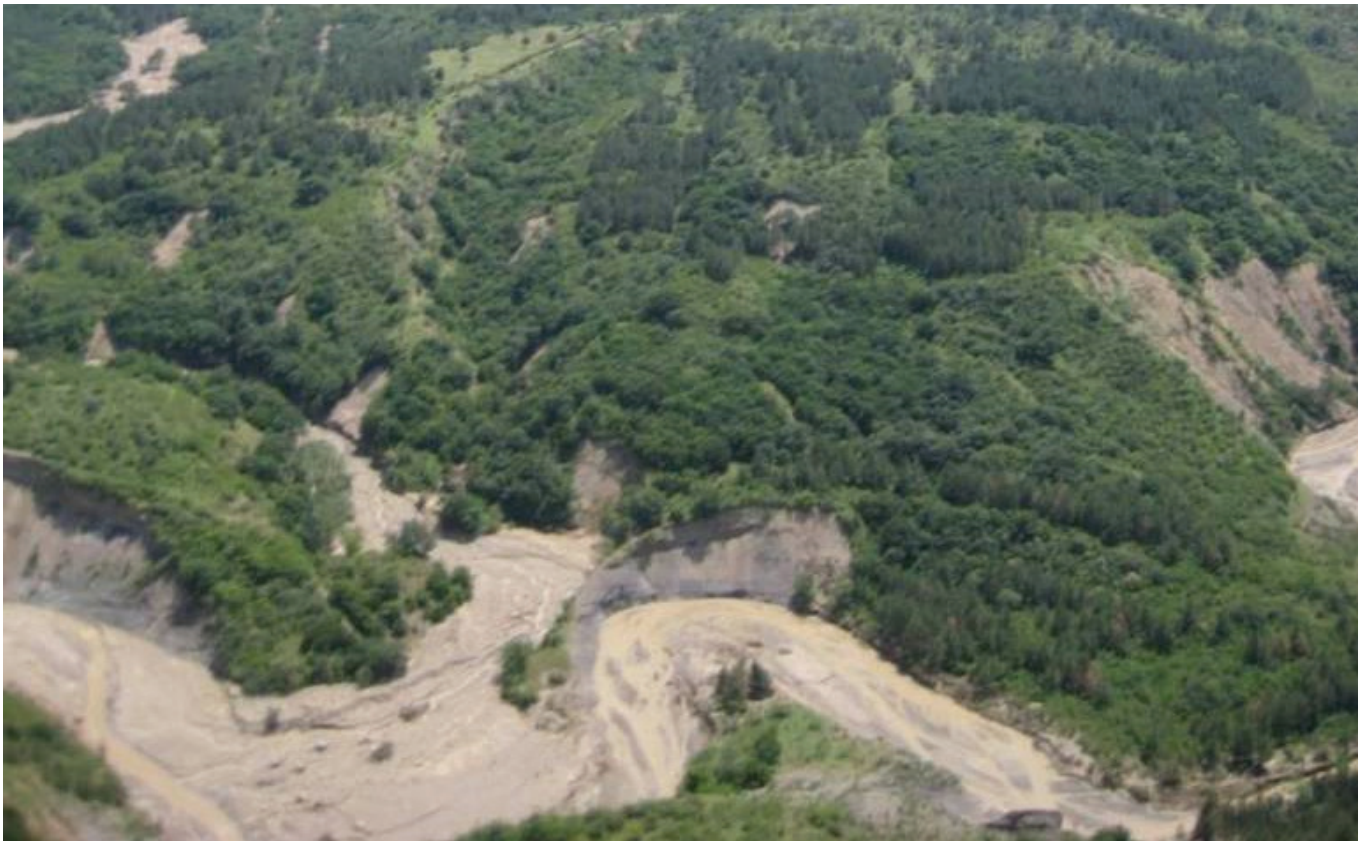
Photo 4 E. View from downstream of landslide towards Akhaldaba village and related over silting for debris flow in Vere watercourse

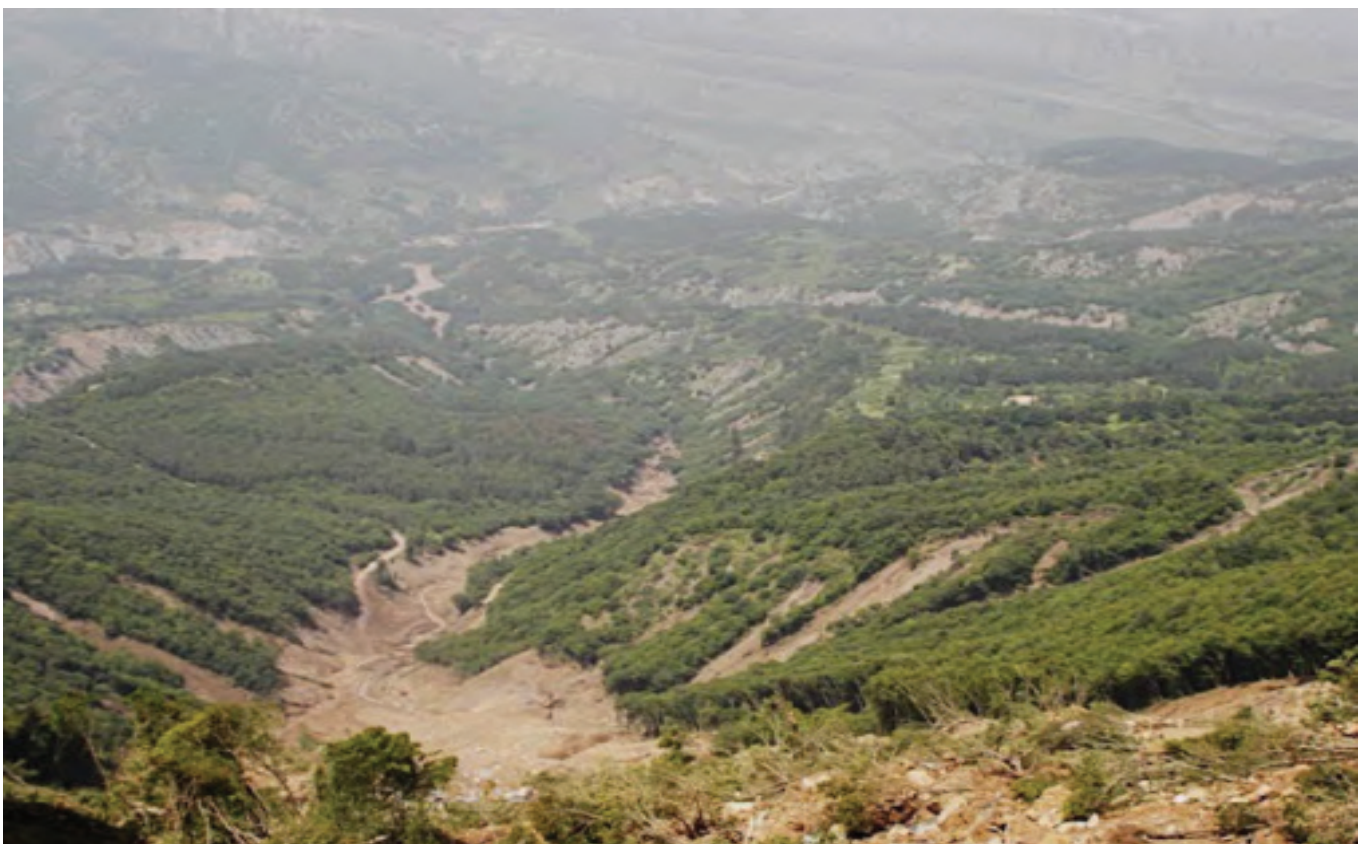
Photo E. 5. Largest landslide settled towards Akhaldaba village. View from above towards Vere River

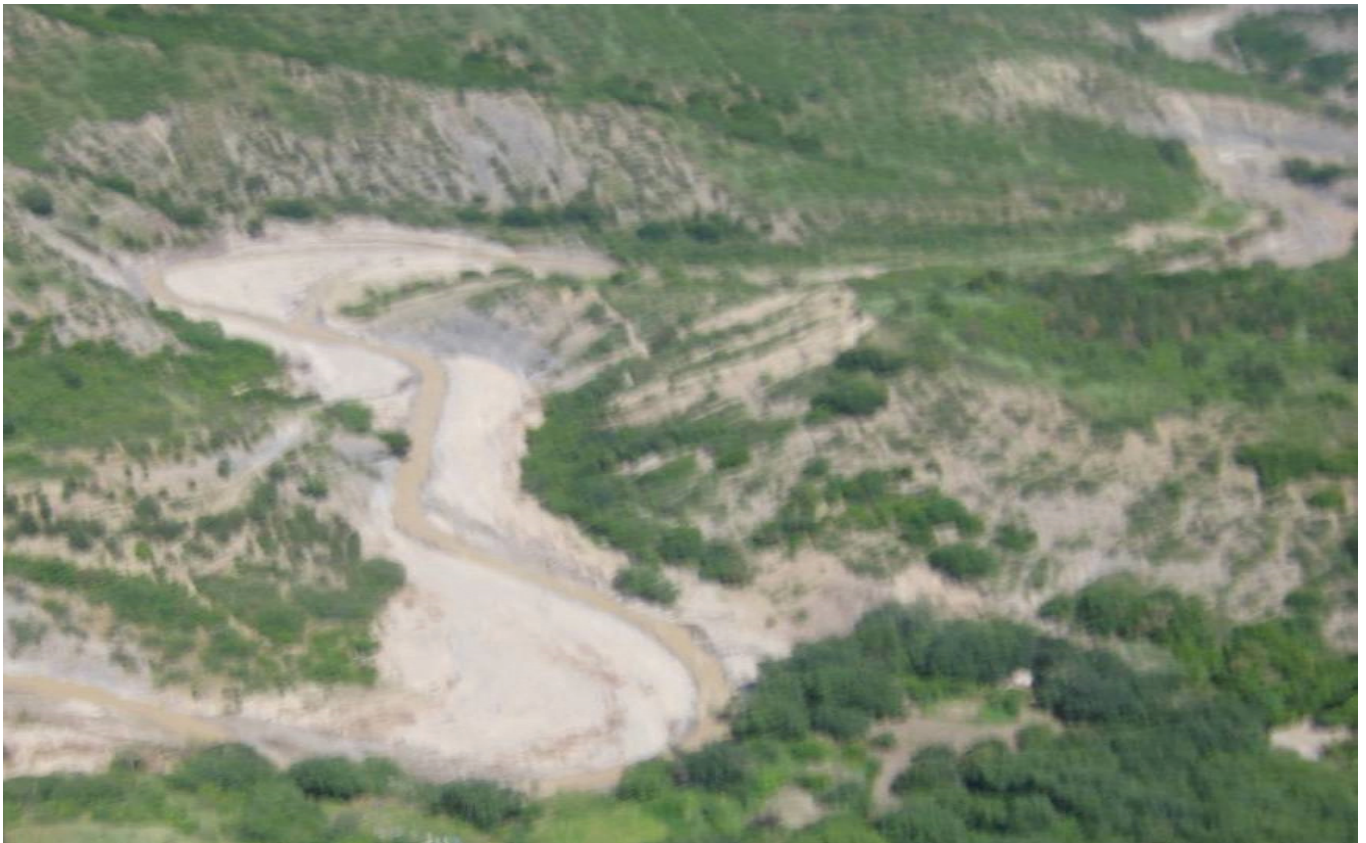
Photo E. 6. Sedimentation in Vere river

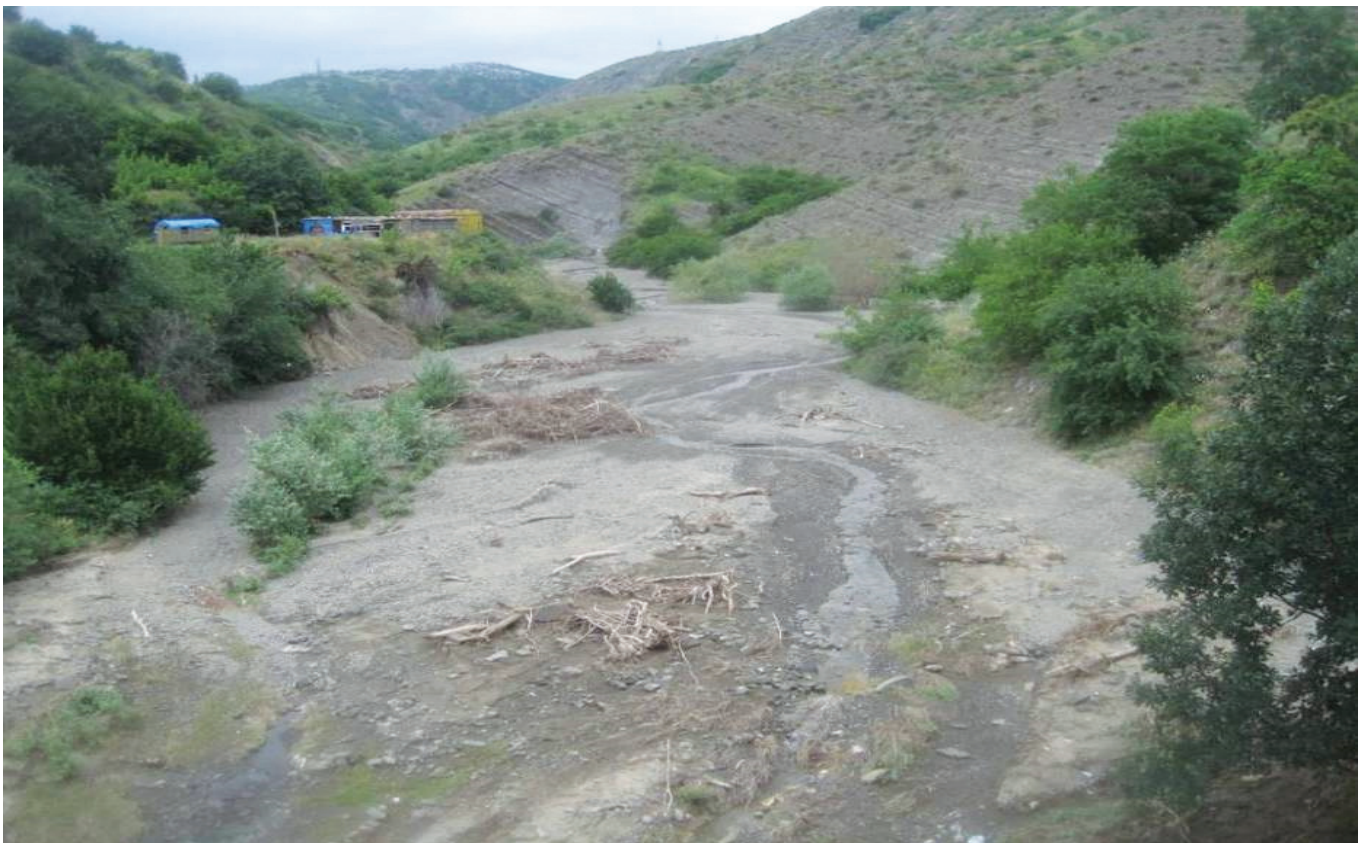
Photo E. 7. Sedimentation in Vere Catchment

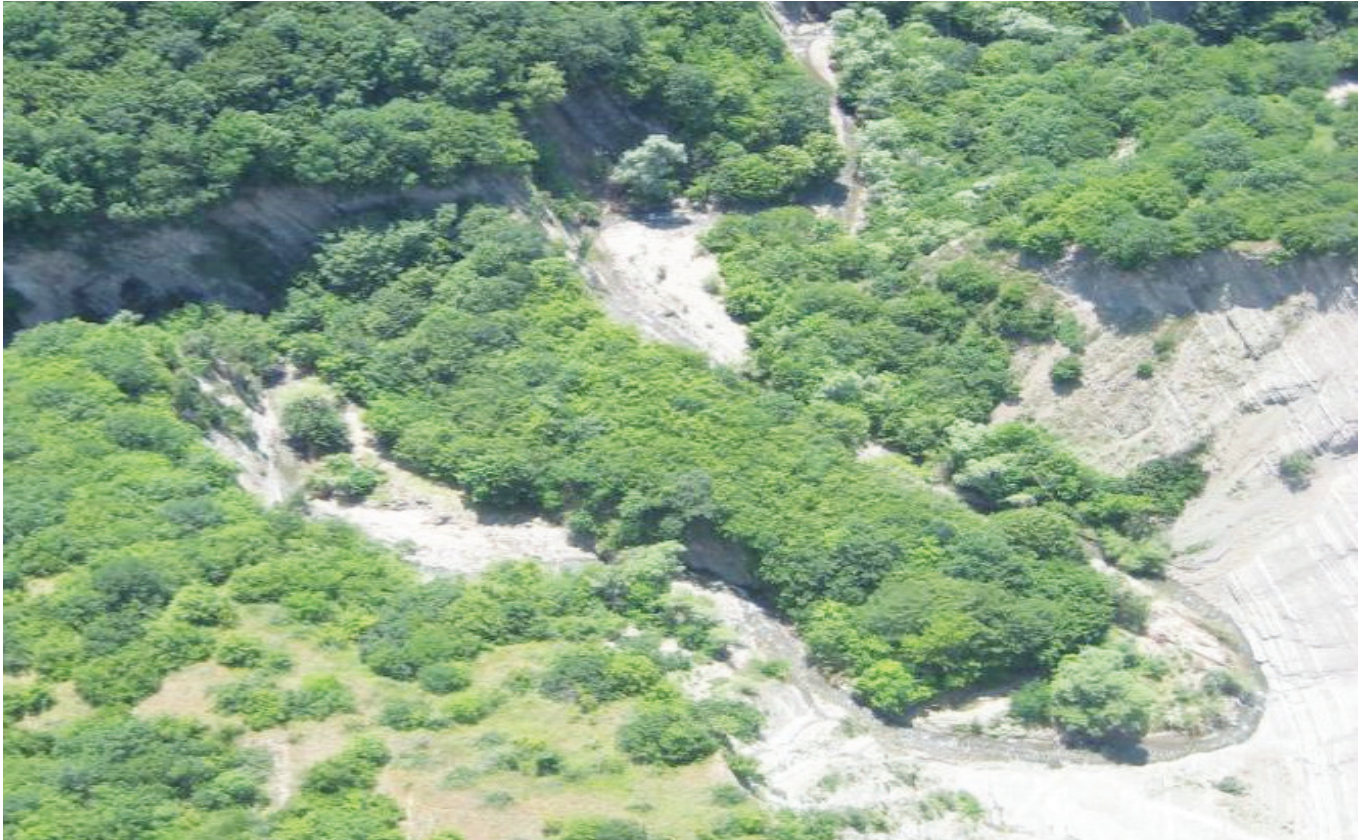
Photo E. 8. Soil Slips

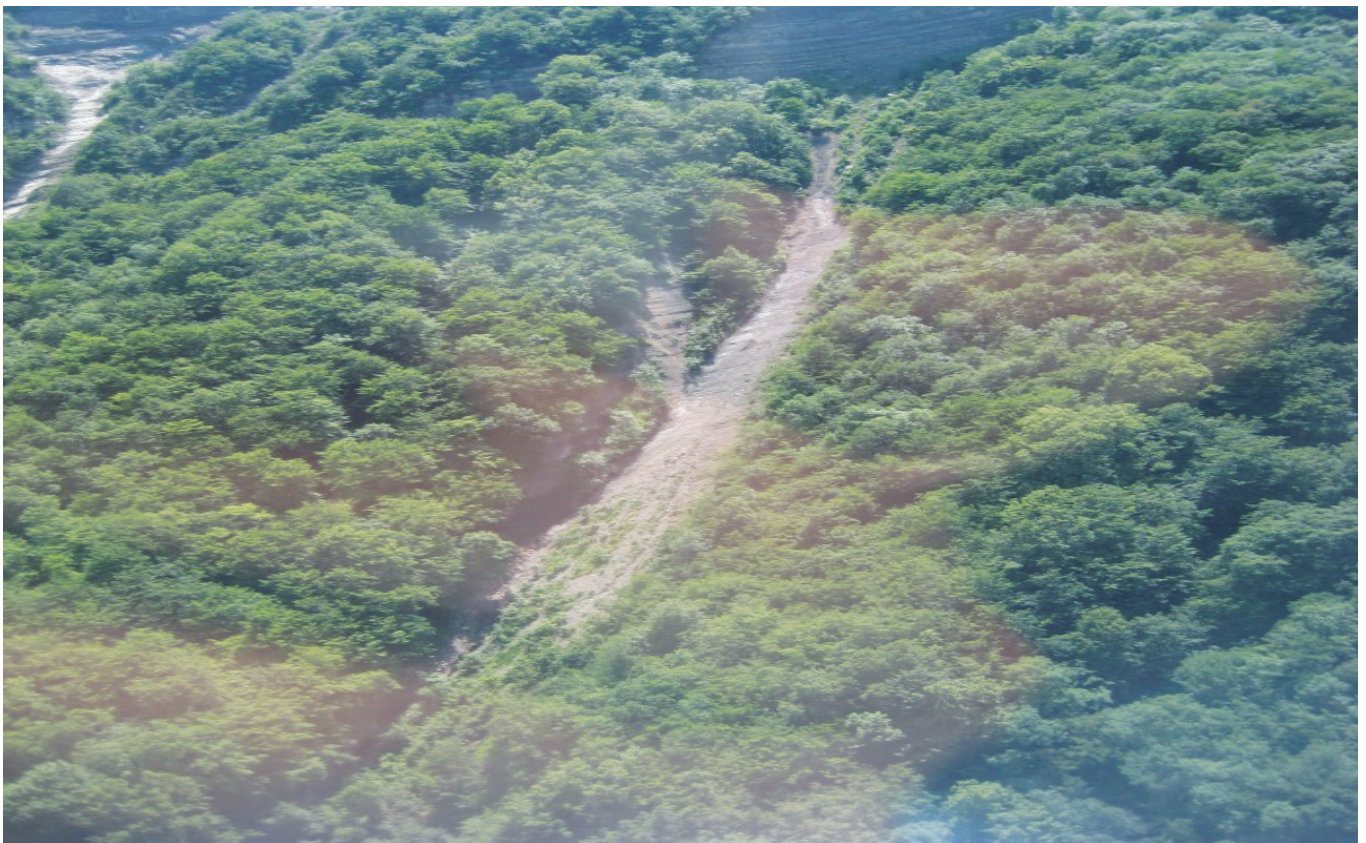
Photo E. 9. Soil Slips

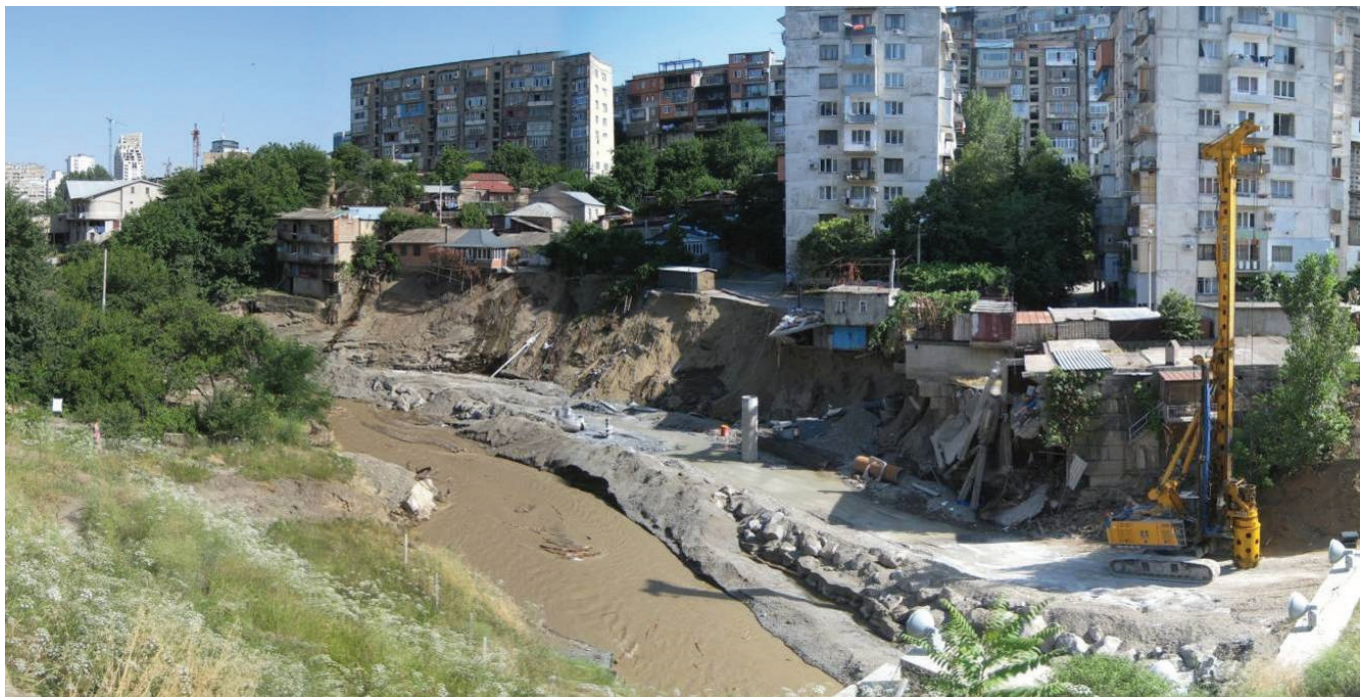
Photo E. 13. Unstable right river bank in this section between Tunnel 6 and 5

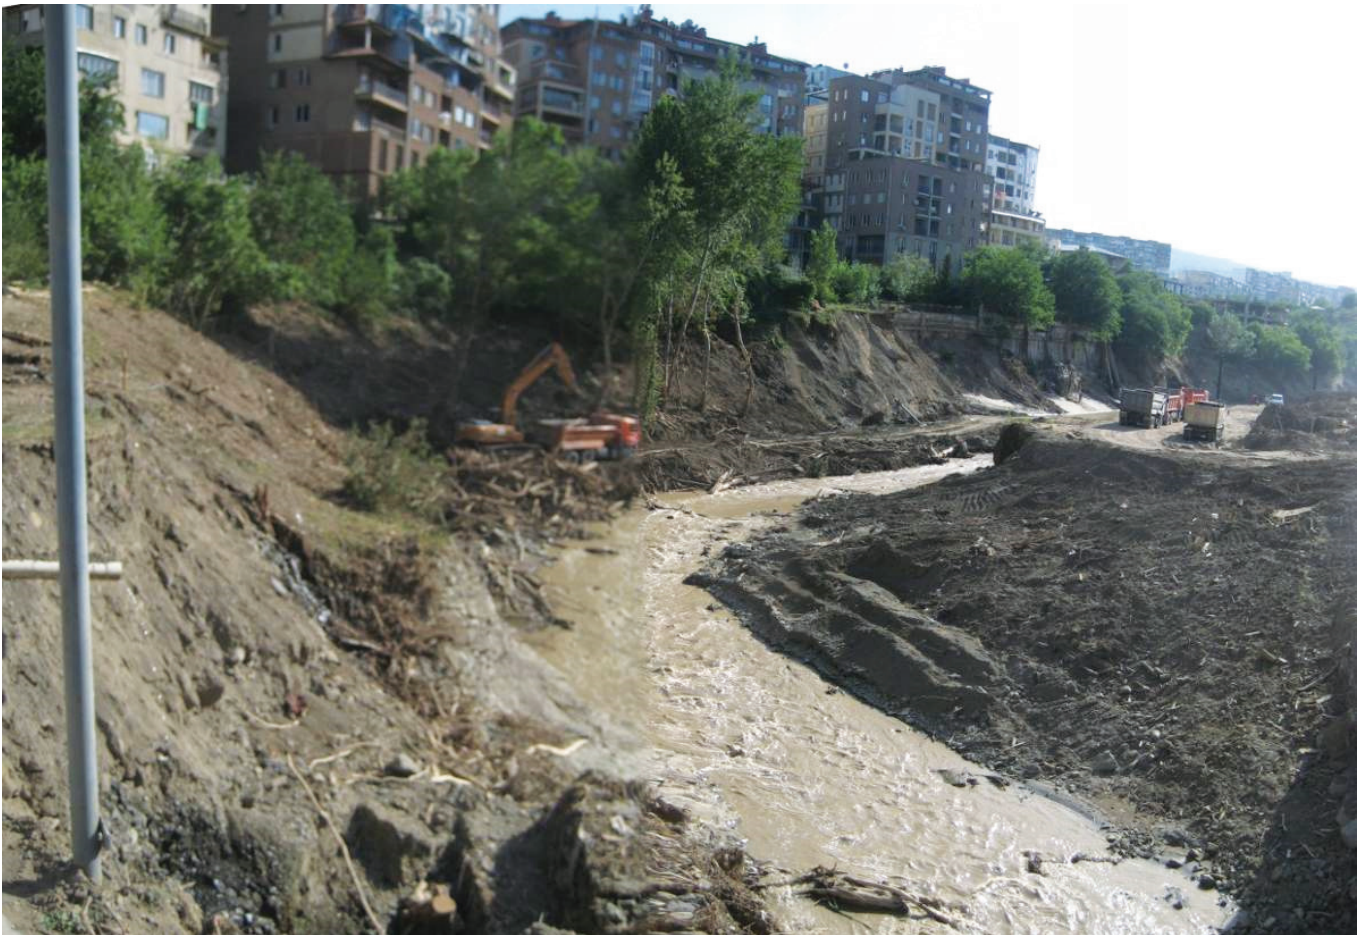
Photo E. 14. Unstable right river bank in this section between Tunnel 6 and 5
