TBILISI DISASTER NEEDS ASSESSMENT 2015

FINAL DRAFT
2 September, 2015

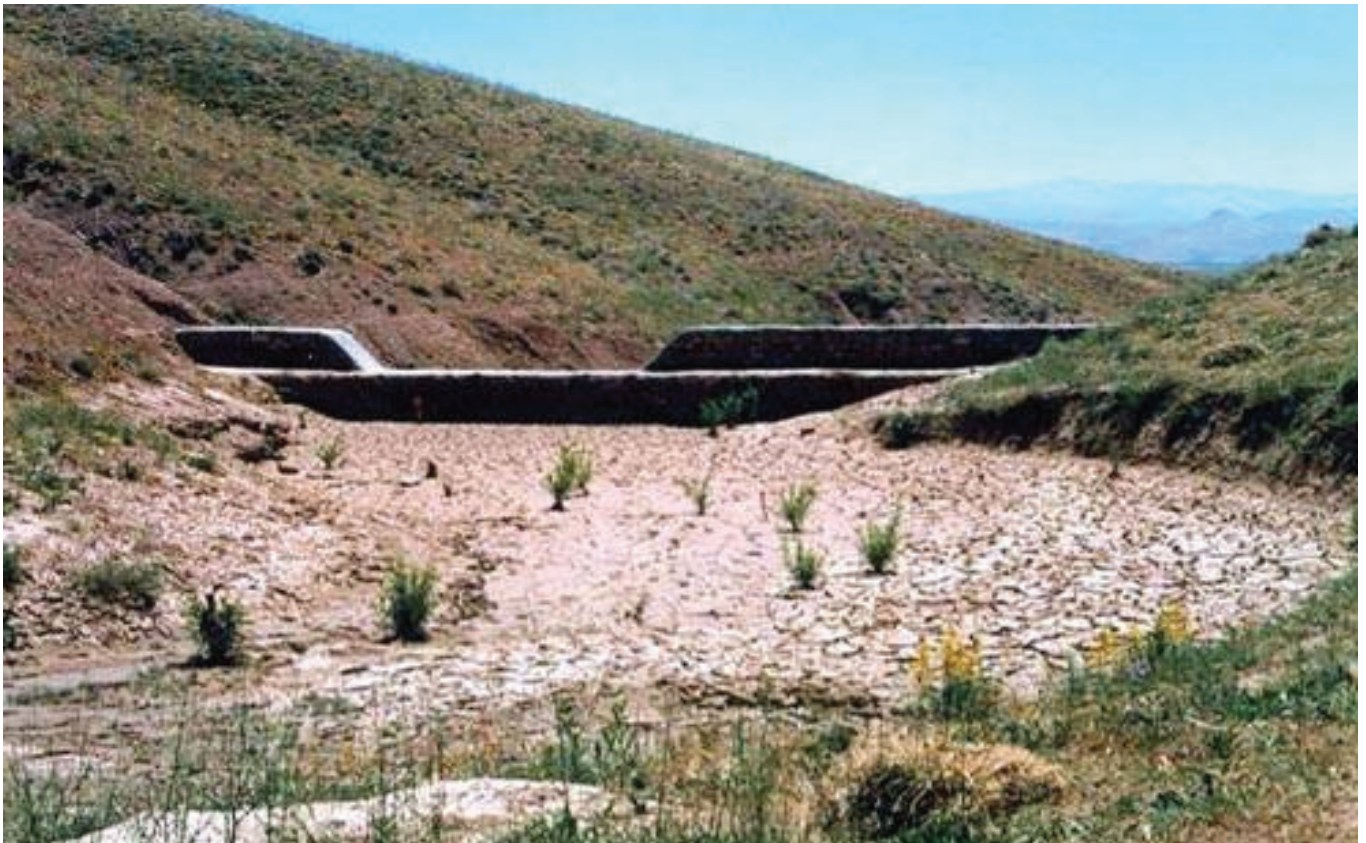
Photo E. 17. Check dam, Gabion Weir

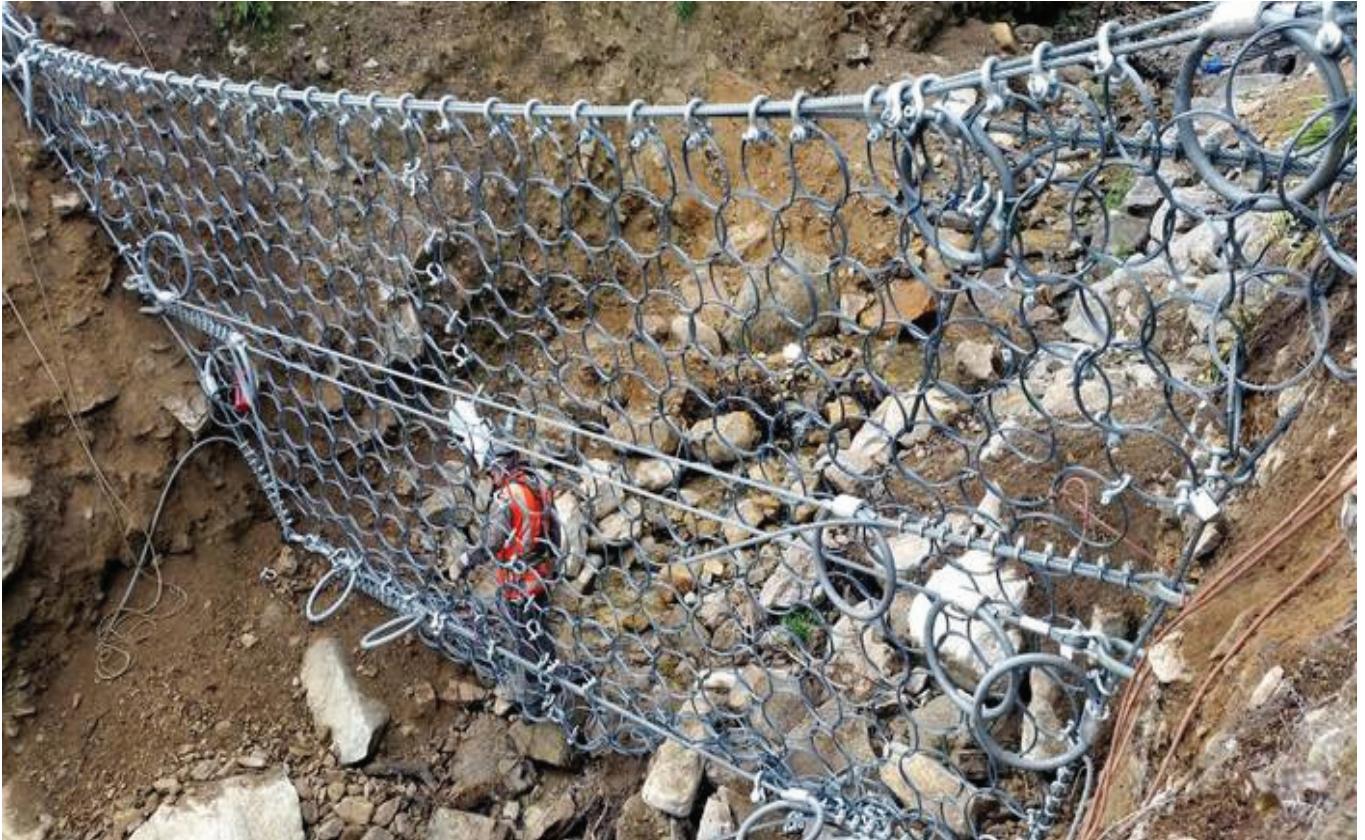
Photo E. 23. Debris flow barrier for secondary watercourses

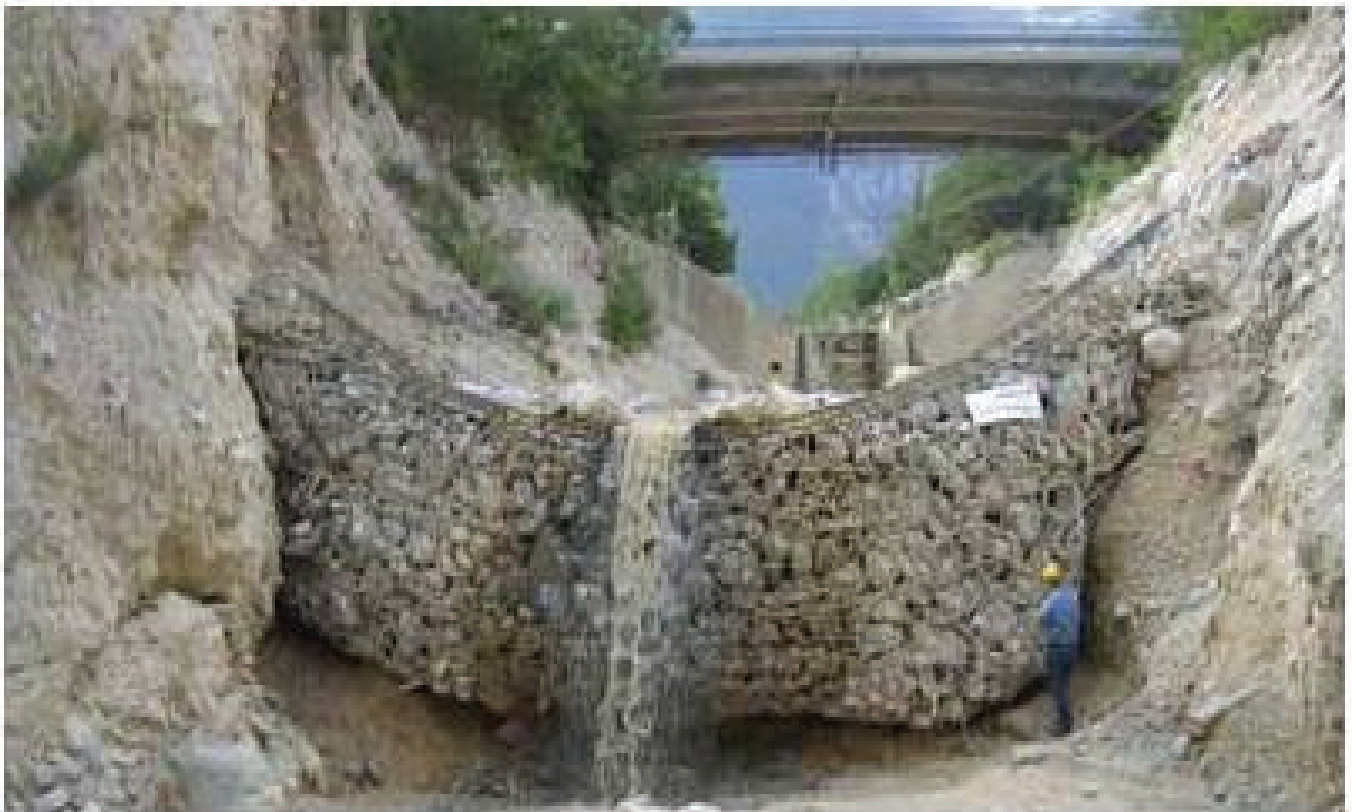
Photo E. 24. Debris flow barrier for secondary watercourses, with debris materials collected, it forms a natural weir

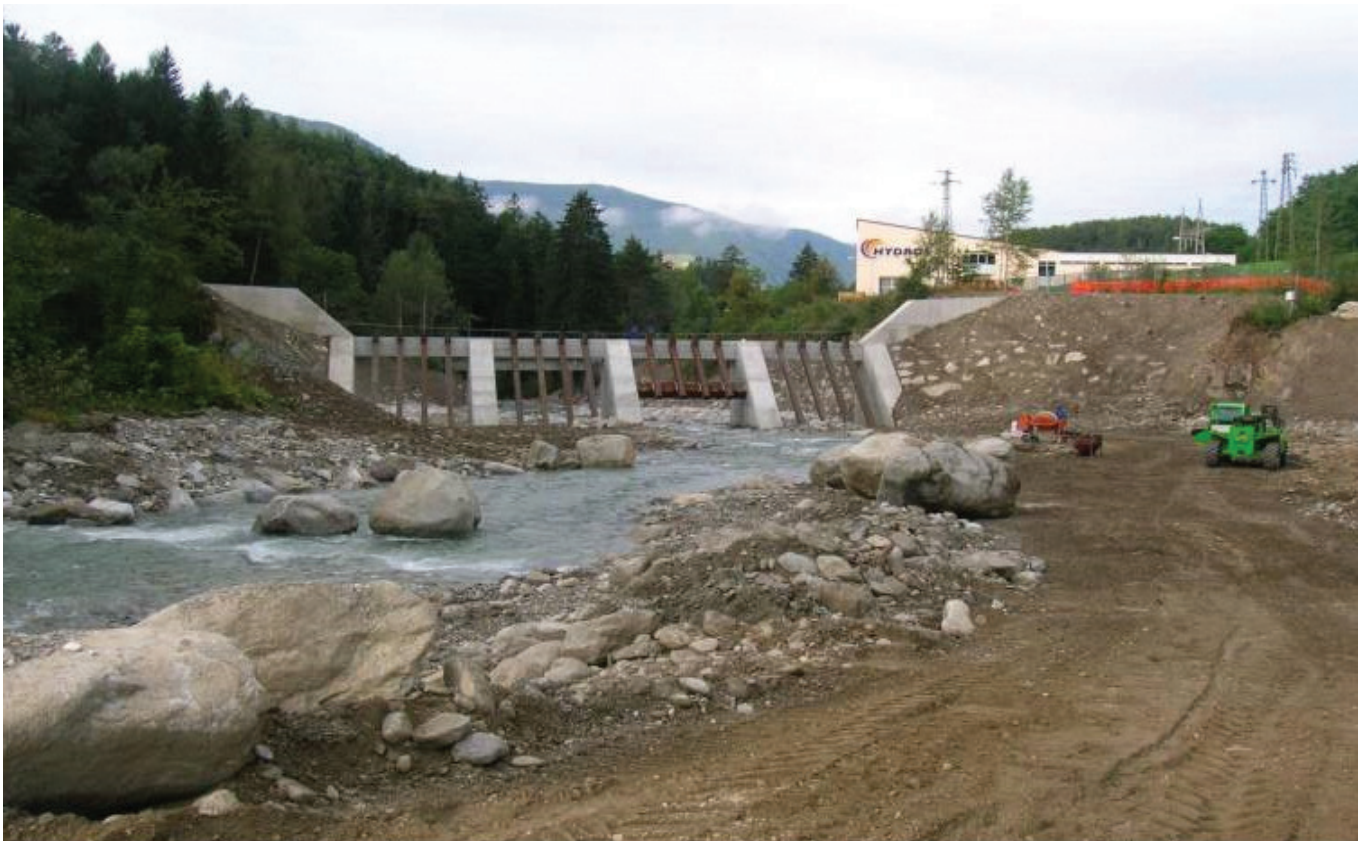
Photo E. 27. Selective Barrier for floating load (debris timber)
