# 1 Expanded subsidy system

## Session3

# Conducted the annual surveys with results disclosed to the public

## Proposed guidelines for making buildings earthquake resistant, showed examples of progressive efforts

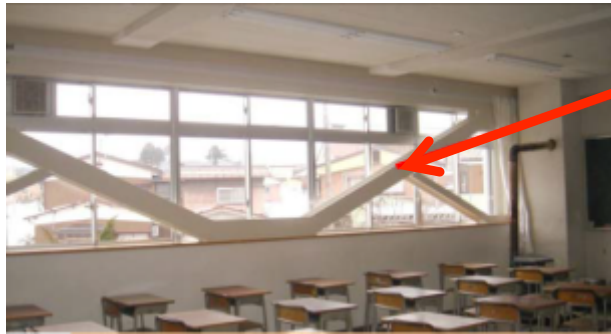
**Steel brace has been added**

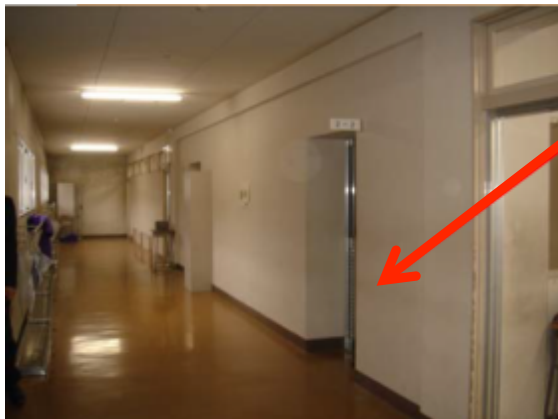
**Shear wall has been added**

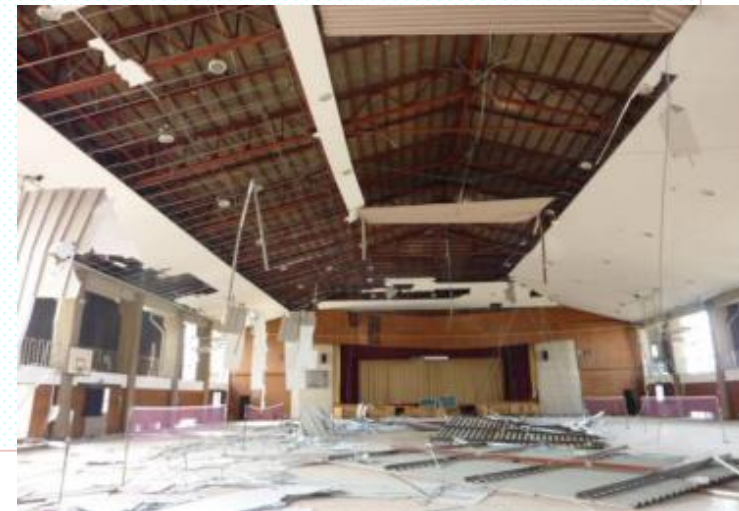
The gymnasium's ceiling collapsed

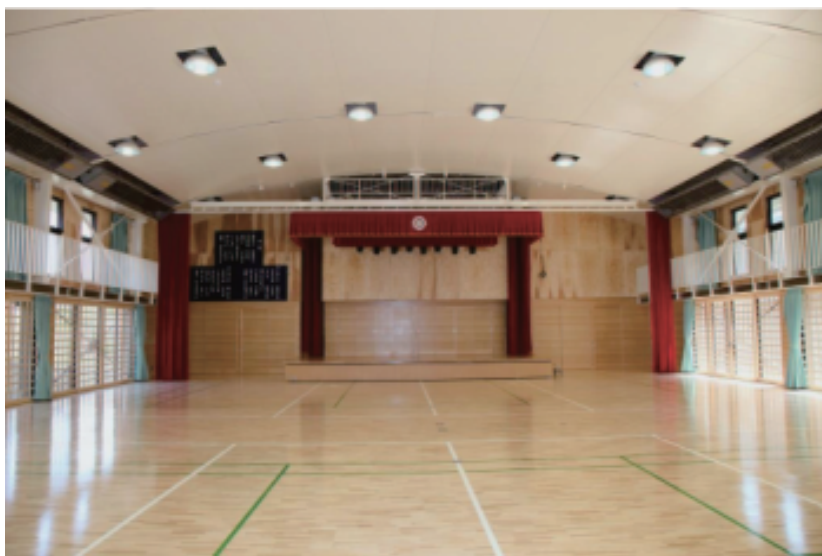
Removal of ceiling

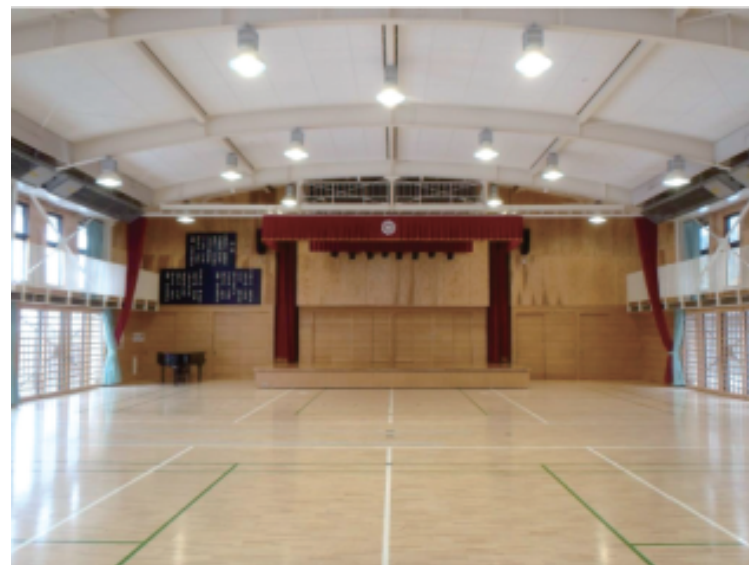
Example where the ceiling is removed

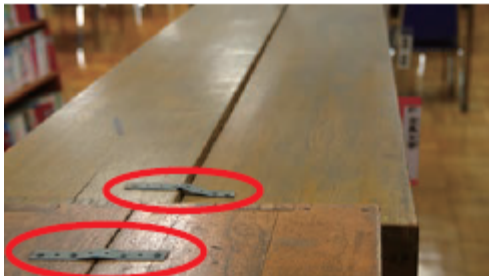
Example where racks are combined and attached together.

Are racks and lockers fixed to walls or floors with metal fittings?

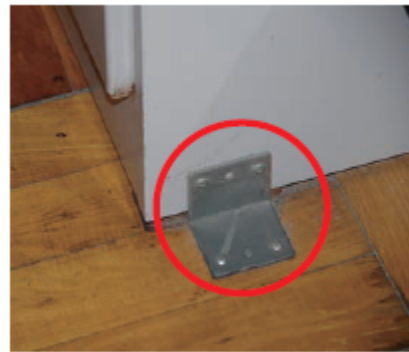
Example where the bottom of a rack is attached to the floor

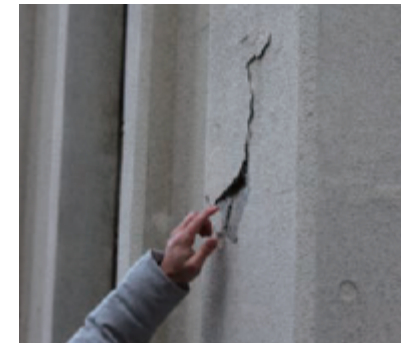
Flaking of mortar

Is there any flaking, chipping, cracking, or floating?

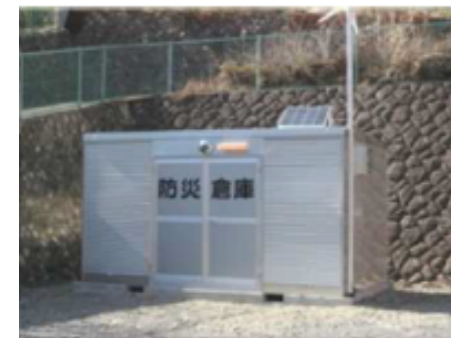
Stockpile warehouse

- \* It is important to secure a stockpile according to the assumed number of evacuees in a place safe from disasters

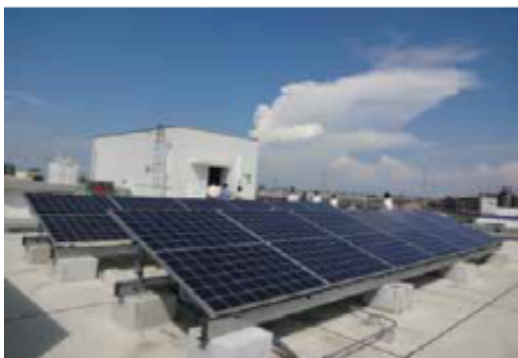
Photovoltaic power generation equipment capable of self-sustaining operation

- \* It is important to store portable generators, etc. to secure power for lighting and other equipment. It is desirable to install photovoltaic power generation equipment capable of self-sustaining operation.
- \* It is important to secure LP gas, portable gas stove, etc. as a heat source for cooking because the existing heat source may become unusable.

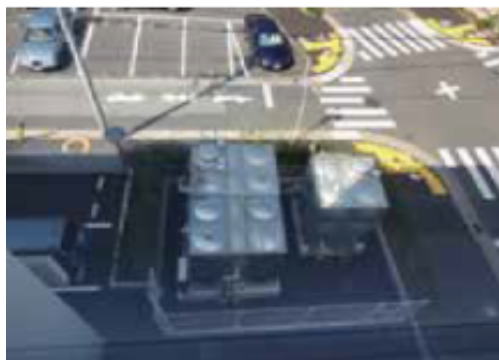
Installation of large water-collecting tank

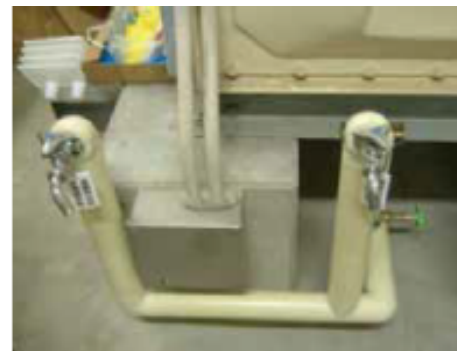
Installation of faucets to an water receiving tank

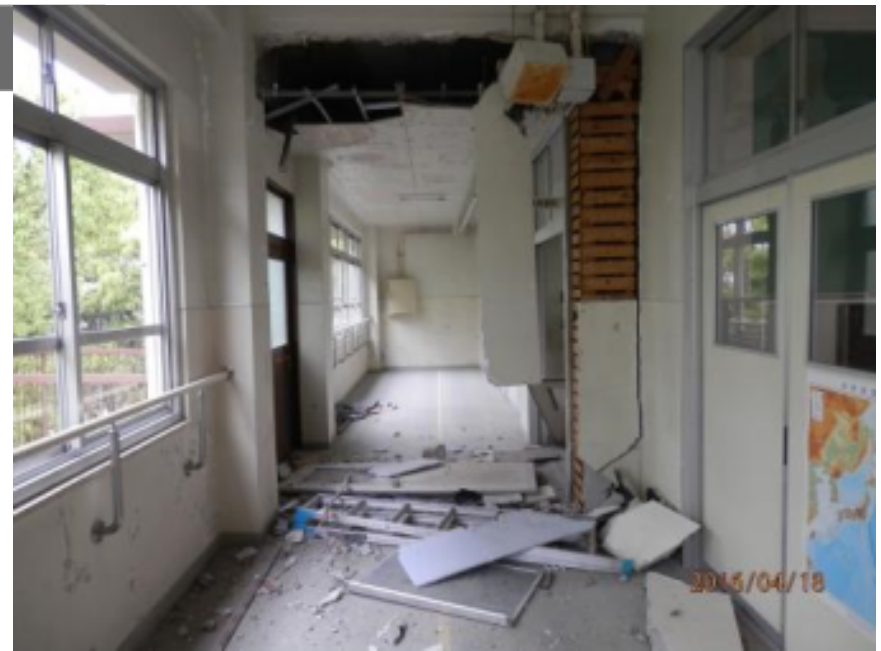
The corridor's ceiling collapsed

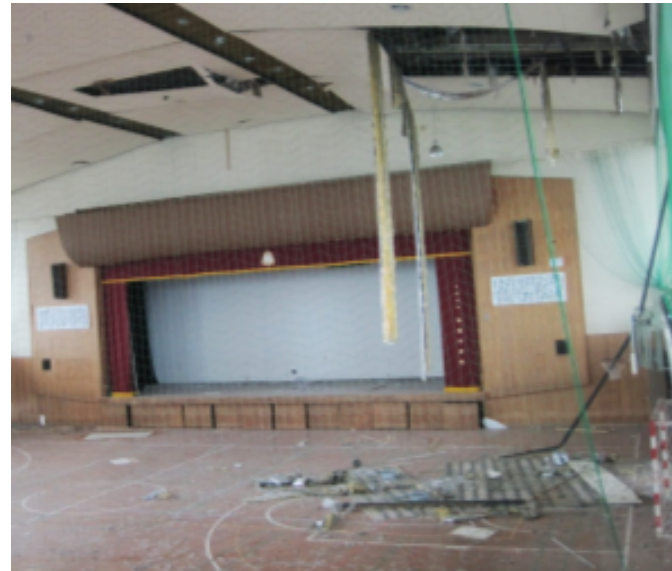
The gymnasium's ceiling collapsed

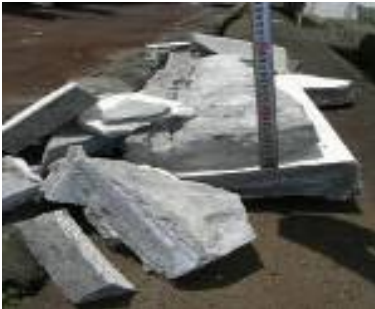
External wall's mortar fell down due to aging

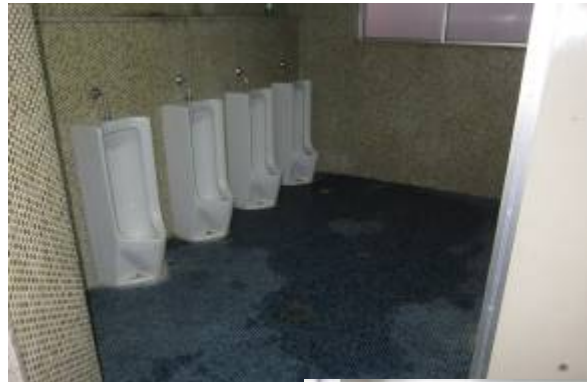
Clogged and smelly toilets due to aging

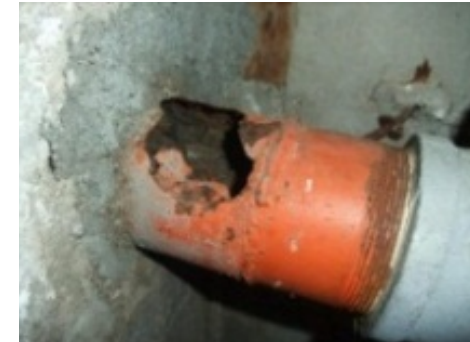
Pipe is broken due to deterioration

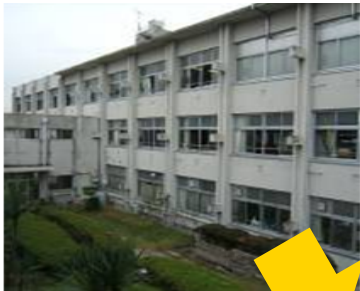
Before  
refurbishment

- Methods for leaving columns and beams but refurbishing any parts such as pipes or interior and exterior fittings.
- Possibly secure an education environment equivalent to reconstruction while reducing costs.
- If refurbishment work to prolong the life of the building is done at the appropriate time, the building can continuously be used more than 30 years after the refurbishment.

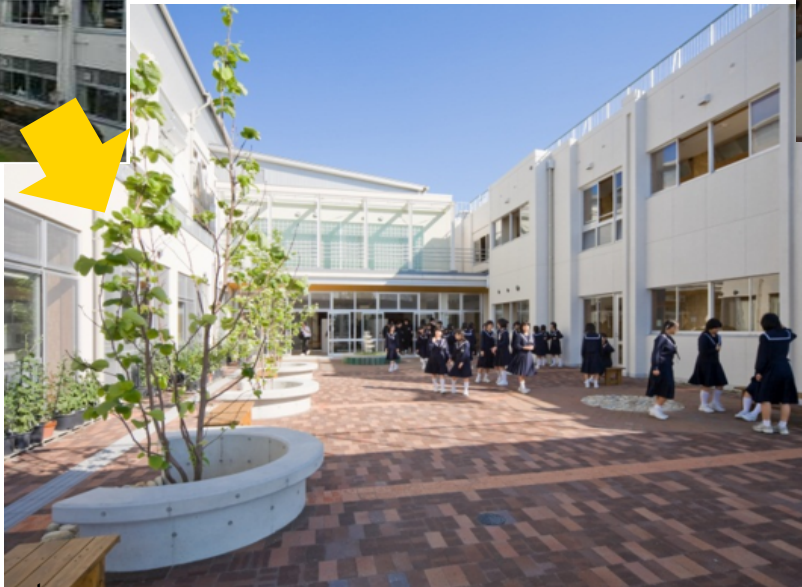
After  
refurbishment

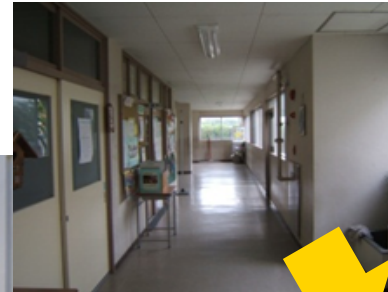
Before  
refurbishment

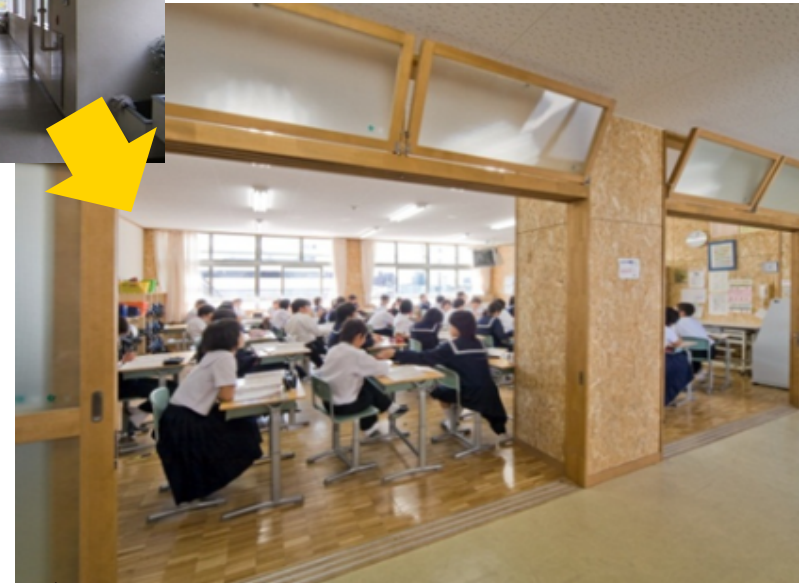
After  
refurbishment
