Modeling Work Informing Design of Potential Solutions for Highly Vulnerable Coasts of Atoll Islands

Republic of the Marshall Islands

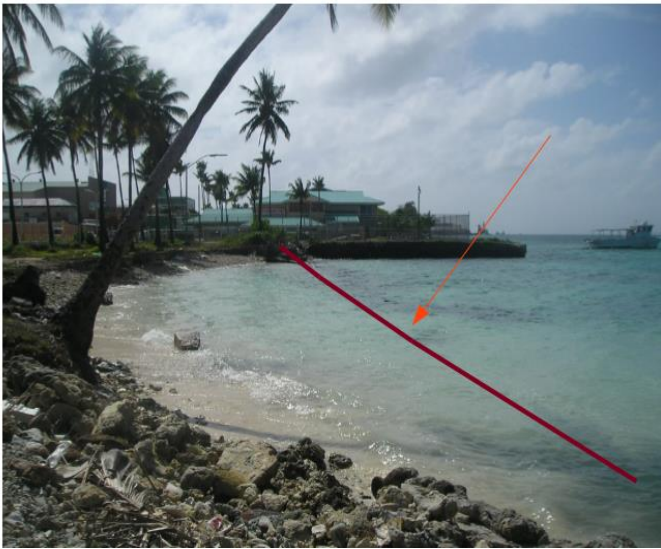
Figure 12: The red line shows the seawall that has been washed away over the years. This area has an inundation of approximately 6 meters over the period of 5 years .

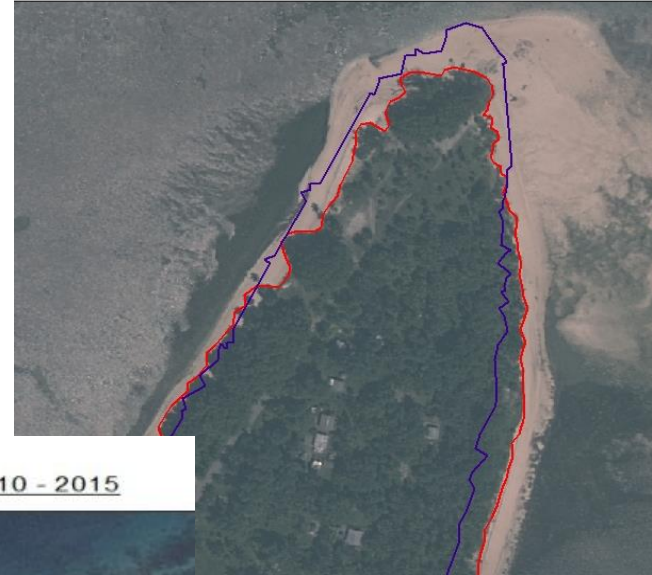
Coastal Change Detection 1983 – 2010

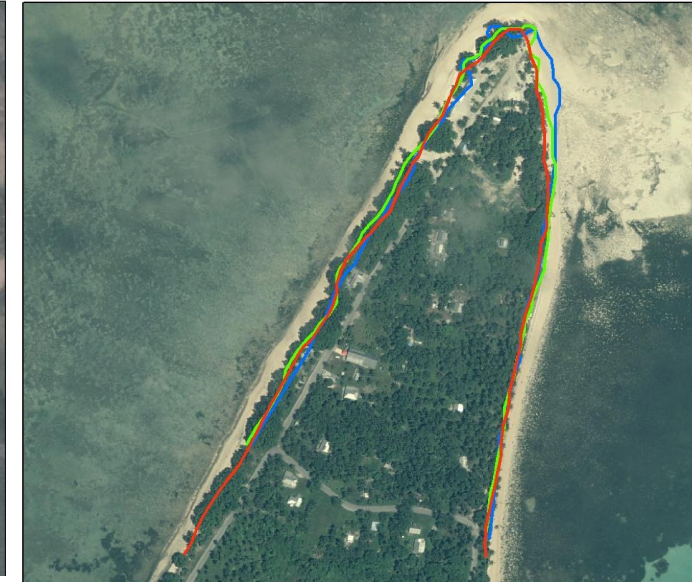
Coastal Change Detection 2007 – 2015

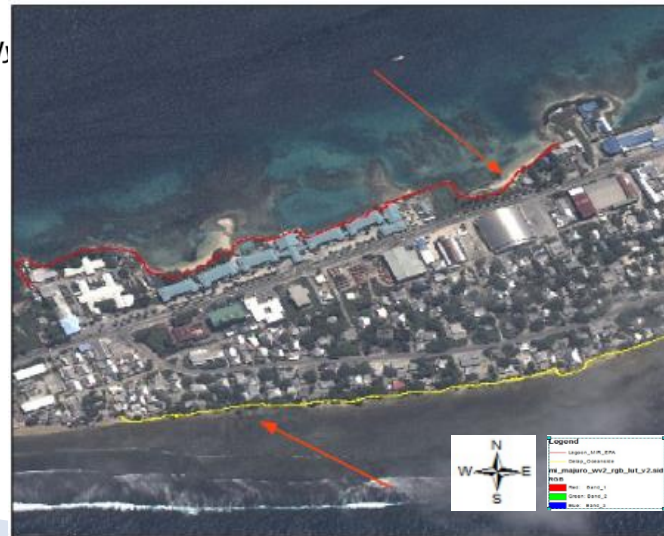
Delap Coastline Change 2010 - 2015

Figure 10: The image shows the high risk eroded areas on Delap

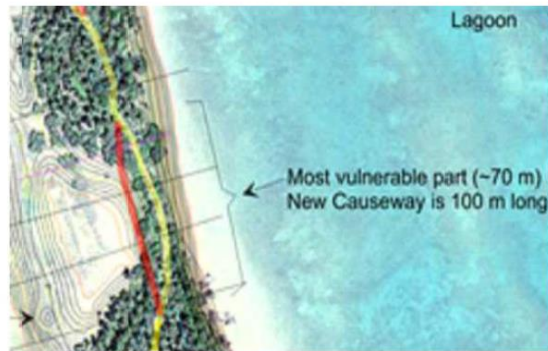
Causeway Cross-Section

New Causeway (red line) set 15 m west of existing road

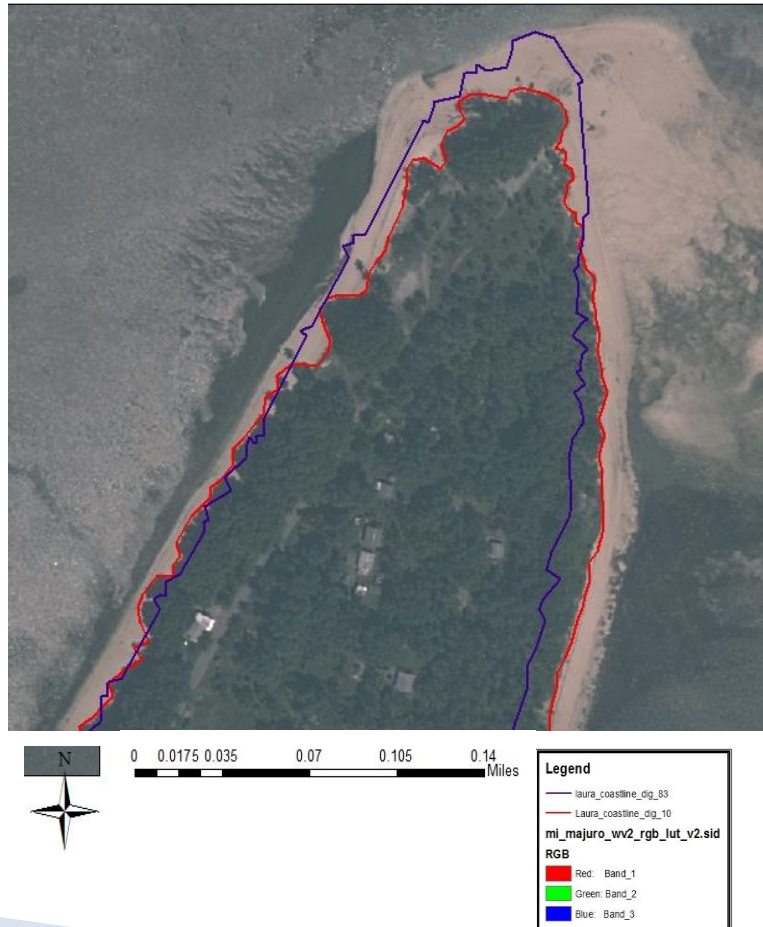
Coastal Change Detection 1983 – 2010

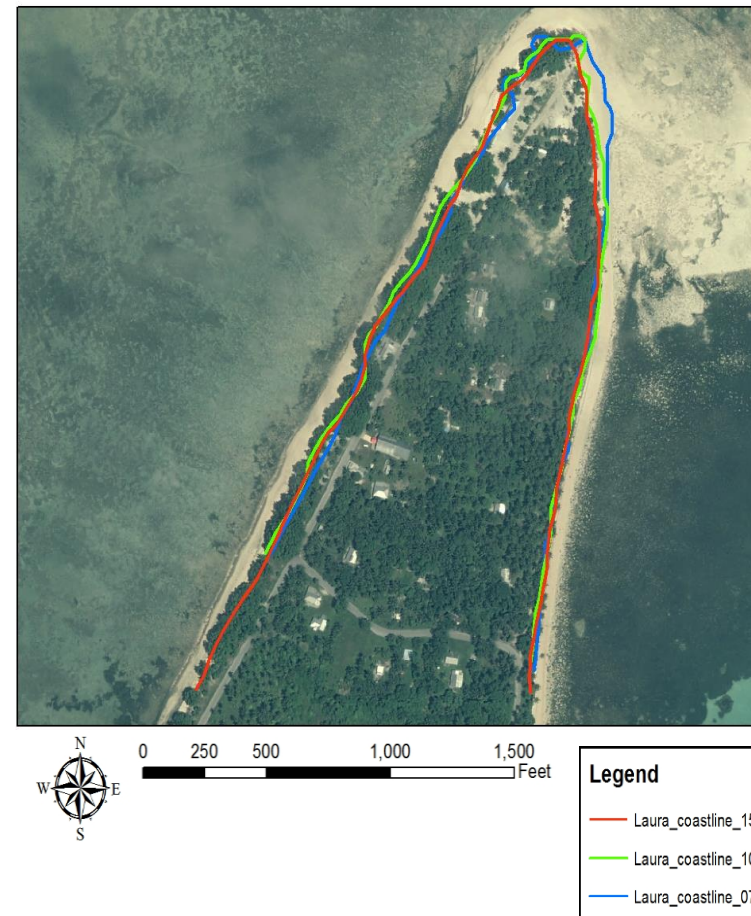
Coastal Change Detection 2007 – 2015
