Rapid Damage and Loss Assessment

November 9-11 and November 28, 2016 Floods

A report by the Government of Saint Vincent and the
Grenadines

December 14, 2016

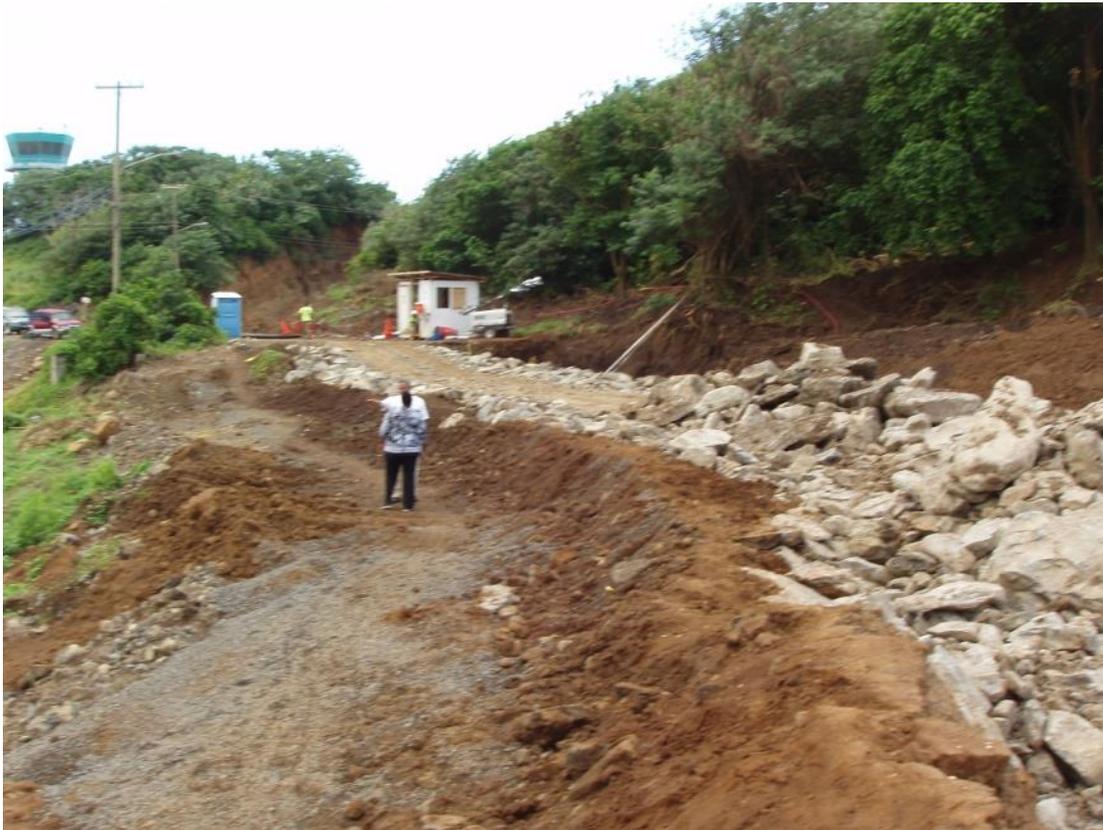
FIGURE 9: WINDWARD HIGHWAY - ARGYLE ROAD RECONSTRUCTION

During the two trough events, damage to the transportation sector was primarily due to flooding, landslip, and rock fall. On Saint Vincent, road blockages were the predominant impact; however, bridges and culverts suffered significant damage, particularly along the upper east coast. Road failure occurred in several locations including along the main east coast highway to the west of the Argyle Airport,⁹ where a section of road (figure 9) failed completely, requiring a major reconstruction. This resulted in the rerouting of traffic along the old coast road that is currently serviced by a temporary one-lane bridge, which is also the focus of emergency construction activities.

As a result of flash flooding events, 18 bridges suffered damage or were left in a vulnerable condition due to scouring and exposure of foundation elements. In the latter case, the bridges appear unaffected, but the underlying damage increased the vulnerability of the structures to future events, including increased river flows simply due to normal weather events. Northern portions of the island are particularly susceptible to debris flows, which greatly increase the damage potential of the flooding event. Other works identified relate to landslip protection and river stabilization to protect infrastructure and minimize risk of future deterioration.

Based on the assessment provided by the MoTW, a total of 62 infrastructure reconstruction or rehabilitation projects were identified relating to the transport and public infrastructure sector (Table 6). These works include bridge replacement and repair works, road repair replacement and associated protective works, and protective works to stabilize landslips and river erosion threatening property and communities. Protection works include bank stabilization for landslip, river training, and bank protection such as gabions, concrete walls, and other measures. Notably, of the 18 bridge-related works, 7 of the projects require the complete demolition and replacement of existing structures.

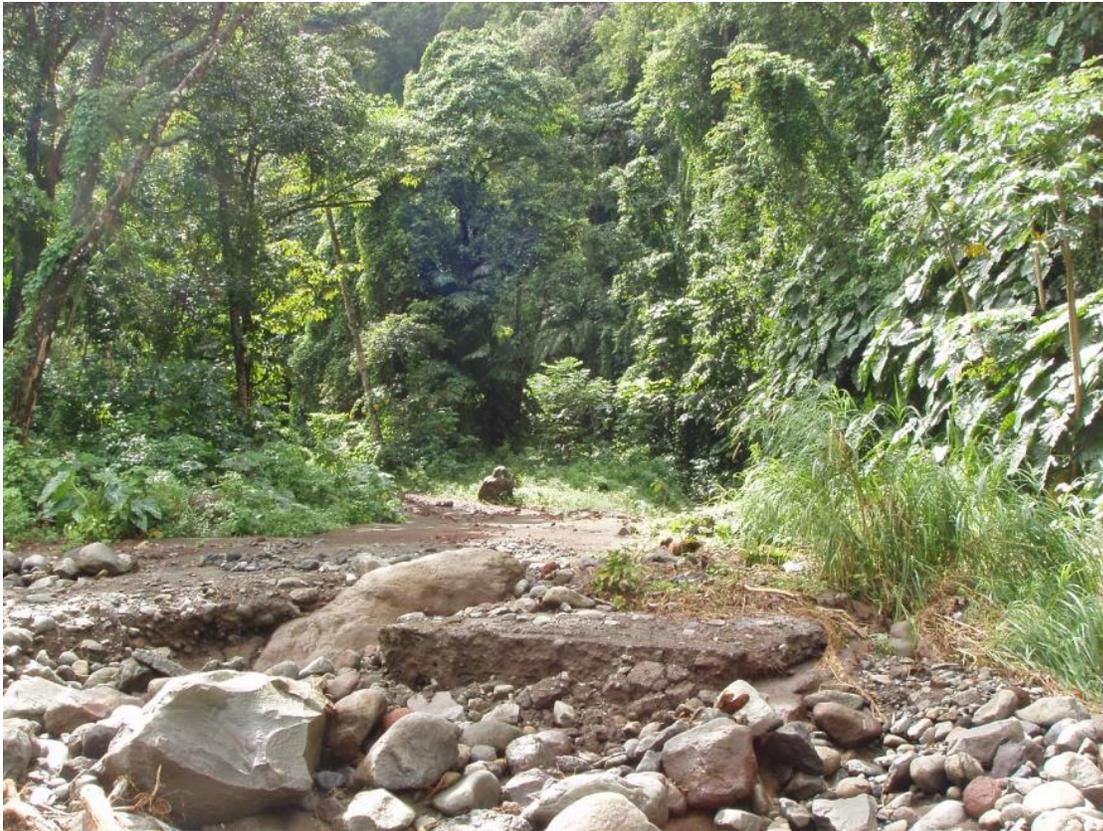
FIGURE 11: ACCESS ROAD TO RICHMOND INTAKE

Damages to the electricity sector were largely associated with hydropower generation. Landslips claimed several local transmission lines, but these were quickly restored. Hydropower represents about 12 percent of the total grid production capacity (details presented in Table 11). Although the generation stations were not damaged during the events, in two cases, hydro-generation was suspended due to pending repair to the water supply system. In the case of Cumberland, a landslip damaged a feed pipe, which was quickly repaired. In the case of the Richmond hydro-generation station, the water intake was damaged and the access road was rendered impassible due to flood damage (Figure 11).

Due to the events, the Richmond facility (20 percent of the hydro-generation capacity) suffered a significant damage. Access to the water intake is blocked and the access road needs to be rehabilitated. This includes the construction of long-term flood protection to account for the change in riverbed characteristics caused by the flooding events. The road is now susceptible to flooding even during normally occurring rainfall events.

The intake to this system suffered damage due to silting and battering by rocks and debris. A temporary repair has been provided to restore the system to operation; however, the intake needs to be reconstructed to account for changes in the river characteristics and current damage to the structure.

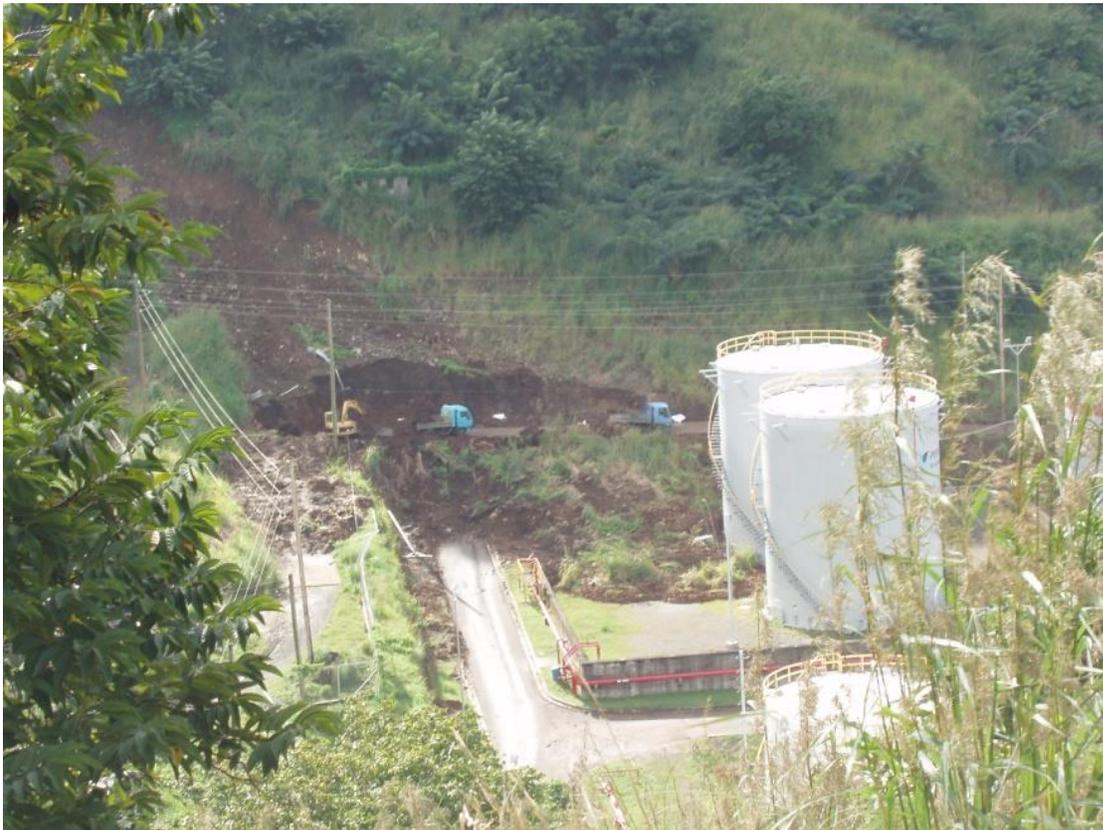
FIGURE 12: LANDSLIDE - CENTRAL FUEL STORAGE

Finally, a landslide at the central fuel storage facility (Figure 12) resulted in minor damage to storage infrastructure. Nonetheless, because of the slide, the facility is at increased risk from future landslide due to the decreased slope stability resulting from the slide. Apart from the cleanup of the immediate slide, slope stabilization measures will need to be taken to mitigate the present unstable condition. This Government-owned site is where Saint Vincent Electricity Services (VINLEC) stores much of its fuel.

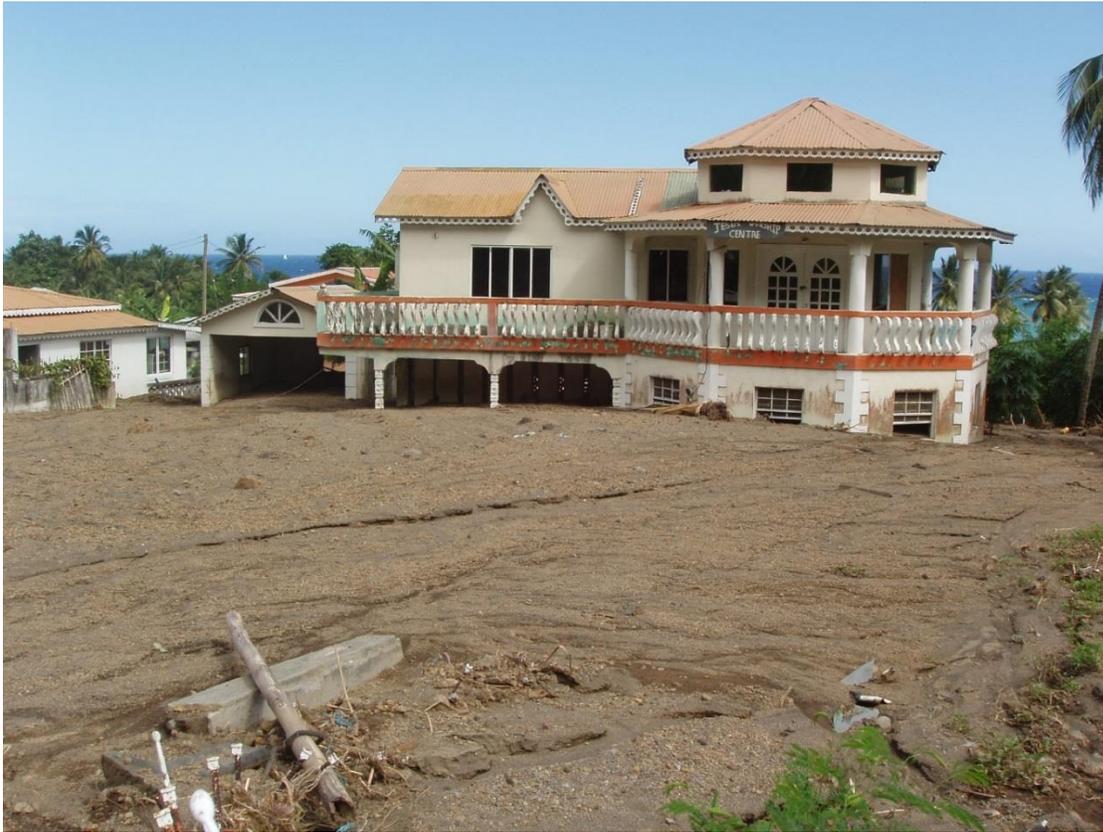
FIGURE 13: HOUSE IN SANDY BAY DAMAGED BY LANDSLIP

Damage within the housing sector is estimated at US\$4.3 million (EC\$11.5 million) exclusive of any costs associated with land acquisition to support relocation requirements. Losses for the sector are not available but include furniture replacement, costs associated with alternative housing, loss of savings kept on the property, and in some cases, loss of livelihood for home-based businesses.

Damage to housing stock occurred on both the leeward and windward sides of the island due to the two troughs. Areas particularly affected on (a) the leeward side were Spring Village, Dark View, Chateaubelair, Petit Bordel, and Fitz Hughes and (b) the windward side were Pepper Village, London, Trench Town, Sandy Bay, Sion Hill, and Back Street. Table 14 presents the summary for housing infrastructure damage by area affected using a four-tiered system of classification to describe the extent of damage to housing.
