Rapid Damage and LossAssessment (DaLA)

December 24-25, 2013 Floods

A report by the Government of Saint Vincent and the Grenadines

January 16, 2014

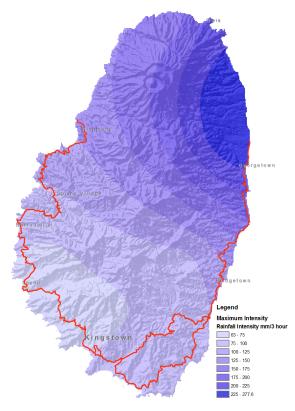
FIGURE 4: PRECIPITATION DISTRIBUTION

Along the northern portion of the island, 308.6 mm of rainfall was recorded over the 24-hour period, but more importantly, 278 mm fell over a 3-hour period from 9 pm to 12 am. While rainfall curves are unavailable for St. Vincent, a review of curves available for Puerto Rico and St. Lucia coupled with interviews with affected persons and staff at the national meteorological office strongly suggest the 3 hour rainfall intensity is in excess of a 1 in 100 year event. Additionally, previous normal rainfall had already saturated the surface soils creating optimum conditions for maximum surface runoff. Witnesses reported unusual lightning and thunder activity associated with the storm and,

some areas, hail during the peak rainfall event, further confirming the system was unusually intense. Rainfall was largely focused on the northern portion of the island where the topography is mountainous and includes the highest elevations on the island, namely the Soufriere volcano. Storm interaction with the island topography in this area likely contributed to the high rainfall rates experienced. Most of the rainfall was experience over the central mountain range where eastern and western watersheds converge. Rainfall was unevenly distributed during the storm and the northern and central portions of the island received disproportionately higher intensities than the southern portions where the rain gauge at the Arnos vale airport reported heavy but not extraordinary precipitation rates and levels.
