Glacial Lakes and Glacial Lake Outburst Floods in Nepal

This report was prepared by the International Centre for Integrated Mountain Development (ICIMOD) for the Global Facility for Disaster Reduction and Recovery (GFDRR)/The World Bank.

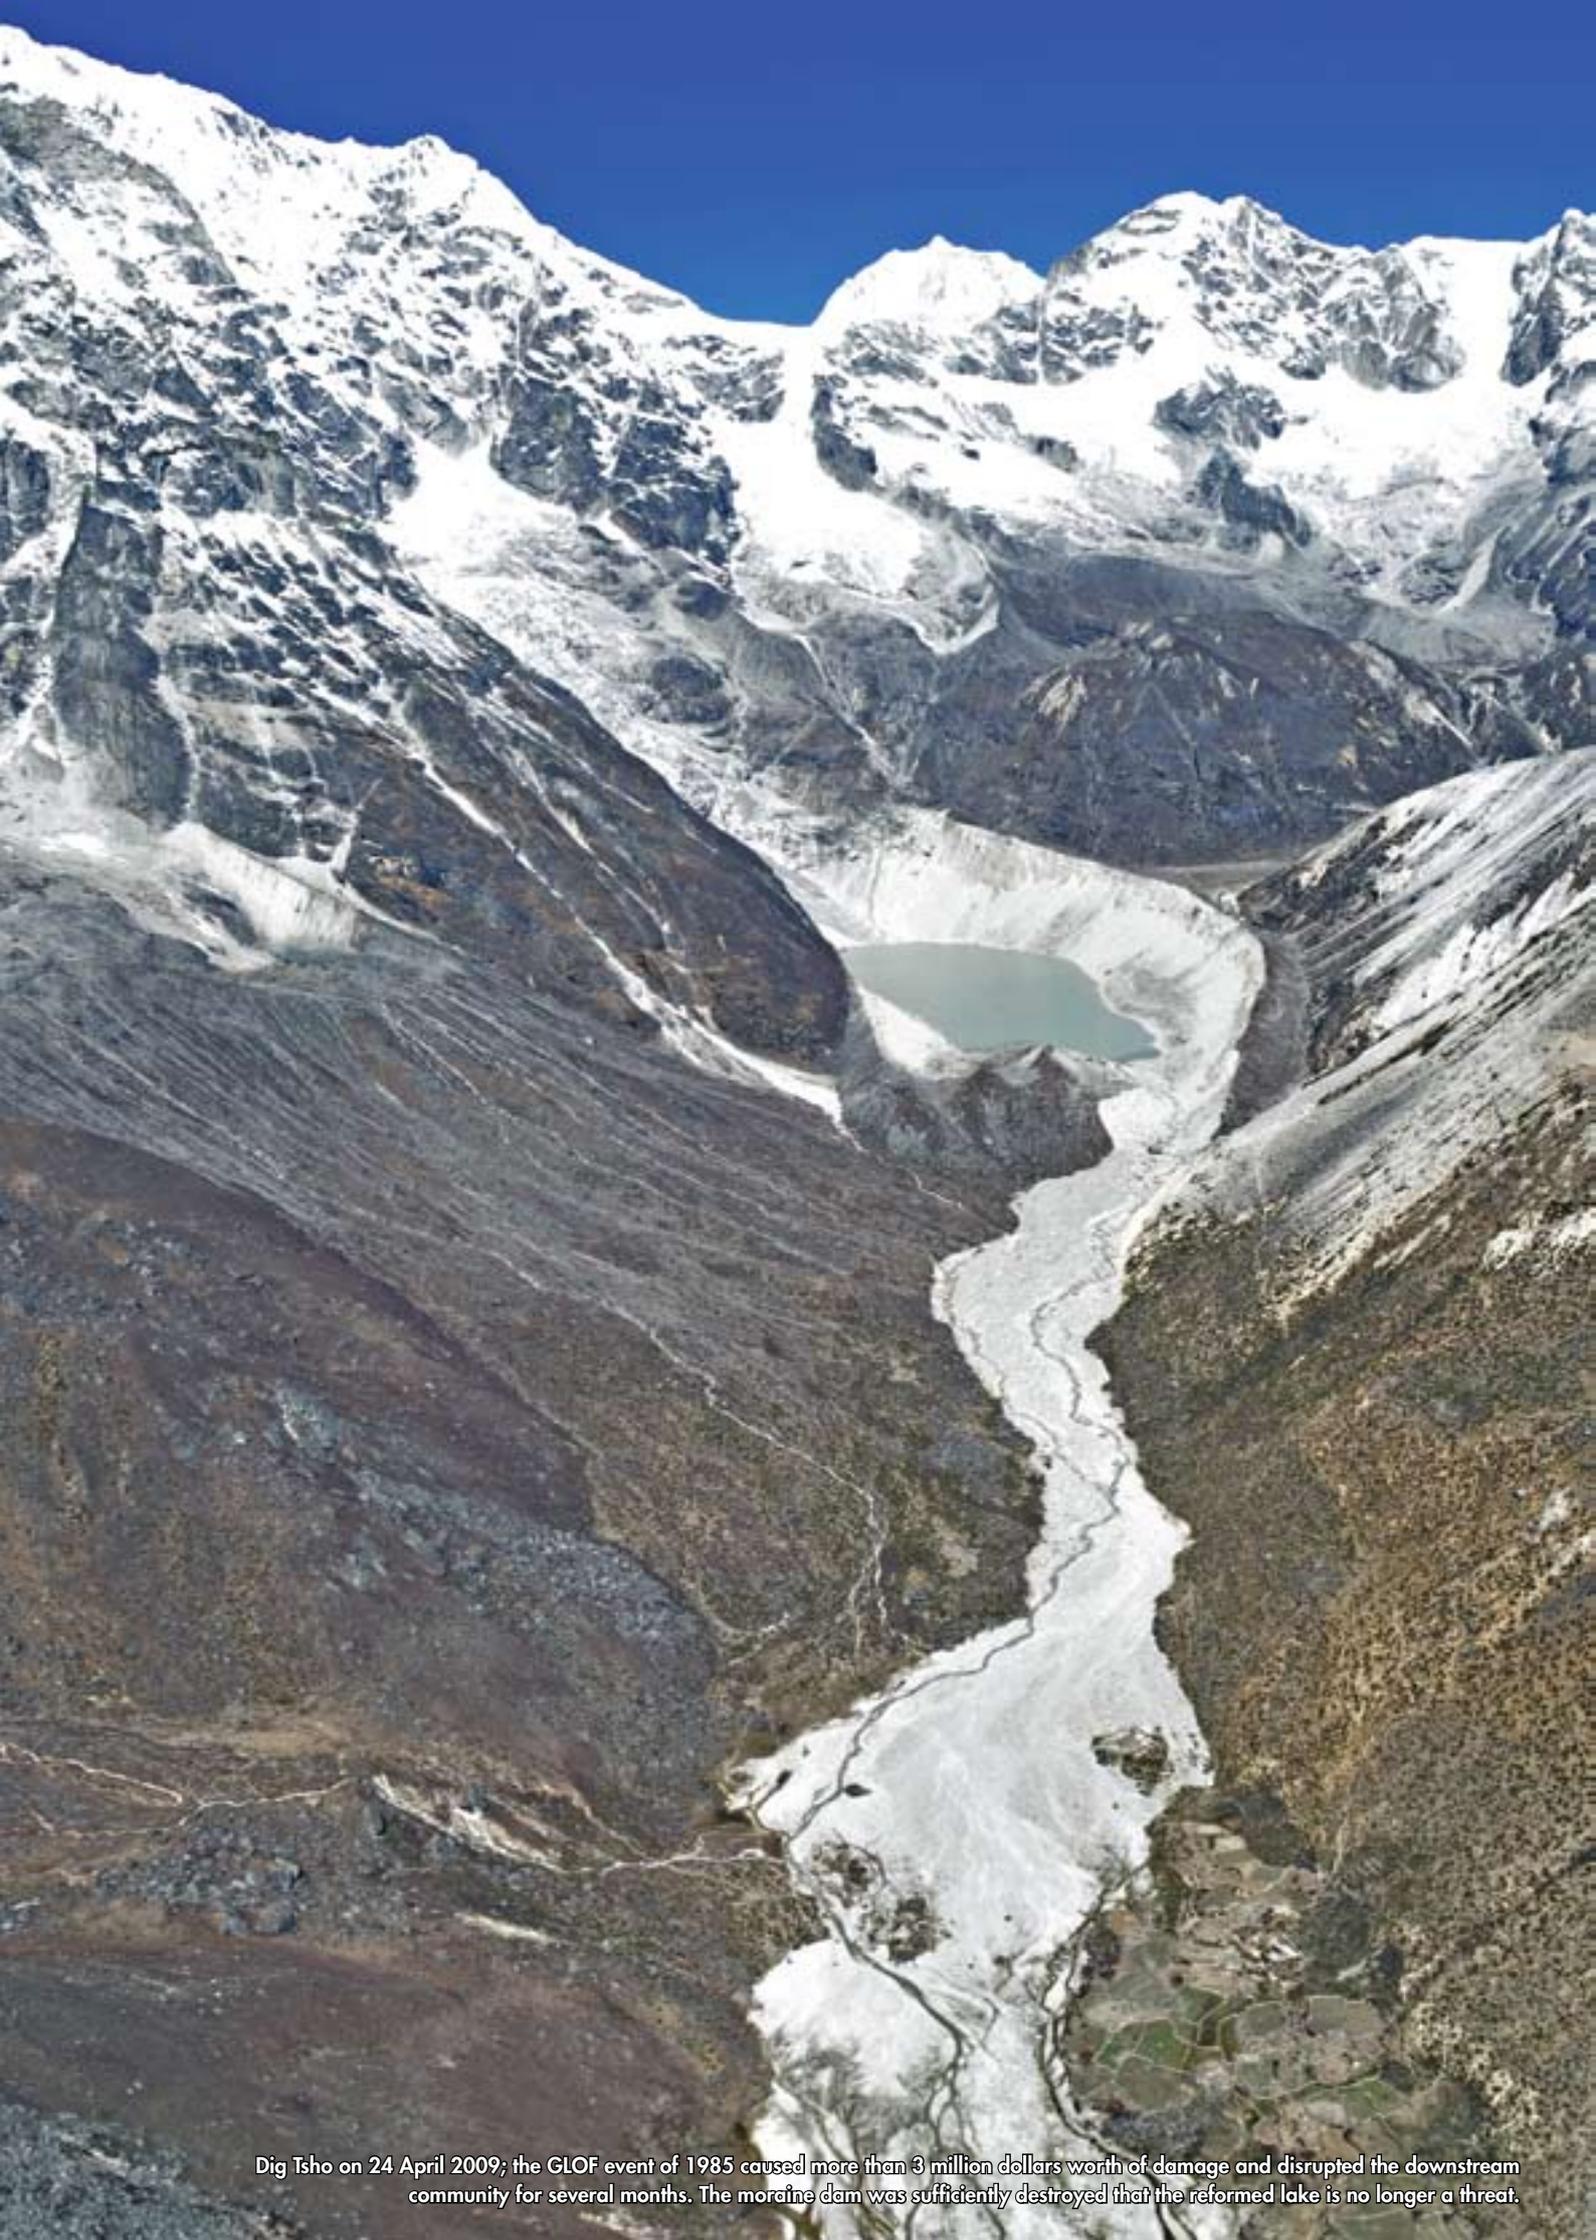
Dig Tsho on 24 April 2009; the GLOF event of 1985 caused more than 3 million dollars worth of damage and disrupted the downstream community for several months. The moraine dam was sufficiently destroyed that the reformed lake is no longer a threat.

When the end moraine dam of the Dig Tsho collapsed, the water from the lake drained into the valley downstream over a four-hour period, wreaking destruction as it went. This sudden outburst destroyed the nearly completed Namche Small Hydel facility, some 11 km downstream and caused other losses as far as 50 to 60 km downstream. Somewhat ironically, Dig Tsho was not typical of the large glacial lakes that have formed supra-glacially, but was one of the smaller 'clean-ice' glacial lakes. The outburst event was triggered by a large ice and rock avalanche that cascaded into the lake from a steep glacial surface: when it splashed into the lake it produced a surge wave. The surge overtopped the end moraine and caused it to collapse, discharging an estimated 6 - 10 million cubic metres of water into the valley below. The outbreak of Dig Tsho caused more than three million dollars worth of damage and disrupted the downstream community of Khumbu for several months. The alarm bells sounded by this outburst event put in motion a plethora of scientific investigations, including, surveys, research, and preliminary estimates of downstream vulnerability among others. The Water and Energy Commission Secretariat (WECS) of the Nepal Government, the International Centre for Integrated Mountain Development (ICIMOD), and the United Nations University (UNU) collaborated in the work that eventually produced the first detailed assessment of a GLOF event in Nepal (WECS internal report 1987; Ives 1986; Vuichard and Zimmermann 1986, 1987).

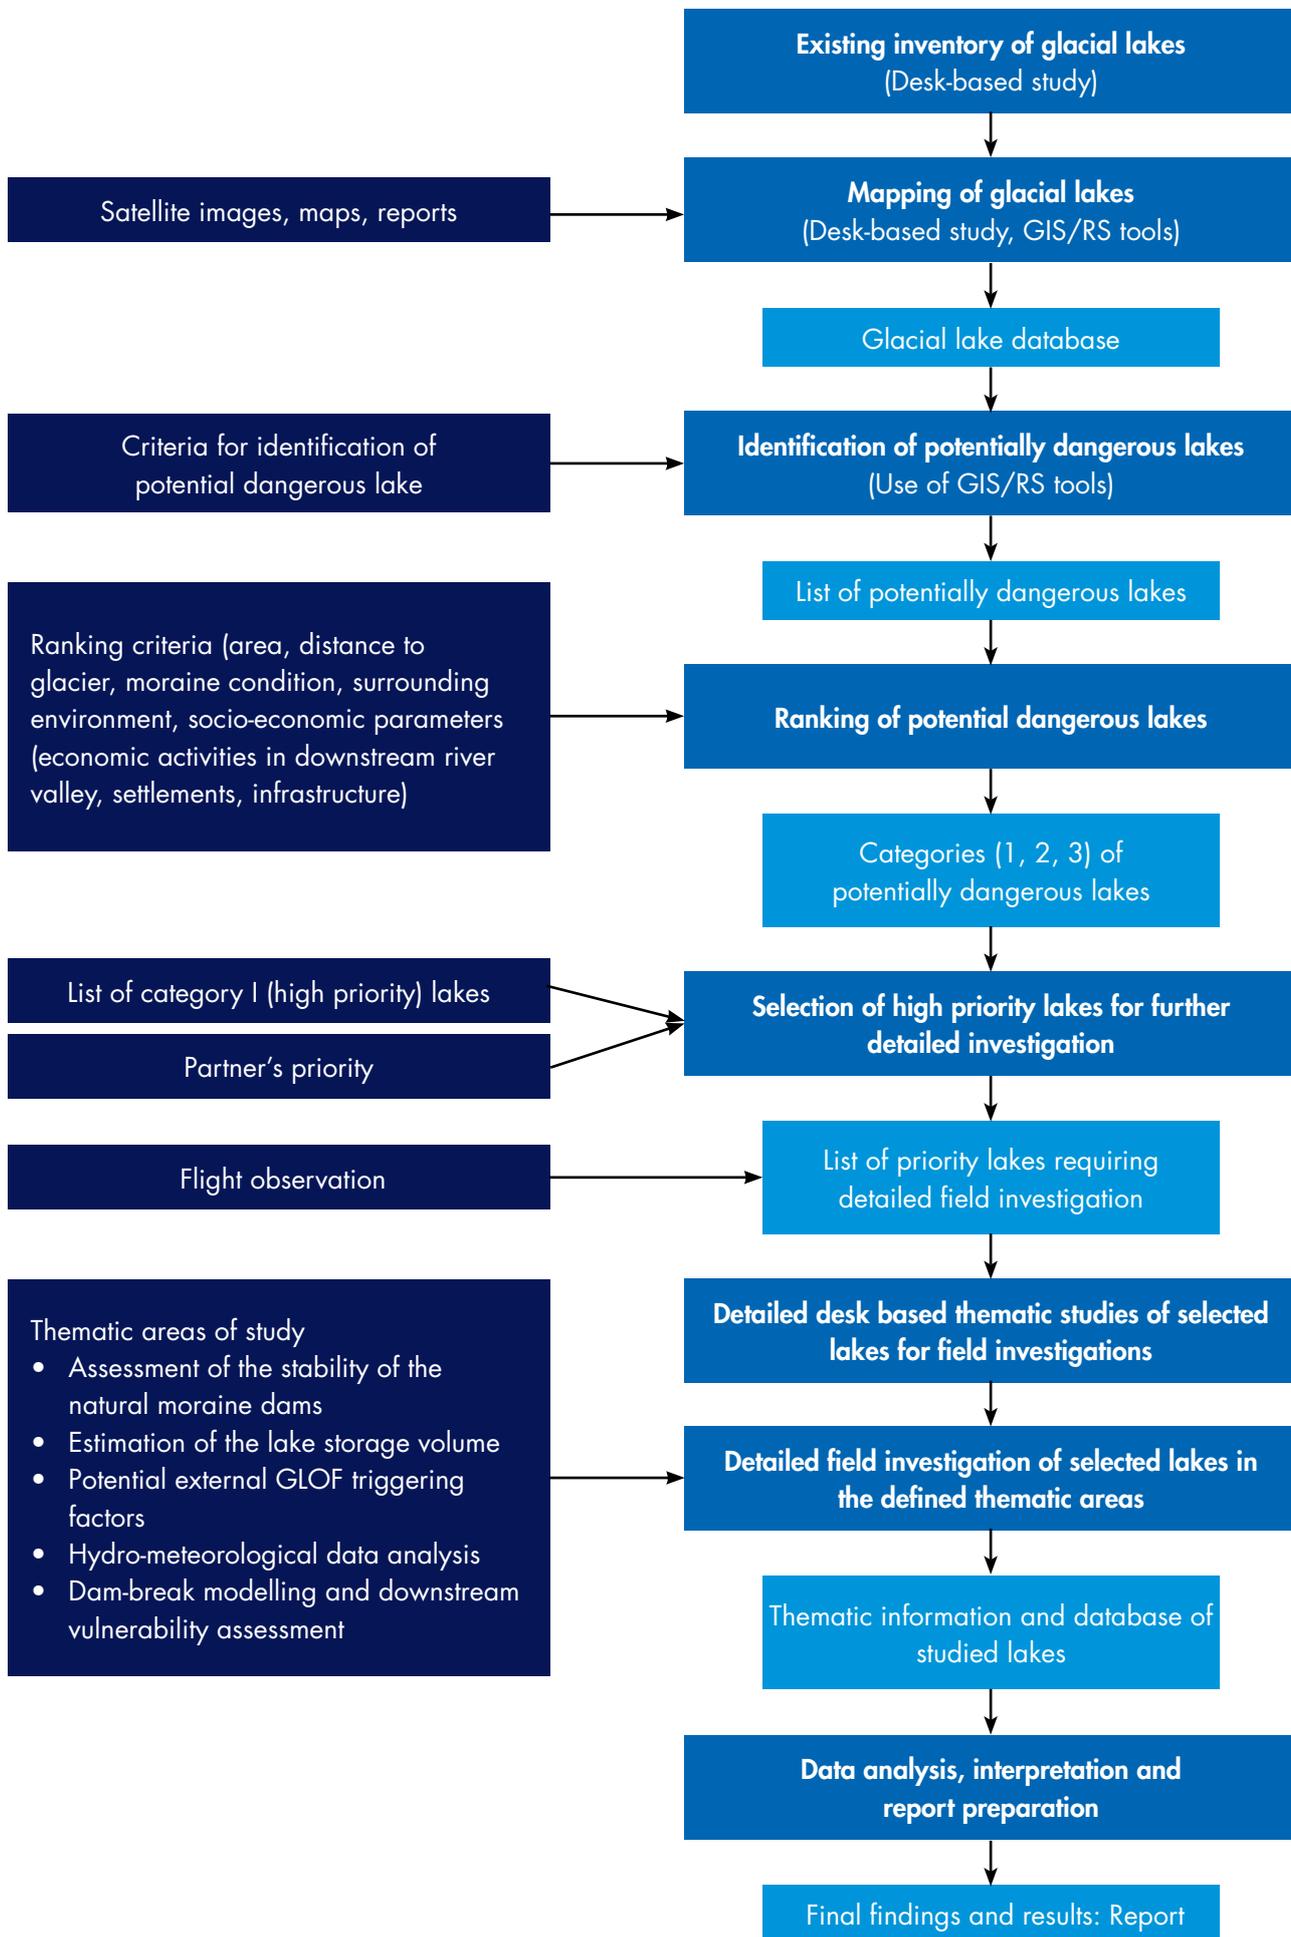
Figure 1.1: Flow diagram of the step-by-step approach for GLOF risk assessment

The next step involves ranking of the potentially dangerous lakes and setting of priorities for further detailed investigation. For this, the physical condition of a lake related to its stability is assessed by taking into consideration its area, the characteristics of the associated glacier, any changes in boundary conditions, and the stability of the surrounding terrain. Downstream socioeconomic parameters must also be obtained (Figure 1.1).

The detailed field investigation should focus mainly on the following aspects: estimation of the stability of natural moraine dams; determination of a lake's storage capacity; potential external triggering factors; hydrometeorological data analysis; modelling a potential dam outburst; and carrying out a downstream vulnerability assessment. For overall GLOF risk management, the magnitude of the hazard is directly related to the downstream vulnerability appraisal (Figure 1.1).

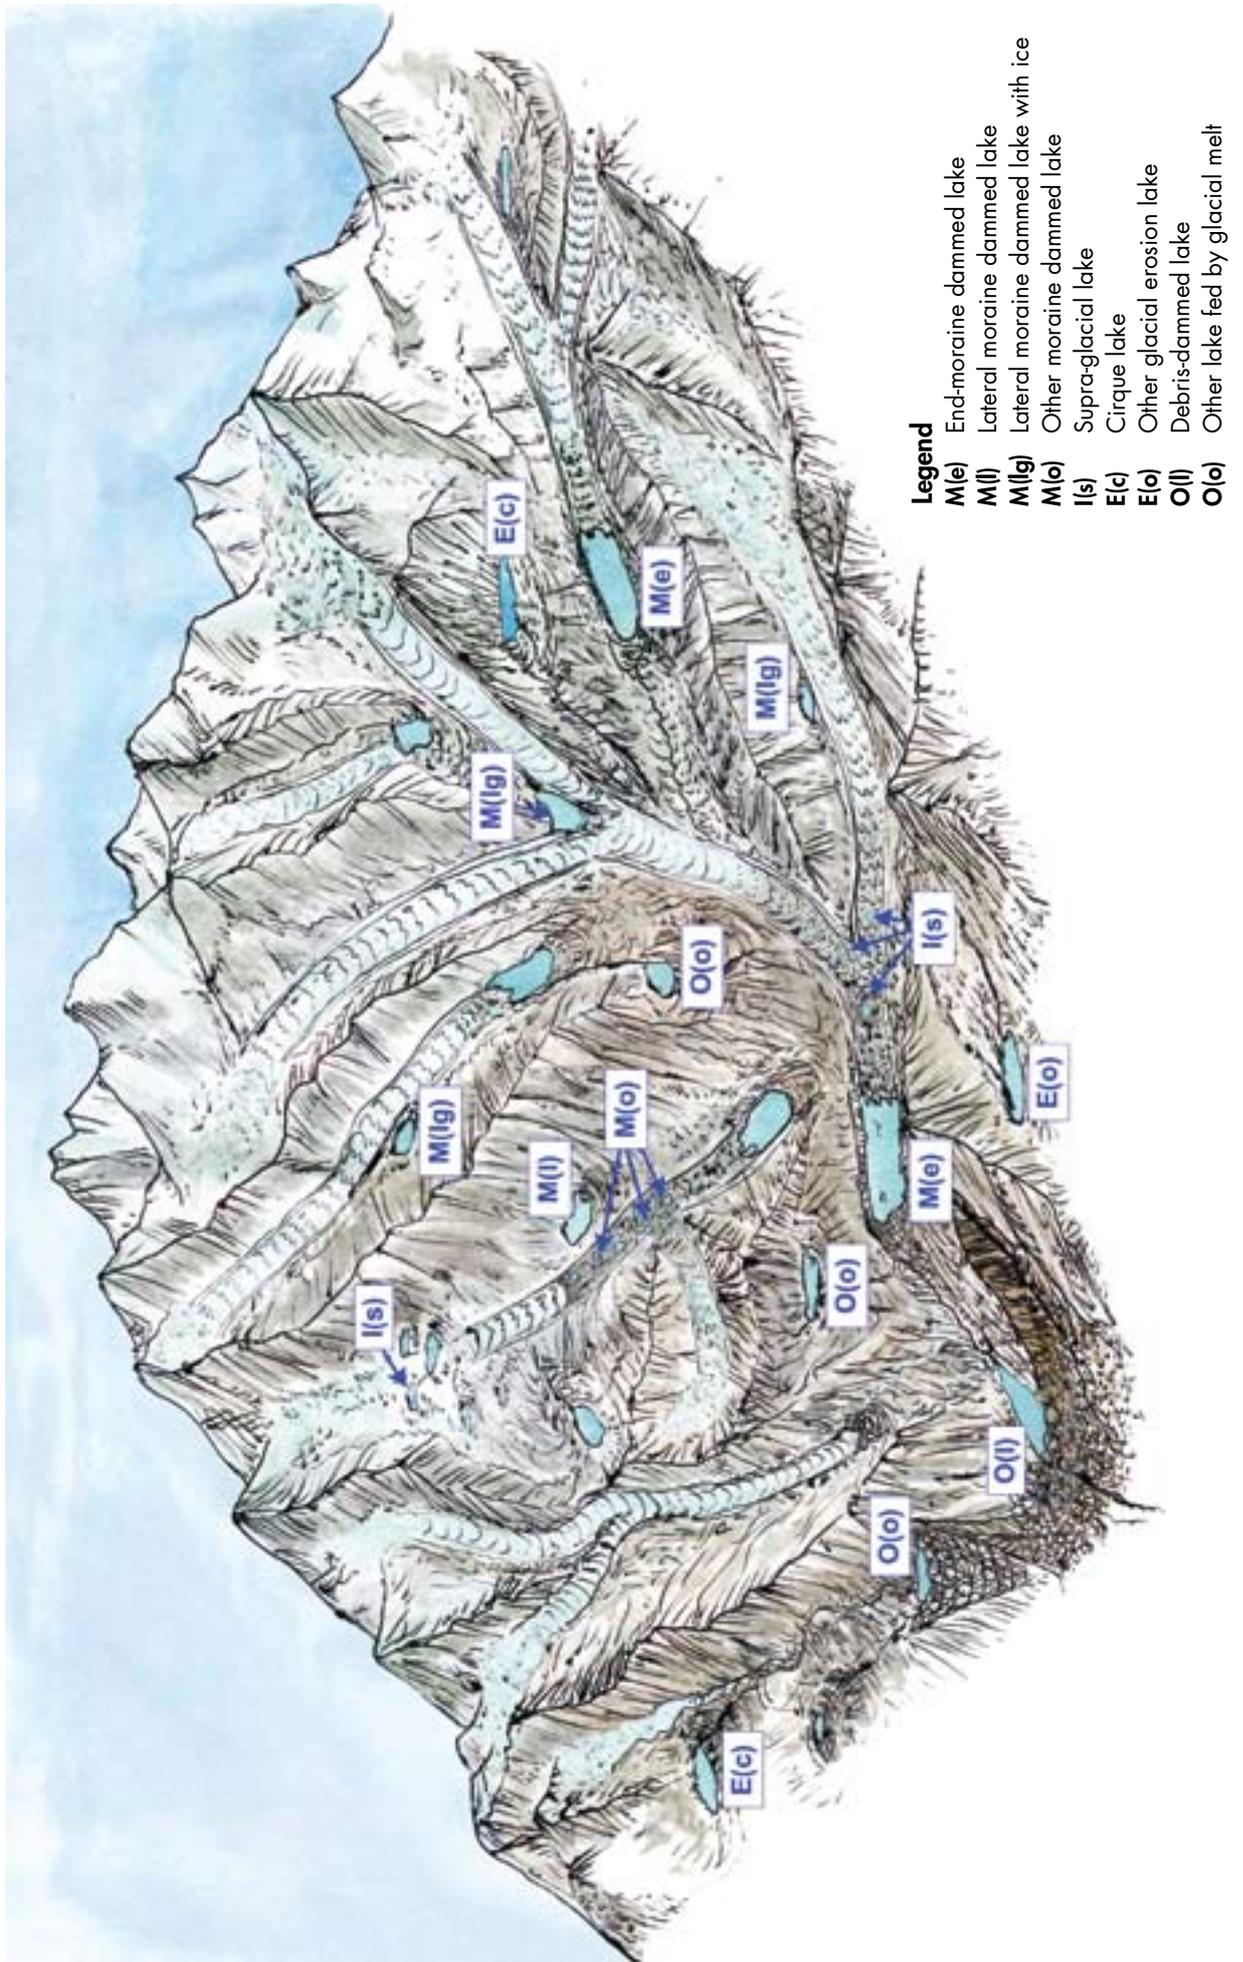
Table 4.2: Classification of glacial lakes: b. schematic diagram

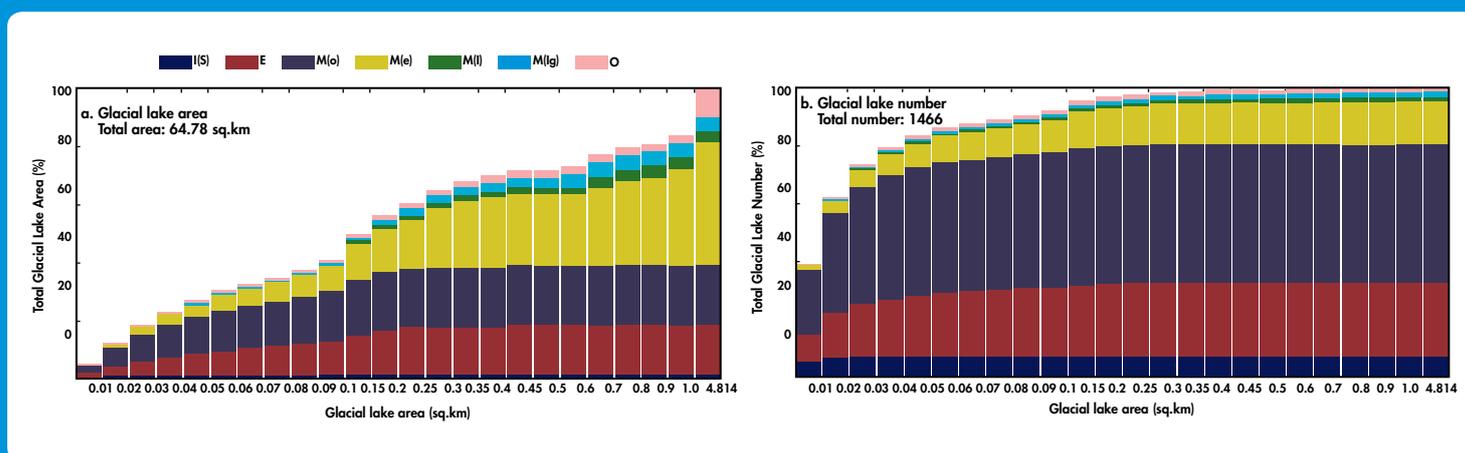
Figure 4.3: Cumulative distribution of glacial lakes (a: area % and b: number %)

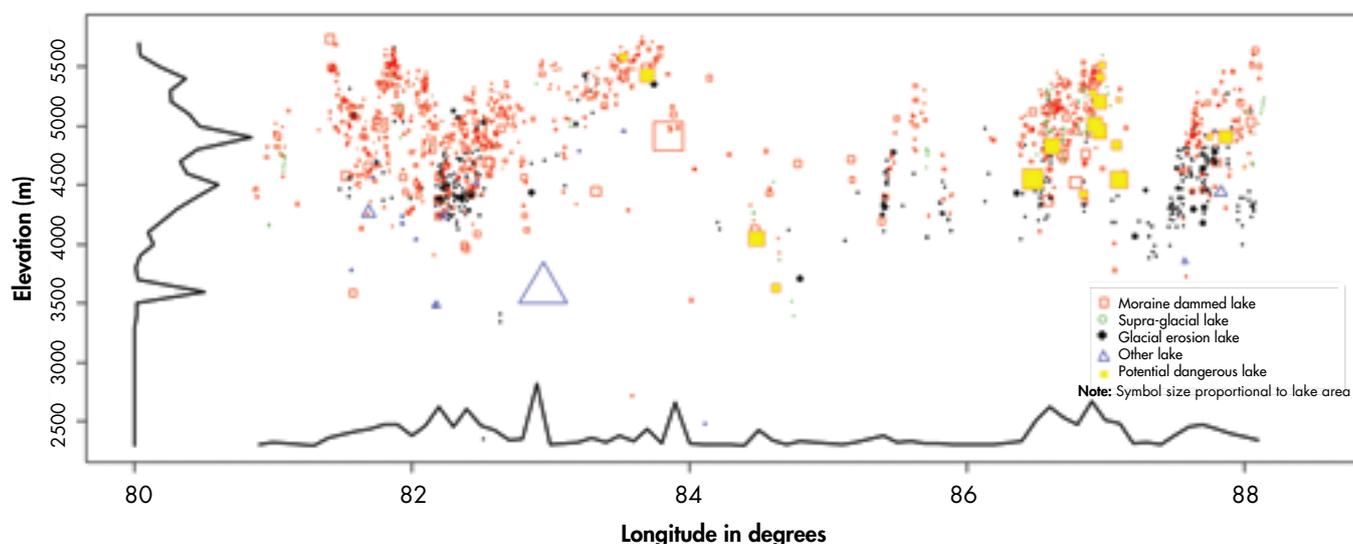
Figure 4.4: Distribution of glacial lakes in relation to longitude and elevation; the line graph shows the distribution of lake area

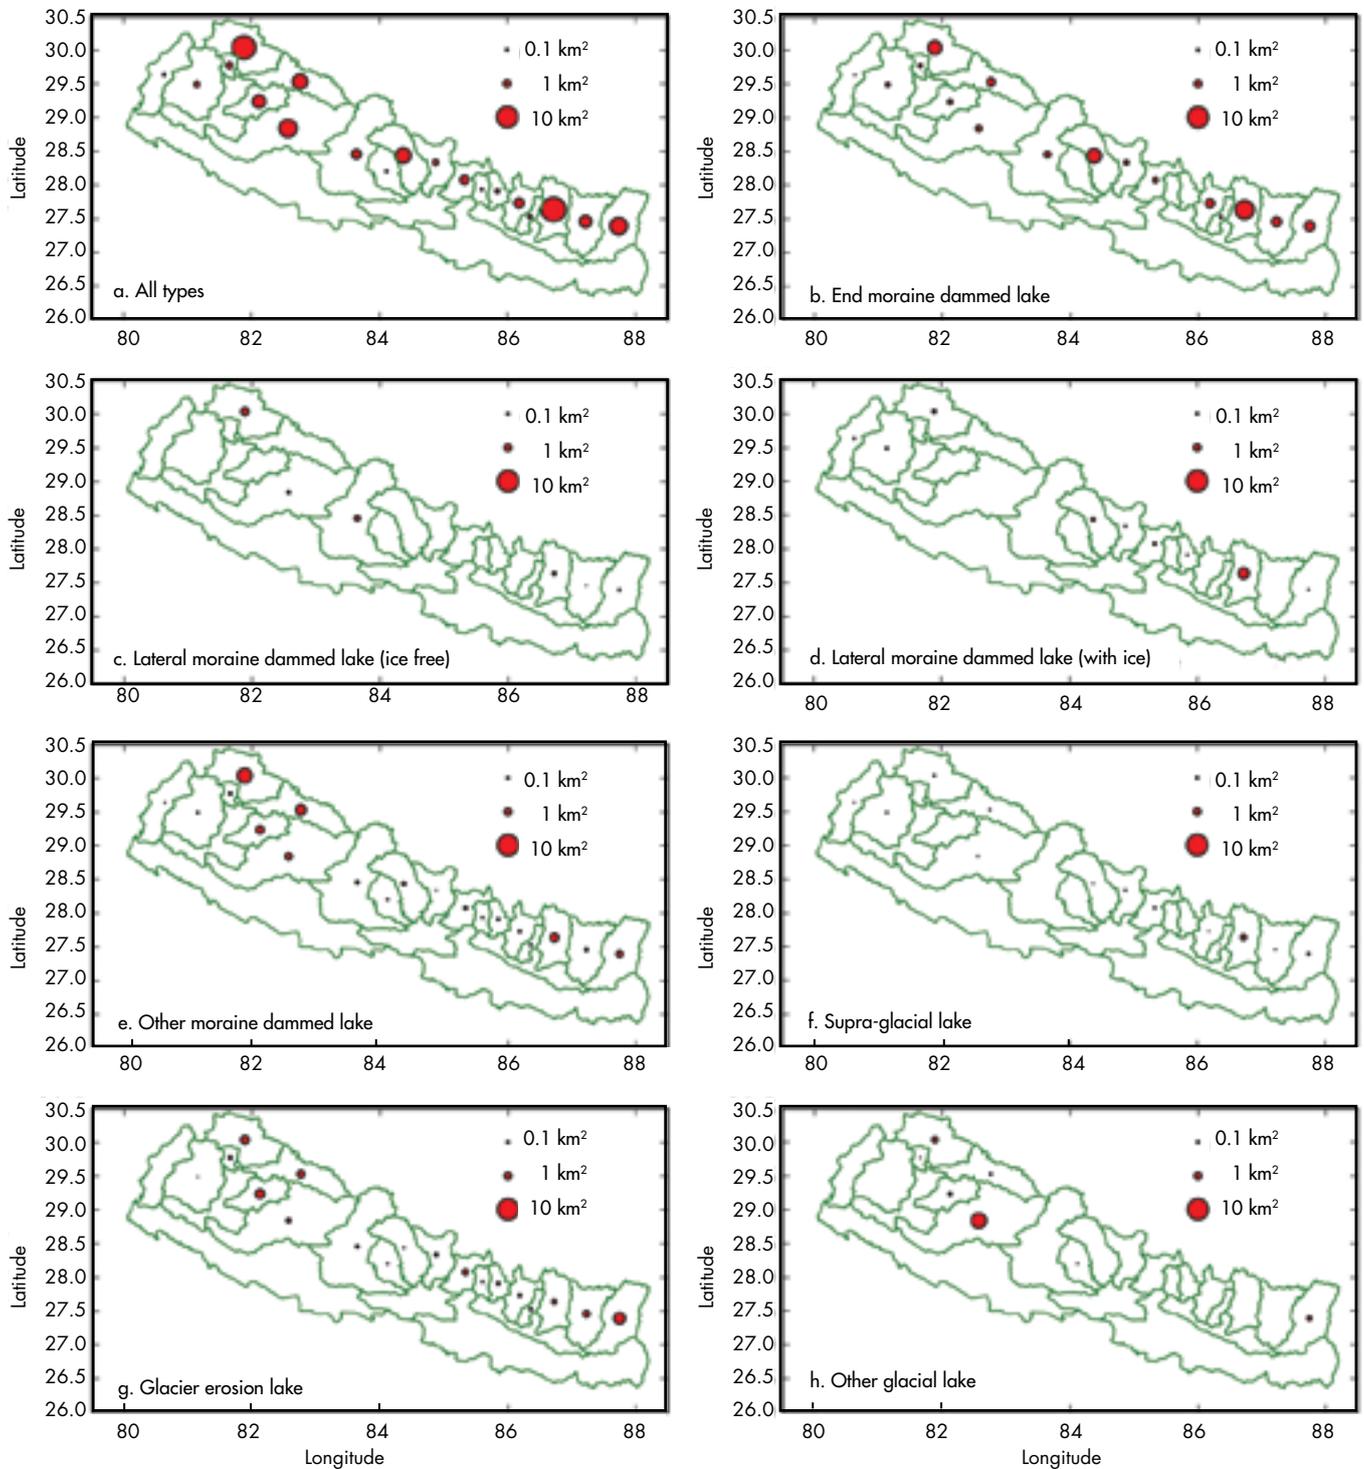
Figure 4.5: Graphical representation of cumulative area of lake types in each sub-basin, (the size of the circle indicates cumulative area)

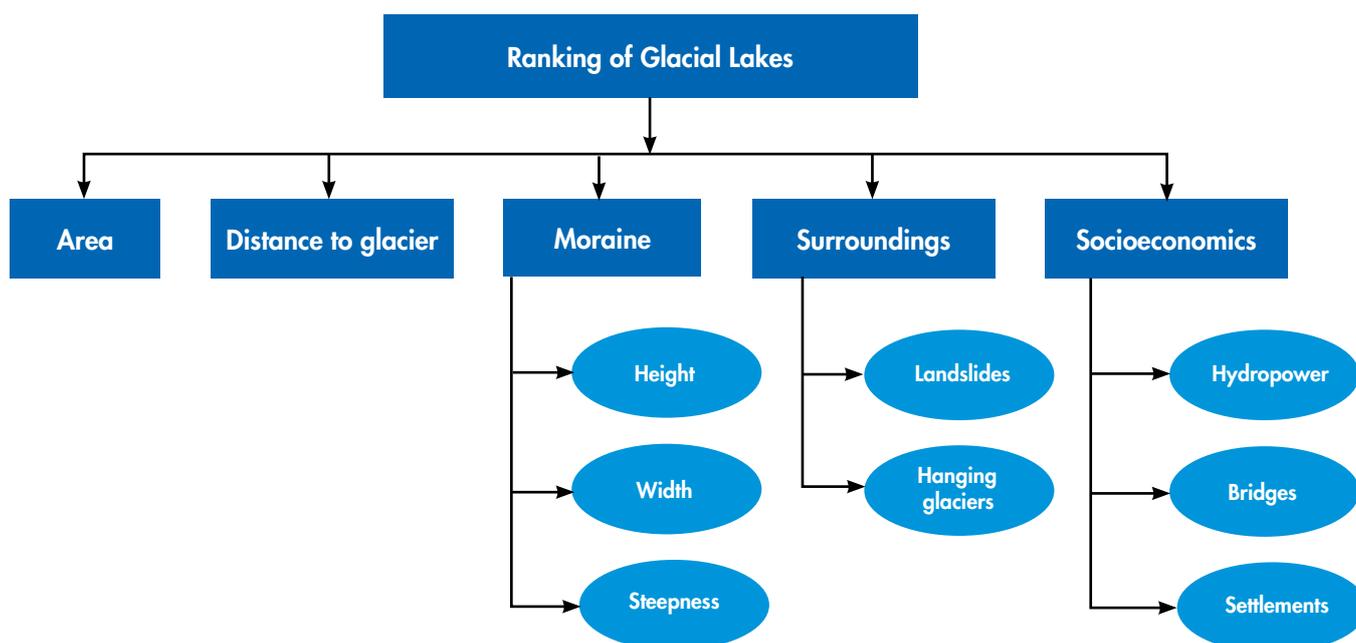
Figure 5.1: Physical and socioeconomic criteria used for ranking critical lakes

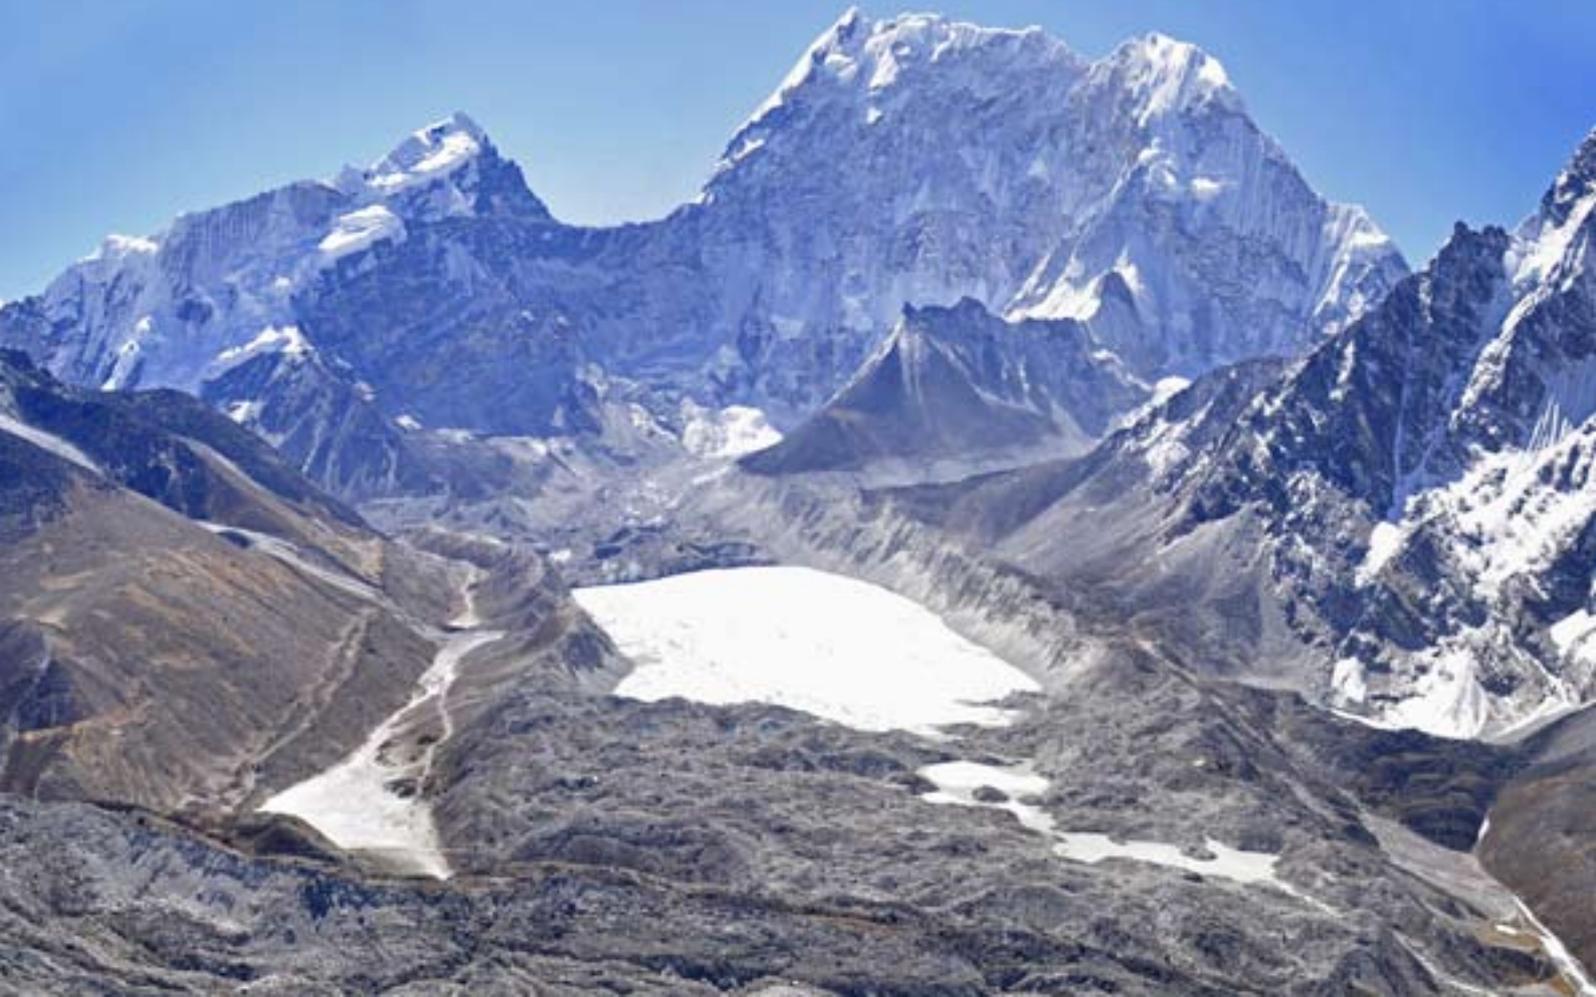
Figure 7.2: Overview of Imja Tsho showing the lake (centre), outlet channel, ponds, side valleys, and surroundings 24 April 2009

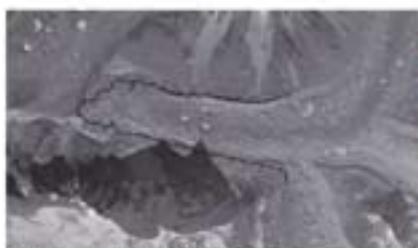
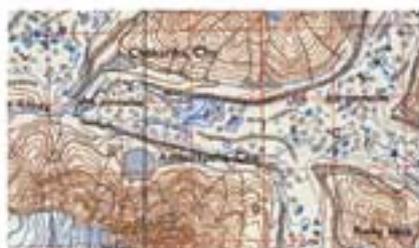
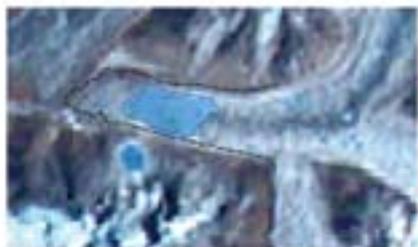
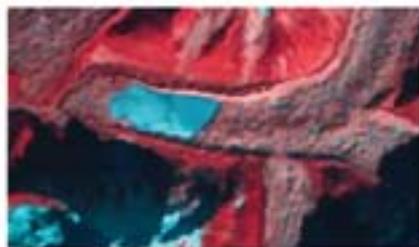
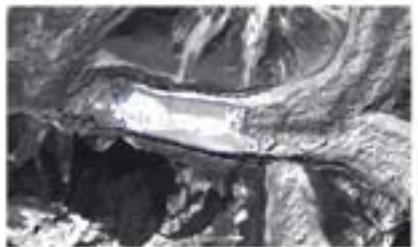
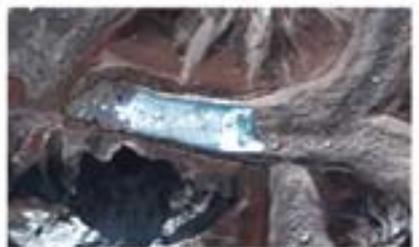
Figure 7.3: Development of Imja Tsho from 1962 to 2010 based on Corona (1962) images, Topographical Map (1967), Landsat MSS (Oct 1975), Landsat TM (April 1984, Dec 1989), Aerial photo (1992), LISS 3 (Jan 1999), Landsat ETM+ (Oct 2001, Nov 2005), ALOS PRISM (2006), AVNIR-2 (Nov 2007, Nov 2008, and Mar 2009), Field Survey (WECS 1992, DHM 1997, GEN 2002 and ICIMOD 2009), and EO1_ALI (USGS) Oct 2010)

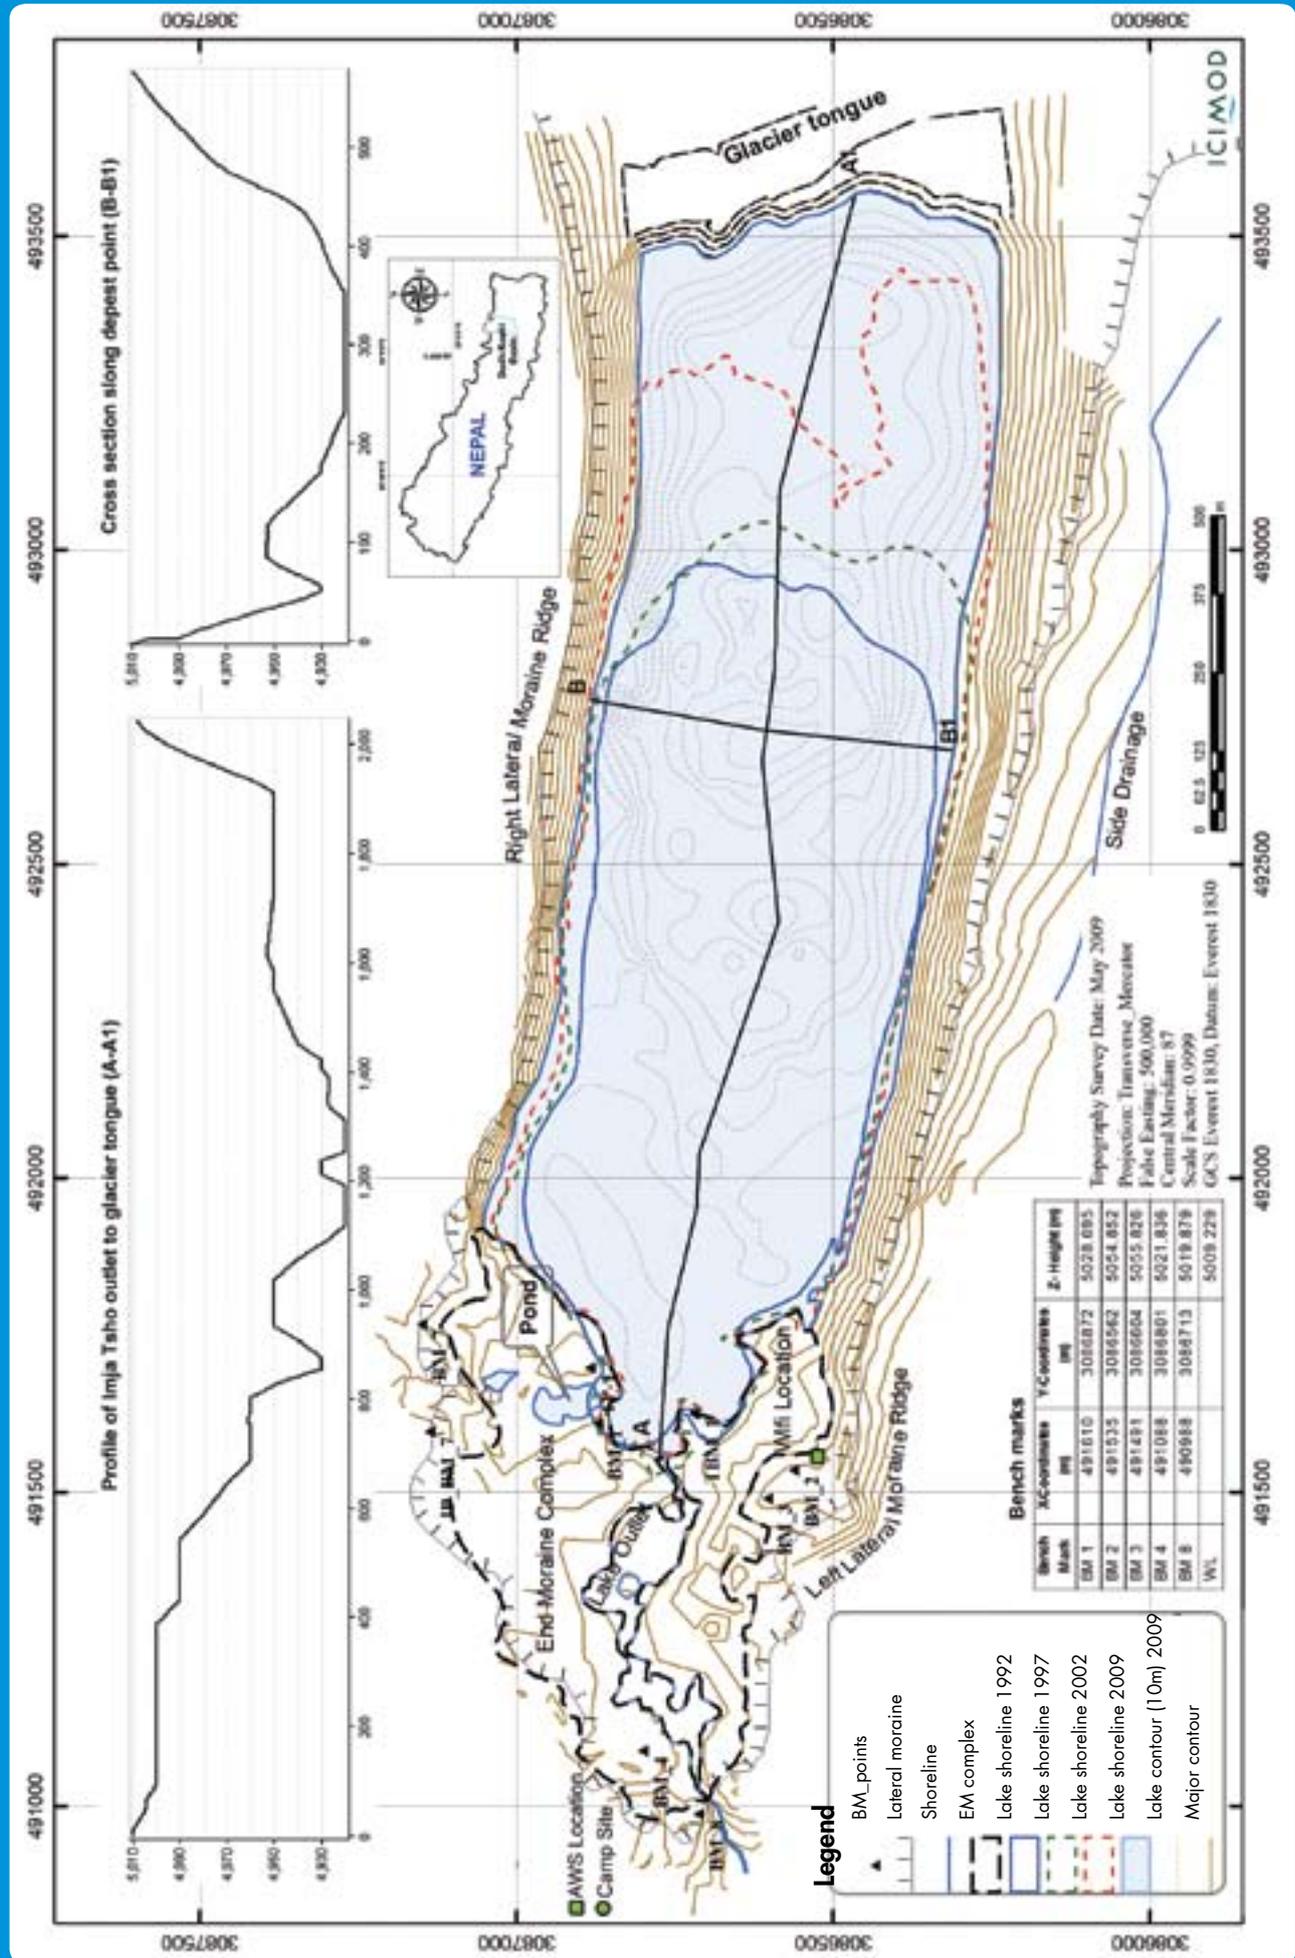
Figure 7.4: Bathymetric and topographic map of Imja Tsho showing the longitudinal profile and cross-section along the deepest point

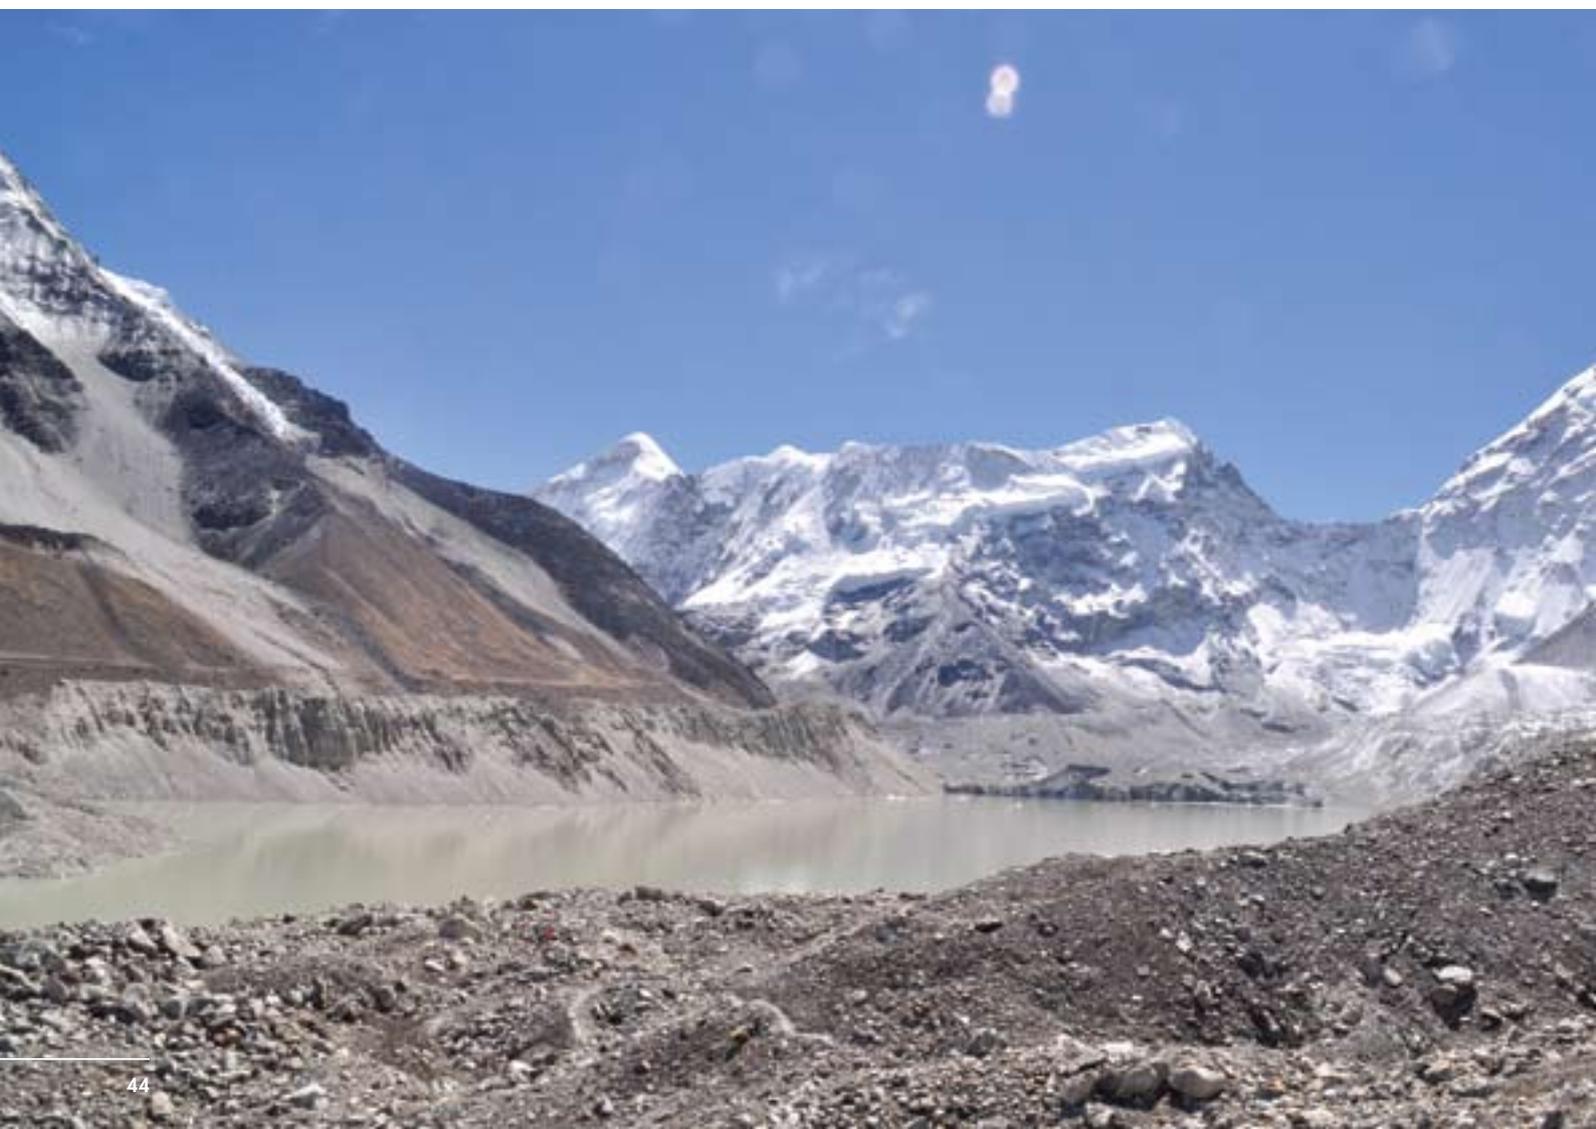
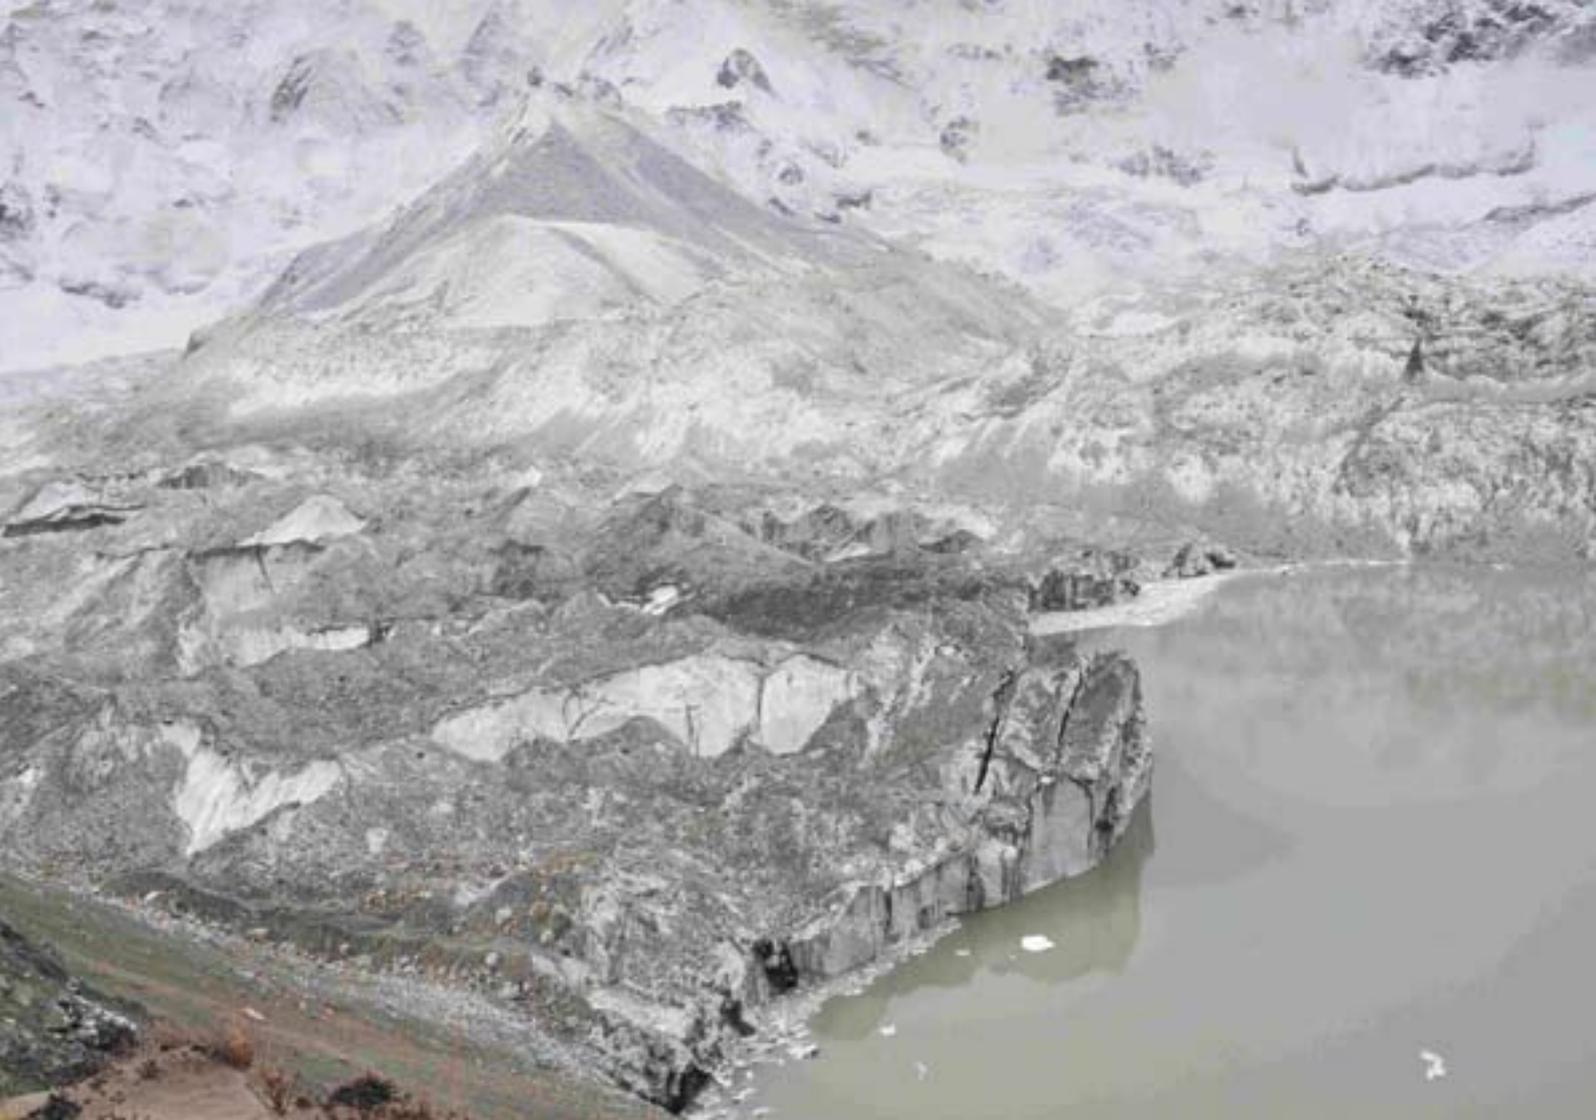
Figure 7.5: **Imja glacier terminus from a distance** (below 24 May 2009) **and closer view** (above right 23 May 2009) **showing thick debris cover and numerous transverse crevasses and collapse features**

be monitored because some portions of it are at risk of breaching since they are comparatively narrow and low and contain unconsolidated material. It is also important to note that the end moraine is subsiding as the buried ice melts, and this melting leaves behind coarse materials and potentially large voids which could also reduce stability. Further study is required to assess the likelihood of a larger than expected icefall from the glacier terminus and the potential impact of the resultant surge. In other parts of the world, temporary blockage of lake outlets through moraines due to freezing water and snow barriers or lake ice debris have led on several occasions to outbursts or related hazards. At Imja Tsho, the flow from the lake is uninterrupted, even though it freezes during the winter and an ice layer up to 70 cm thick is formed on the lake itself. This was determined from bore holes during the earlier bathymetric survey (GEN 2006).
