Glacial Lakes and Glacial Lake Outburst Floods in Nepal

This report was prepared by the International Centre for Integrated Mountain Development (ICIMOD) for the Global Facility for Disaster Reduction and Recovery (GFDRR)/The World Bank.

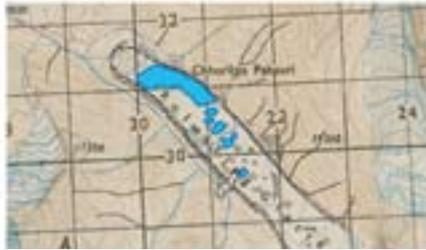
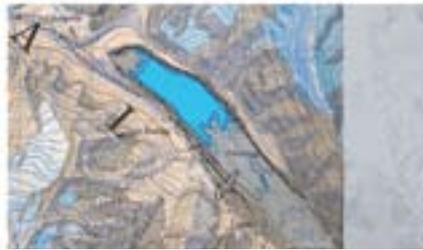
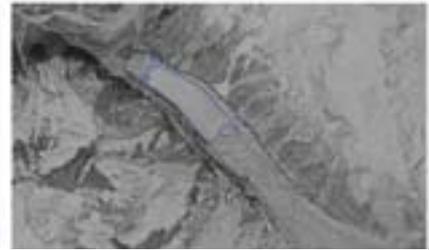
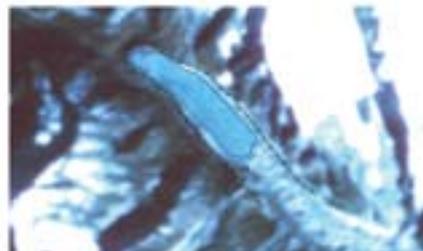
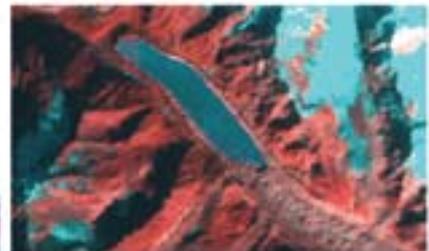
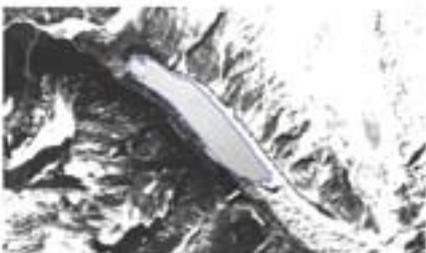
Figure 7.7: Development of Tsho Rolpa from 1957 to 2009 based on Topography Map (1957-59), Schneider Map (1960-68), Corona (1973), Landsat MSS (1975), Spacelab IR (1983), Landsat TM (1991), Aerial Photo (1992), LISS-3 (1999), Landsat ETM+ (2000), AVNIR-2 (2007), WECS Field Survey (1993-94) and ICIMOD (2009)

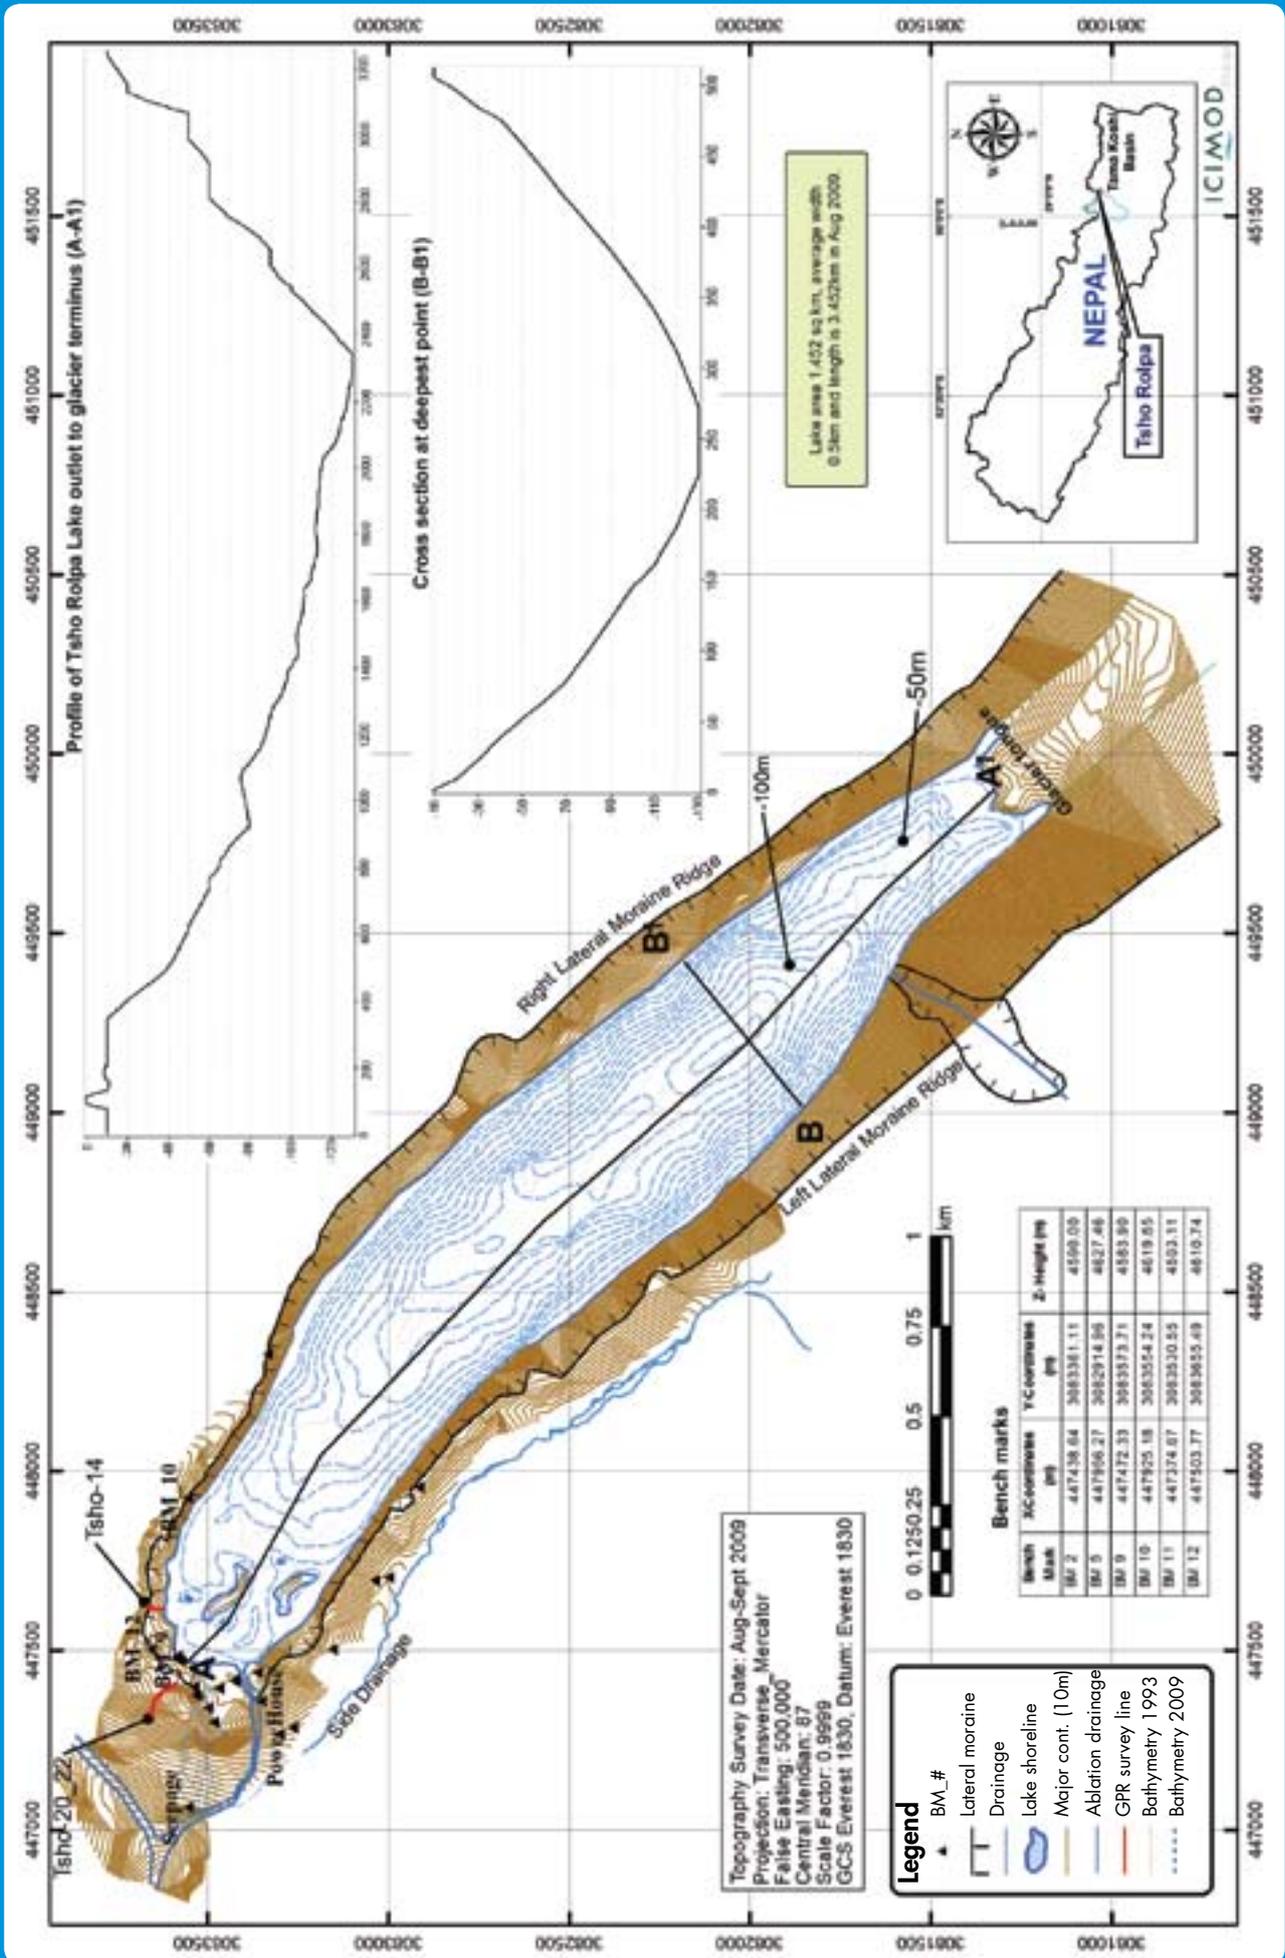
Figure 7.8: Bathymetric and topographic map of Tsho Rolpa showing the longitudinal profile and cross-section through the deepest point

reduced the lake level by three metres. As a result, by 2000, satellite images (Landsat ETM+ 2000) showed that the area had decreased to 1.53 sq. km. Growth of the lake after 2000 was slow. The 2005 satellite image (Landsat ETM+ 2005) indicated an area of 1.535 sq.km and the 2007 satellite image (AVNIR-2) an area of 1.538 sq.km. Tsho Rolpa is thought to be one of the most dangerous lakes in Nepal; it is continuously monitored by the Department of Hydrology and Meteorology (DHM).

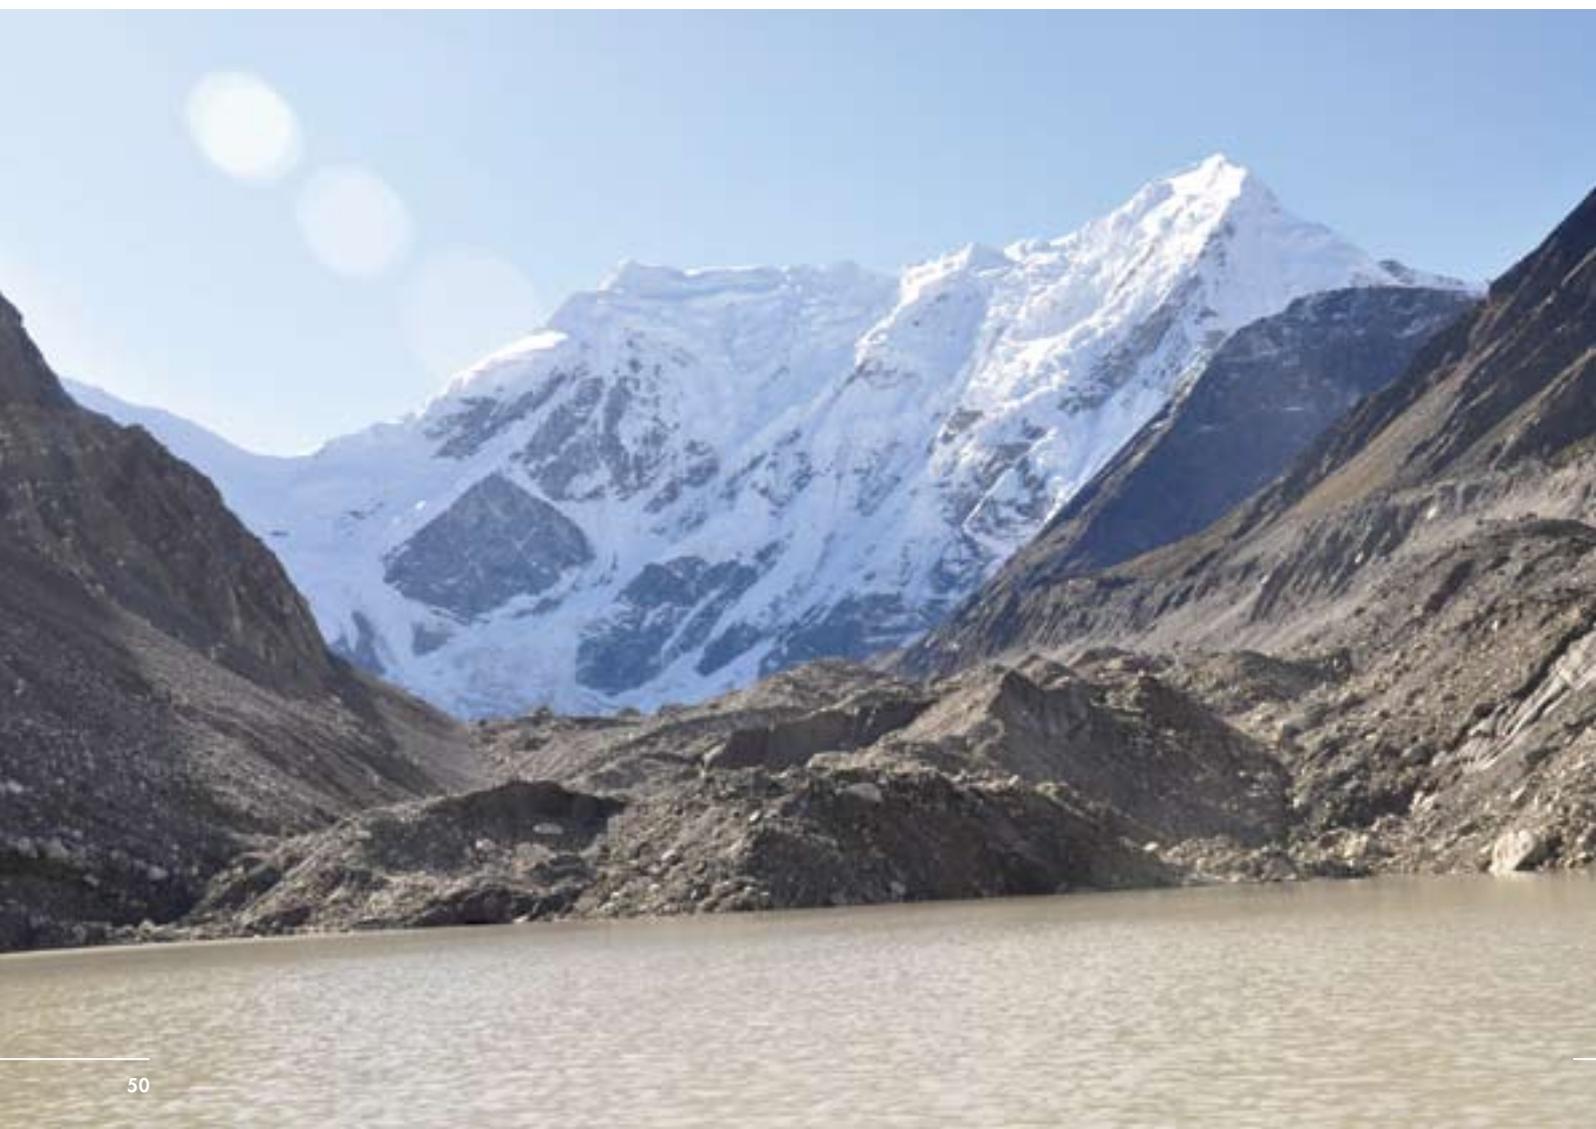
Figure 7.9: **Glacier terminus with thick debris cover in contact with the Tsho Rolpa. Thermokarsts are exposed on both the left and right lateral moraines which are also in contact with the glacier terminus, 11 September 2009**

Trakarding glacier descends into the Tsho Rolpa at 4,546 masl. In 1997, there was a nearly vertical ice wall about 30 to 40 m above the lake at the terminus; this has now been reduced to a surface slope towards the lake with a height of only a few metres.

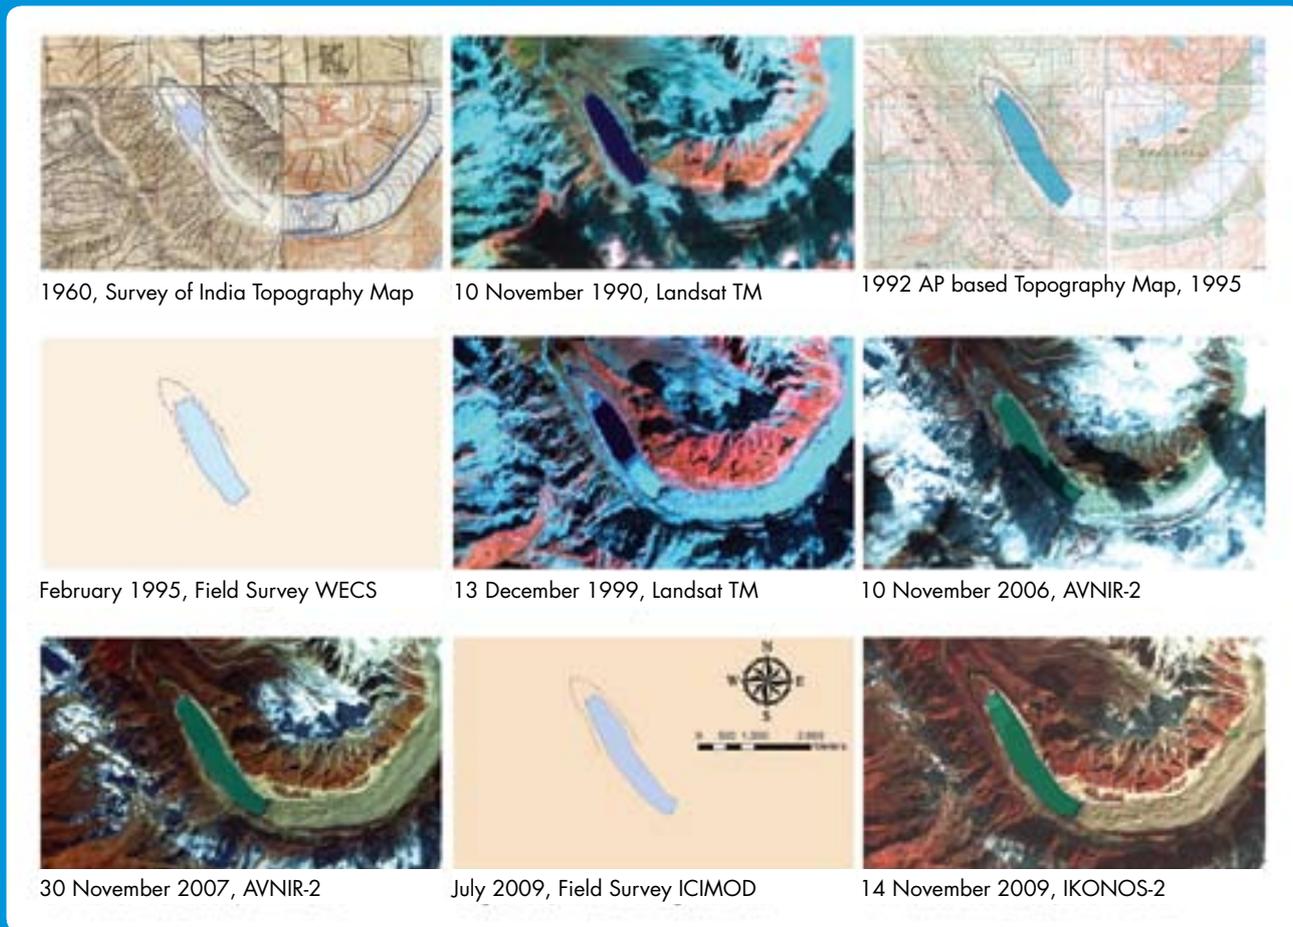
Figure 7.11: Development of Thulagi Lake between 1960 and 2009 based on the Topographical Map of the Survey of India (1960), Nepal Survey Department (1995), Landsat TM (Nov 1990, Dec 1999), AVNIR-2 (Nov 2006 and Nov 2007), IKONOS-2 (Nov 2009), WECS Field Survey (1995) and ICIMOD (2009)

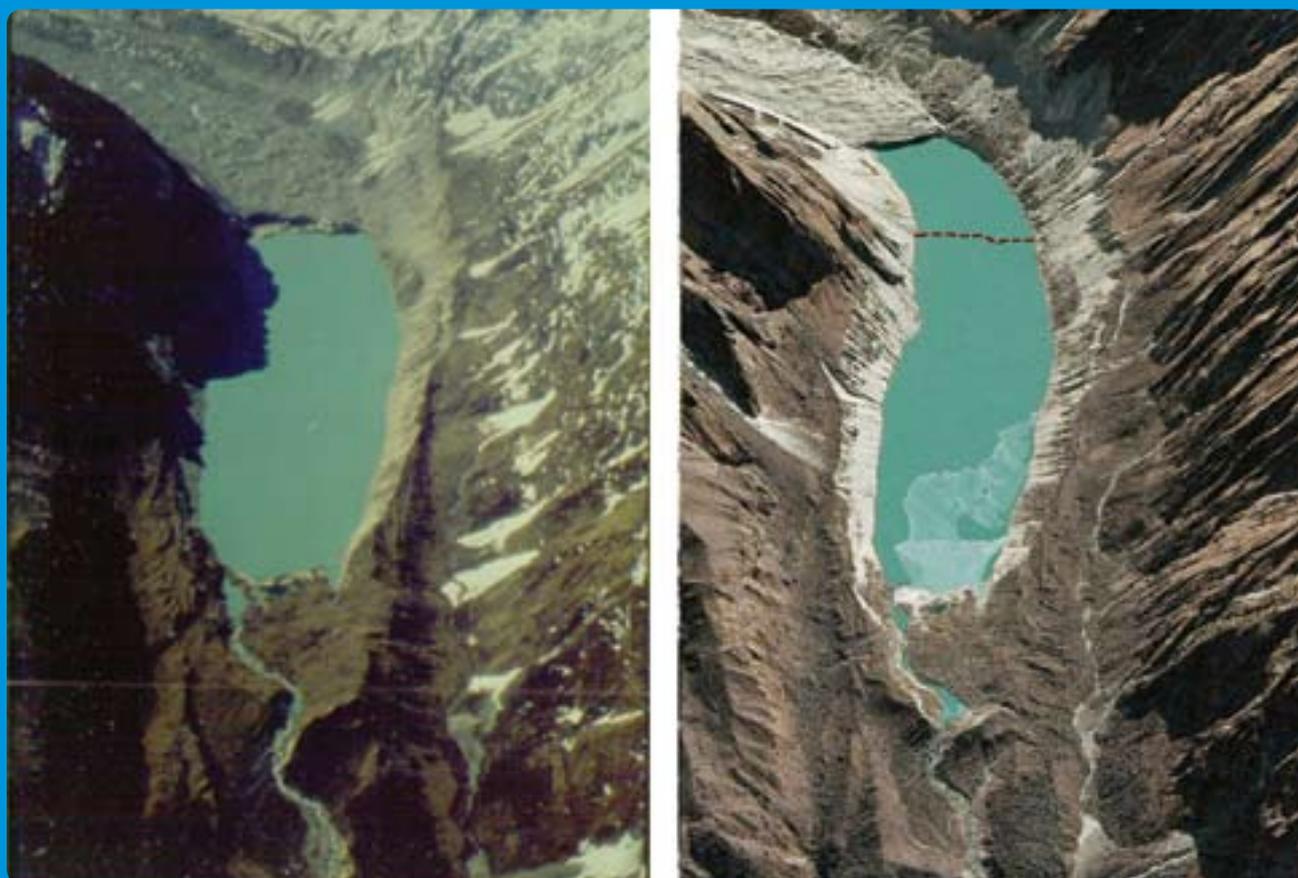
Figure 7.12: Overview of Thulagi Glacier and glacial lake in 1992 photo (left) and 2009 December Quick Bird image (right); the red line shows the expanded area

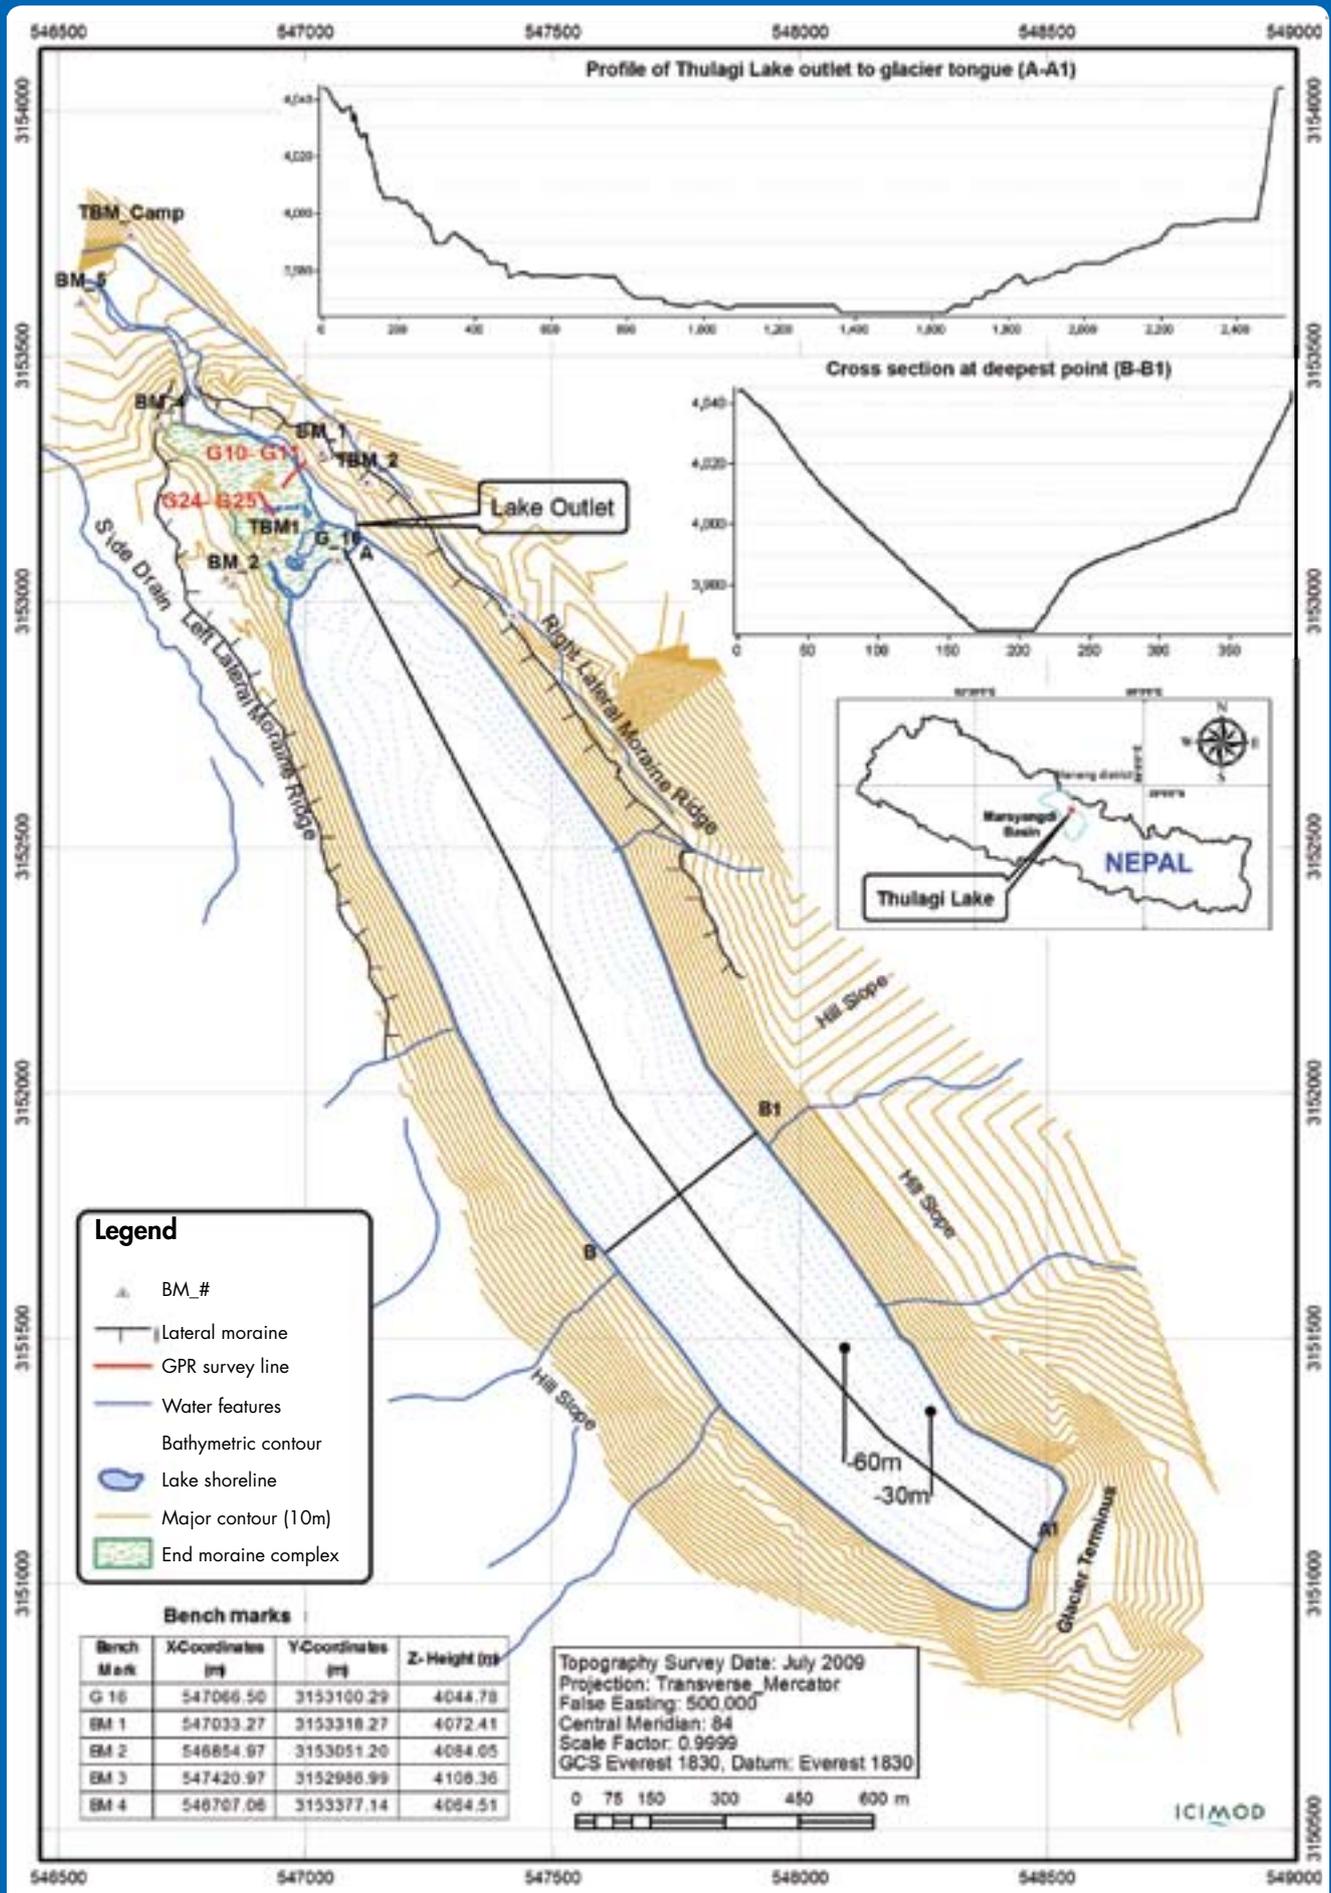
Figure 7.13: Bathymetric and topographical map of Thulagi glacial lake showing the longitudinal profile and cross section along the deepest point. The GPR lines G24-25 and G10-11 show the location of buried ice.

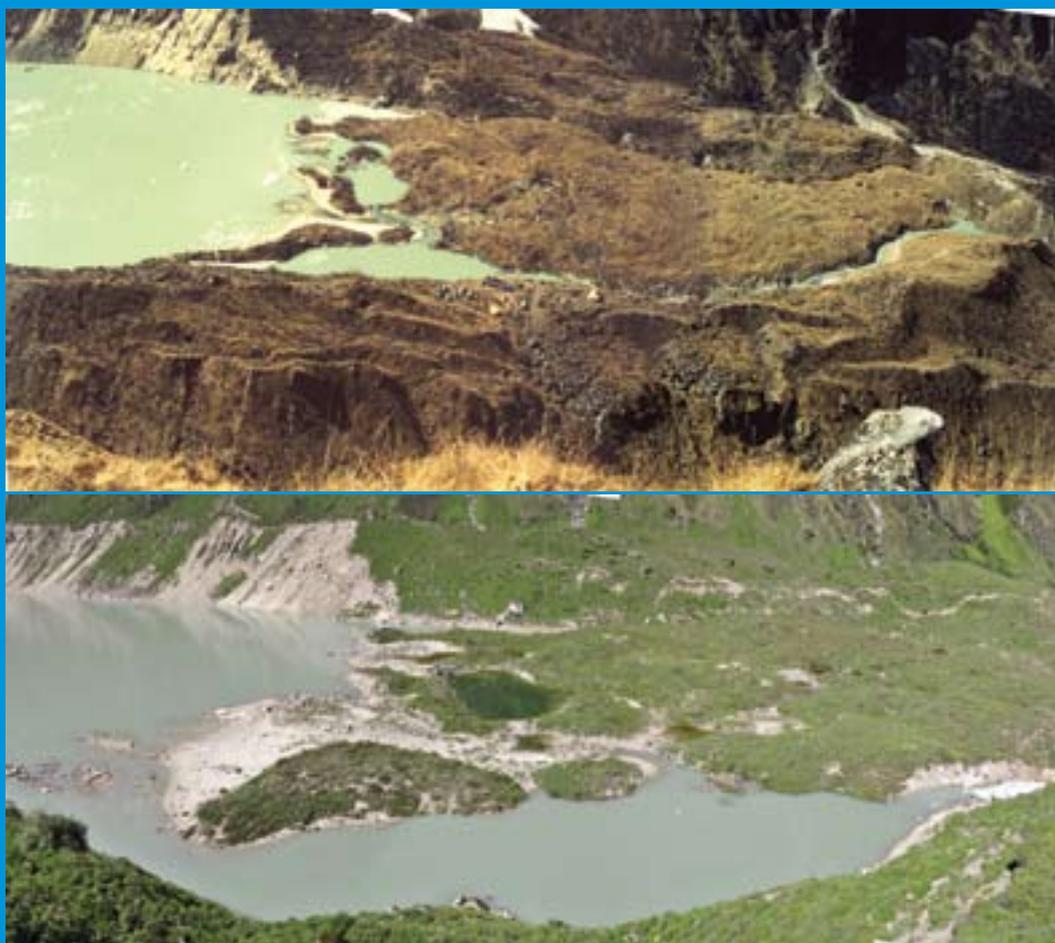
Figure 7.14: Changes in the shoreline of Thulagi Lake between 1996 (above) and 13 July 2009 (below), show the flow has now shifted towards the right lateral moraine, there are linear subsidence features on the left and right lateral moraines

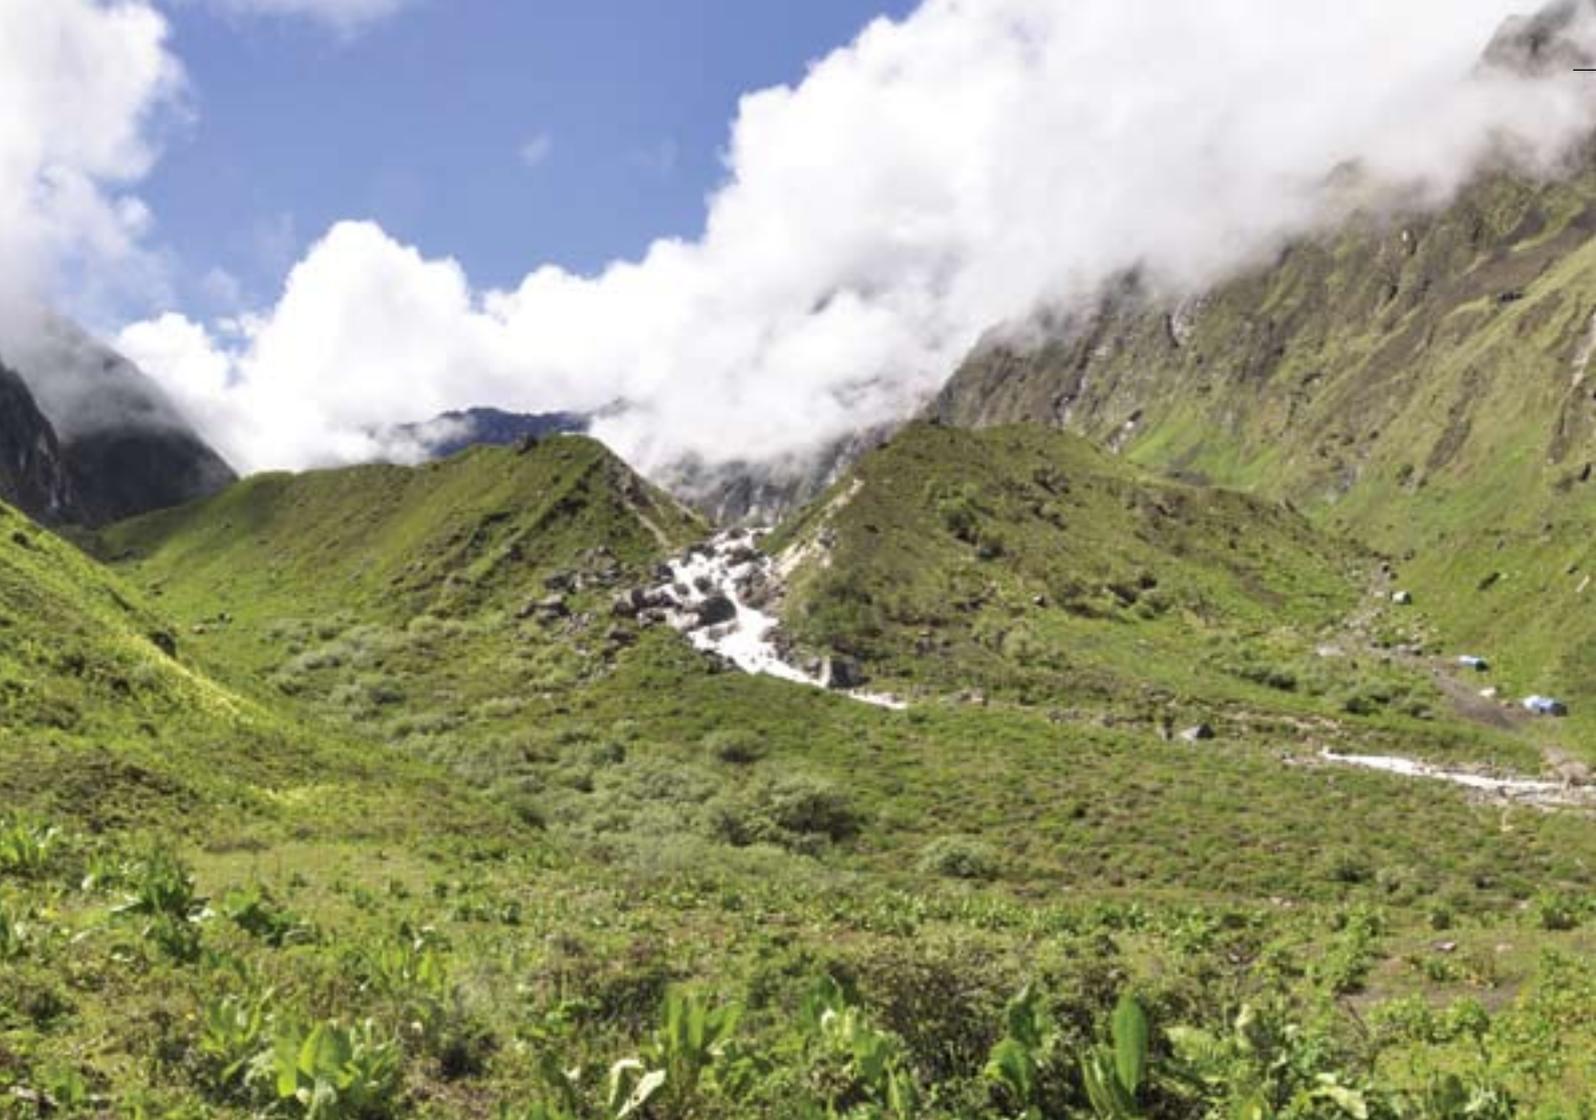
Figure 7.15: The steep Thulagi outlet flowing through a narrow valley, 17 July 2009

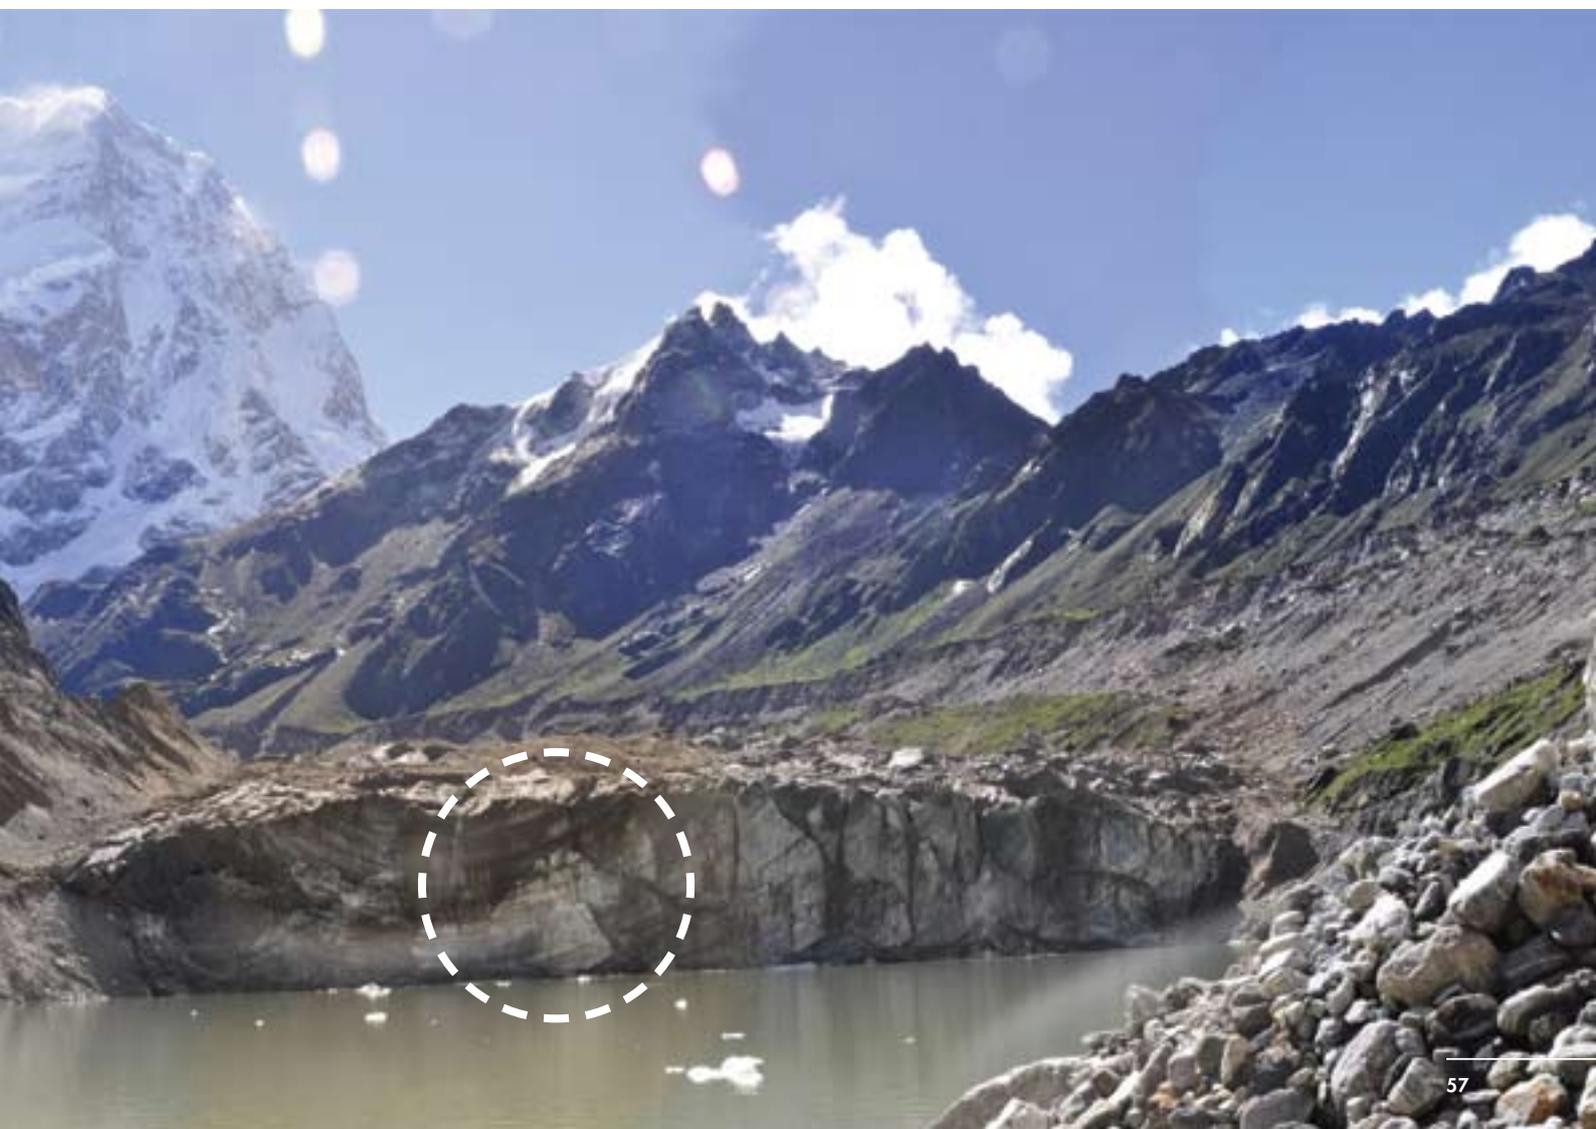
Figure 7.16: The Thulagi Glacier terminus in contact with the lake, the glacier tongue is about 40 m high above the water surface and exhibits snow stratigraphy (circle), 22 July 2009

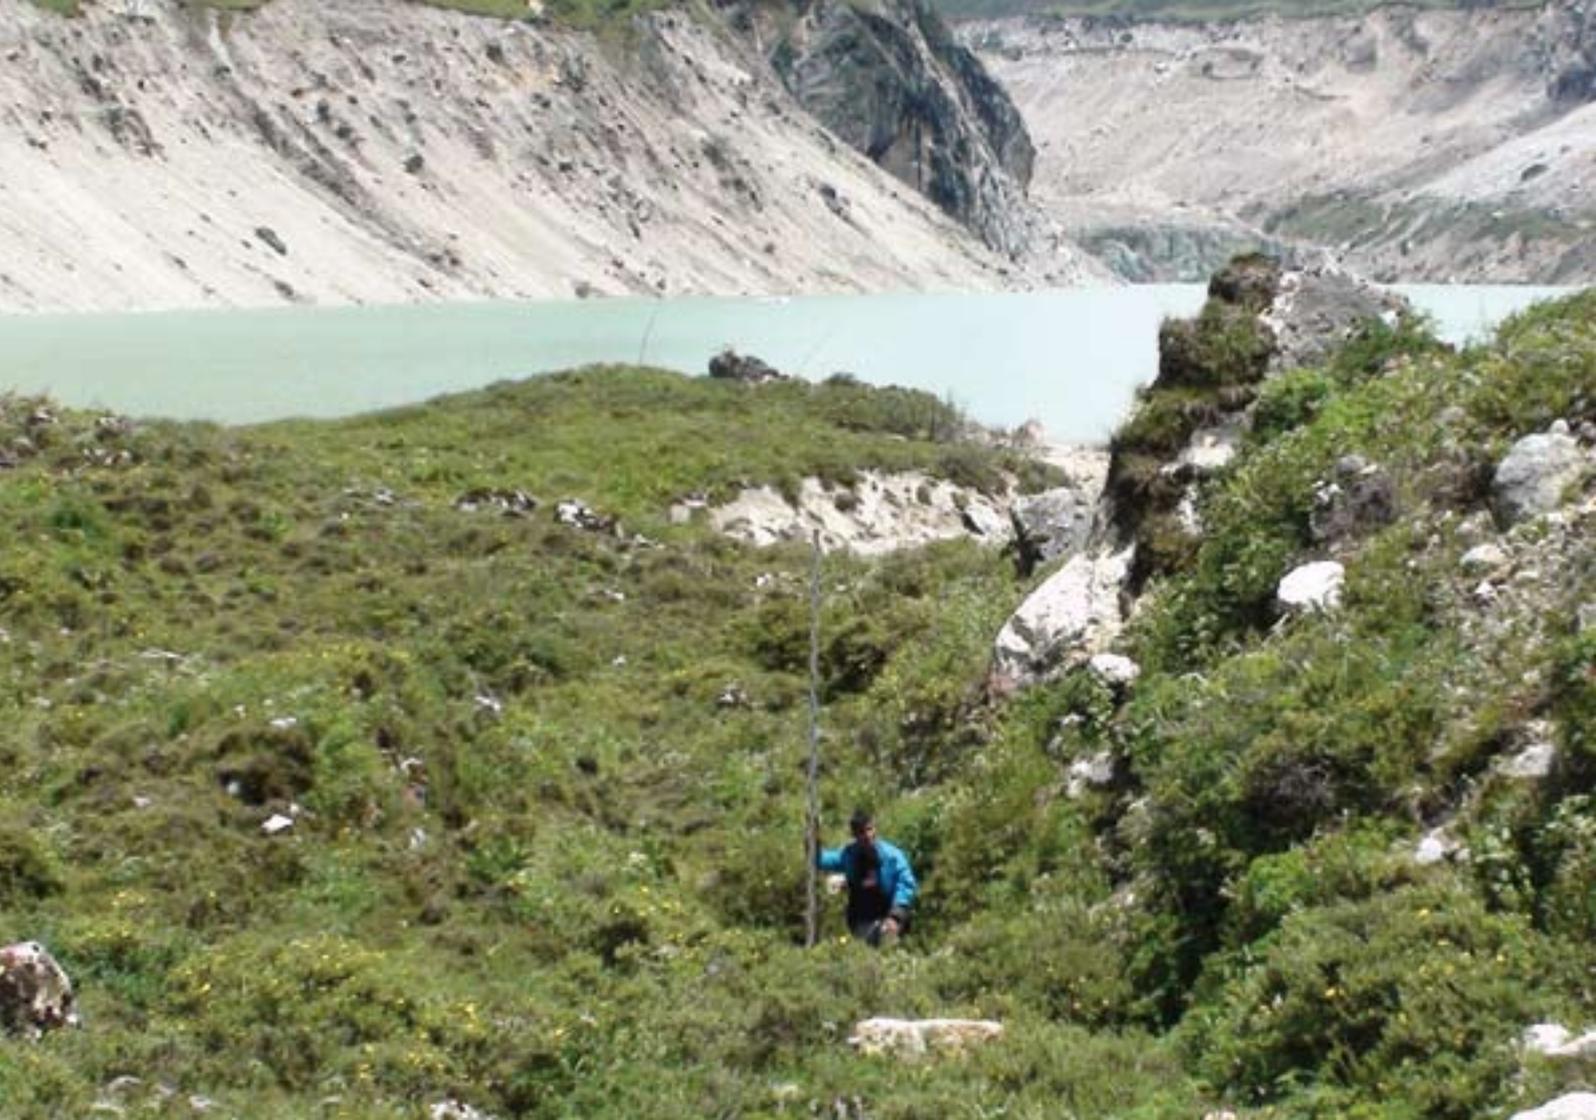
Figure 7.17: Contact of the lateral and end moraine complex with extensive linear features and sink holes at Thulagi Lake, 24 July 2009

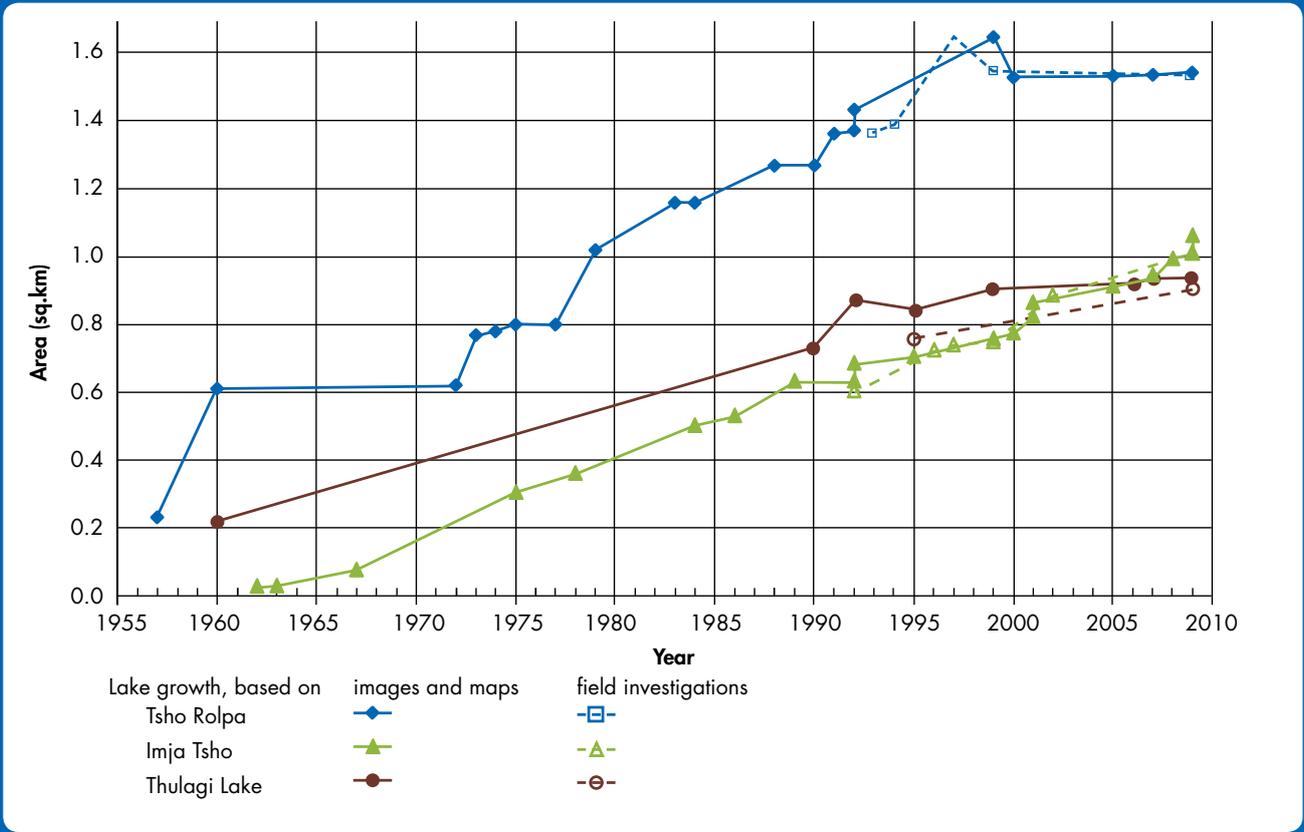
Figure 7.18: Comparison of lake development from images, topographical maps, and field investigation data for the Imja Tsho, Tsho Rolpa, and Thulagi Lakes. Imja lake grew at a slower rate up to 2000 when the rate increased; the growth rate of Tsho Rolpa diminished substantially after mitigation in 2000

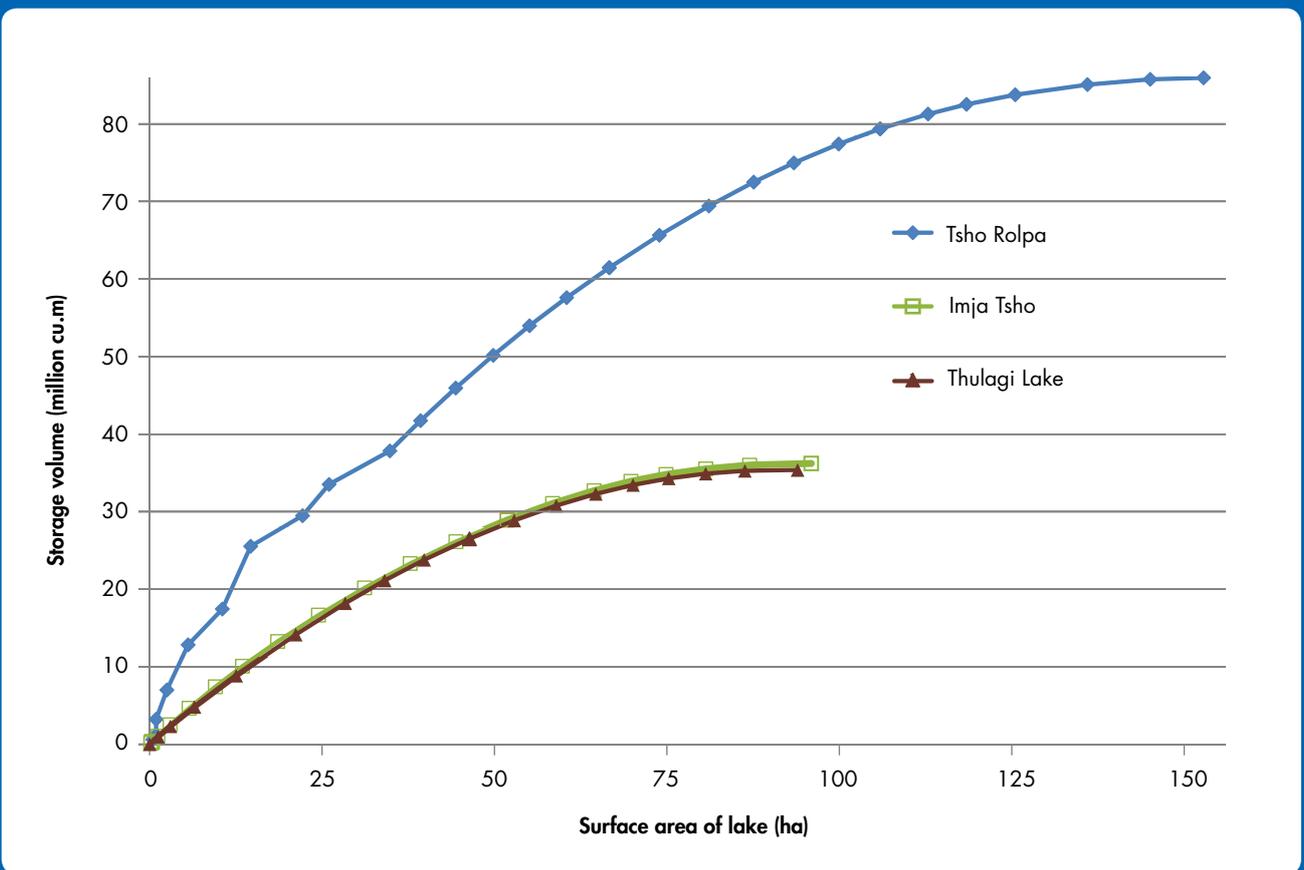
Figure 7.19: The relationship of volume and depth for the Tsho Rolpa, Thulagi, and Imja lakes.

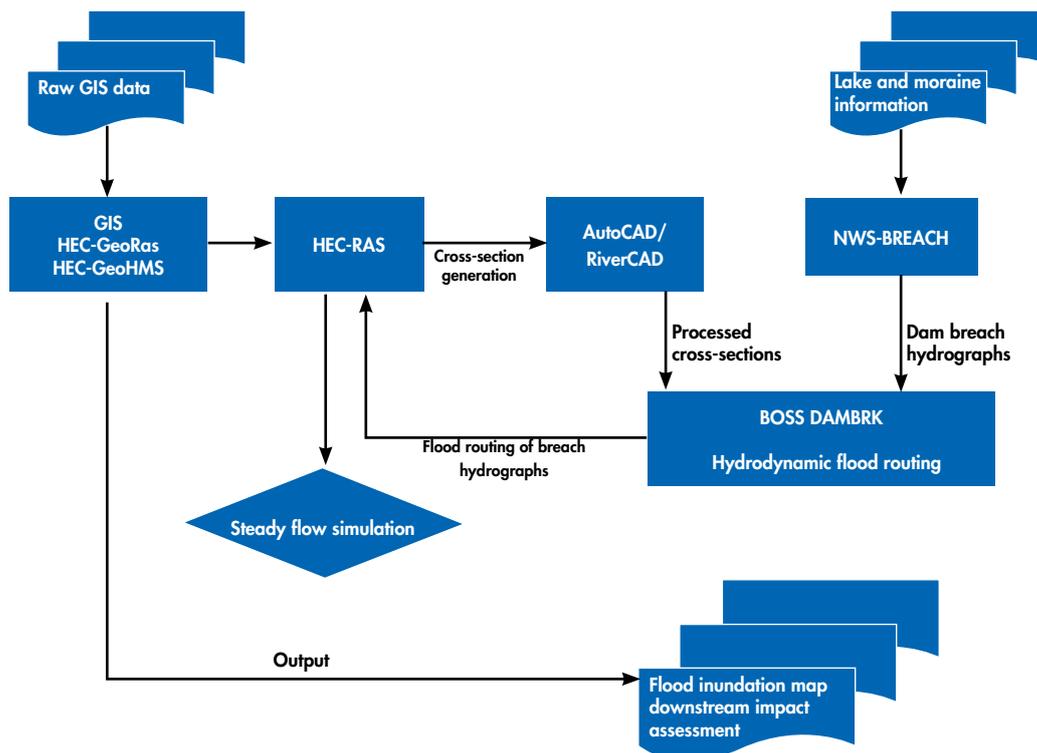
Figure 8.1: Schematic representation of the methodology used for modelling GLOFs and assessing downstream impacts

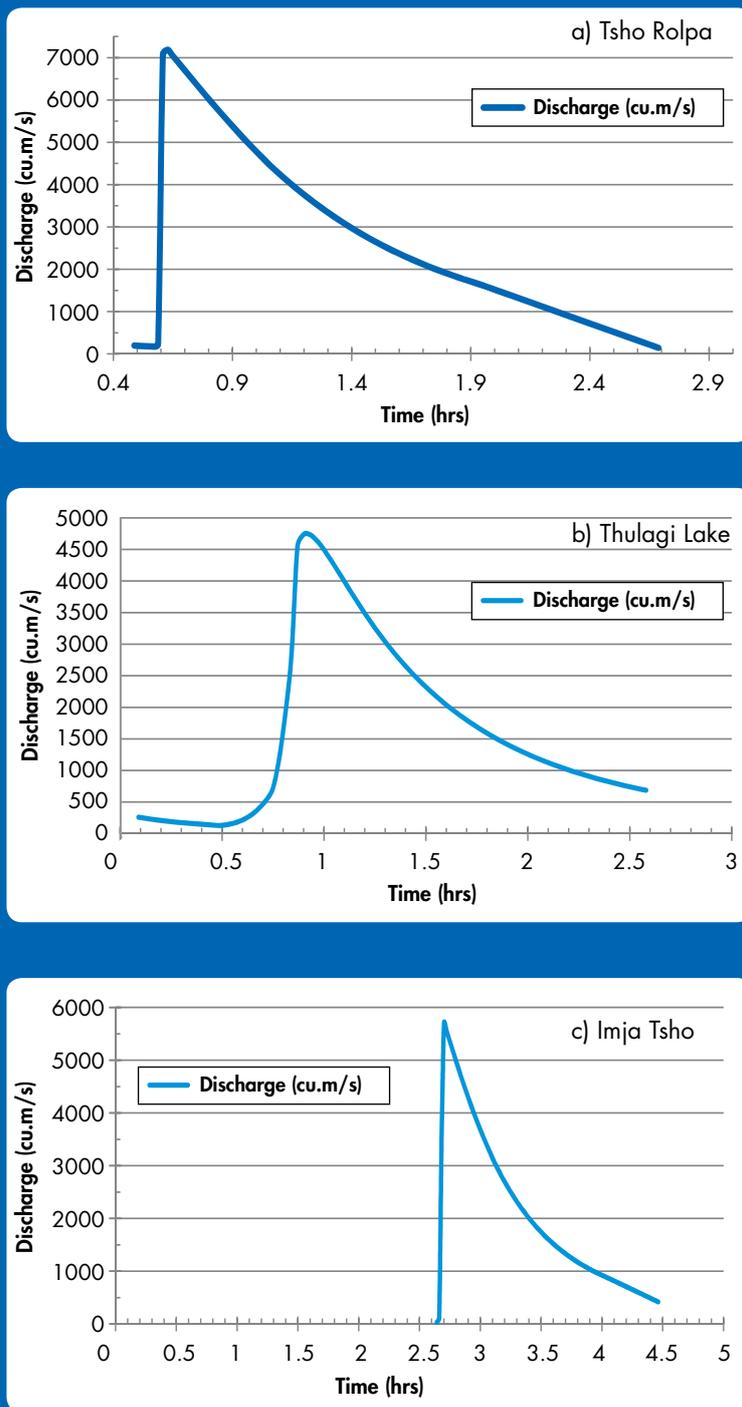
Figure 8.2: Breach hydrograph of a potential breach
