Glacial Lakes and Glacial Lake Outburst Floods in Nepal

This report was prepared by the International Centre for Integrated Mountain Development (ICIMOD) for the Global Facility for Disaster Reduction and Recovery (GFDRR)/The World Bank.

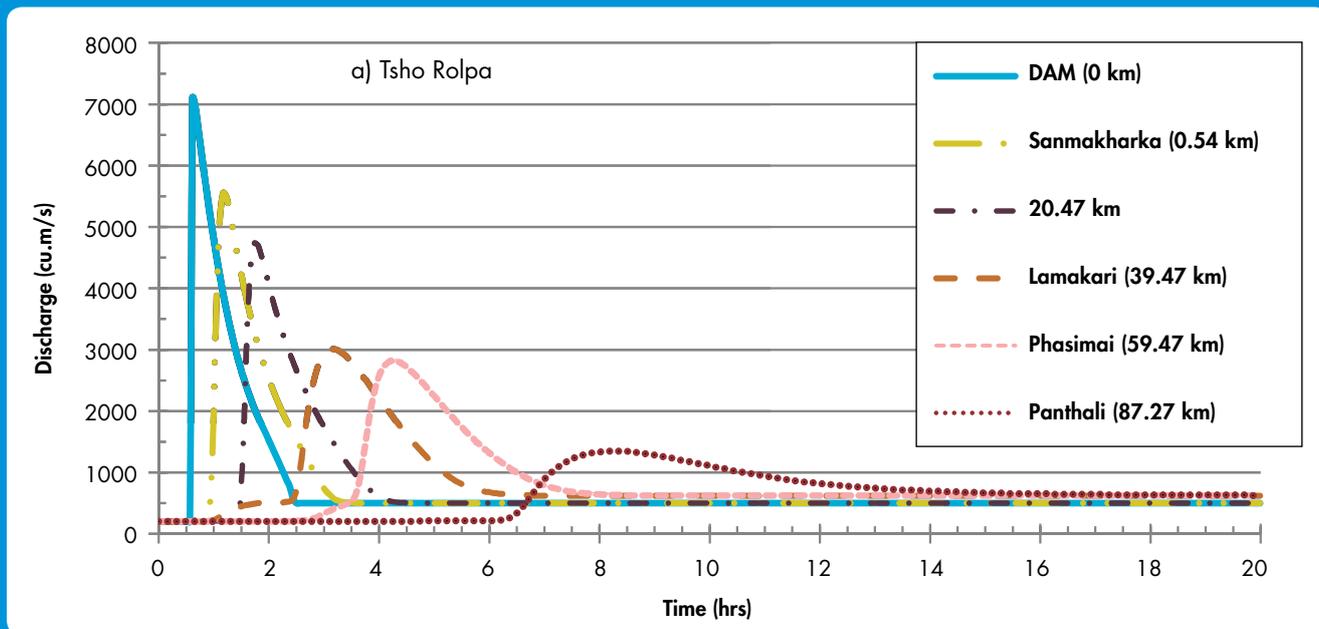
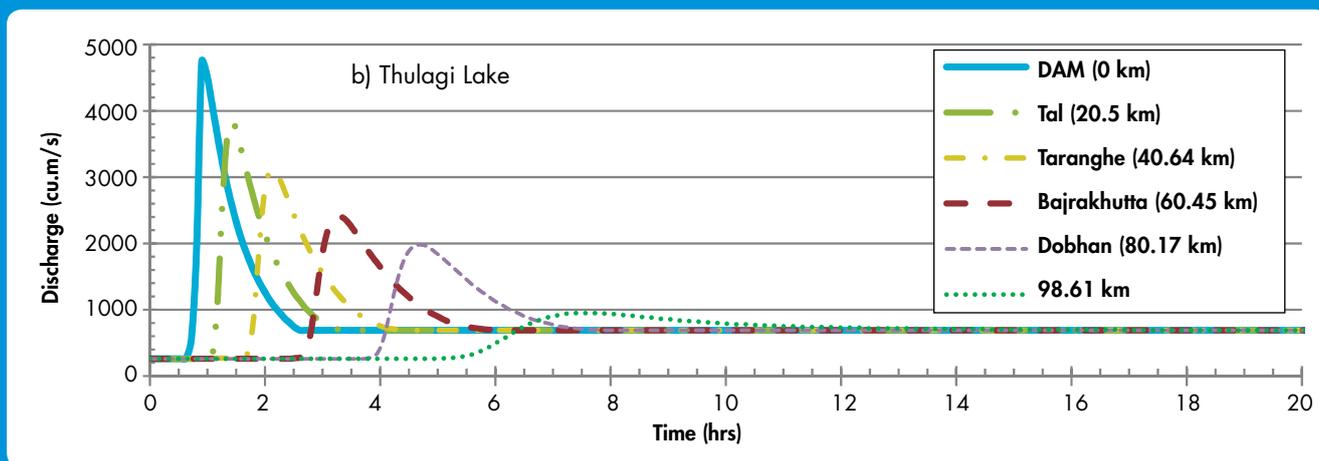
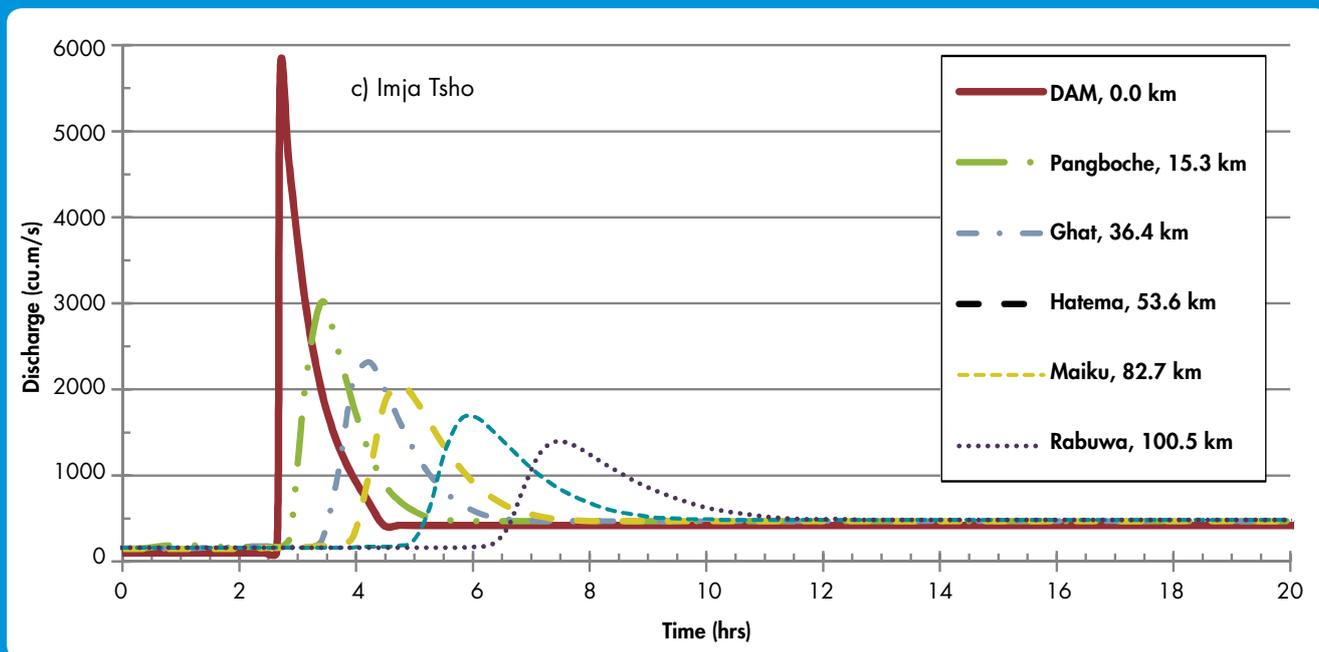
Figure 8.3: Flood attenuation at various downstream locations

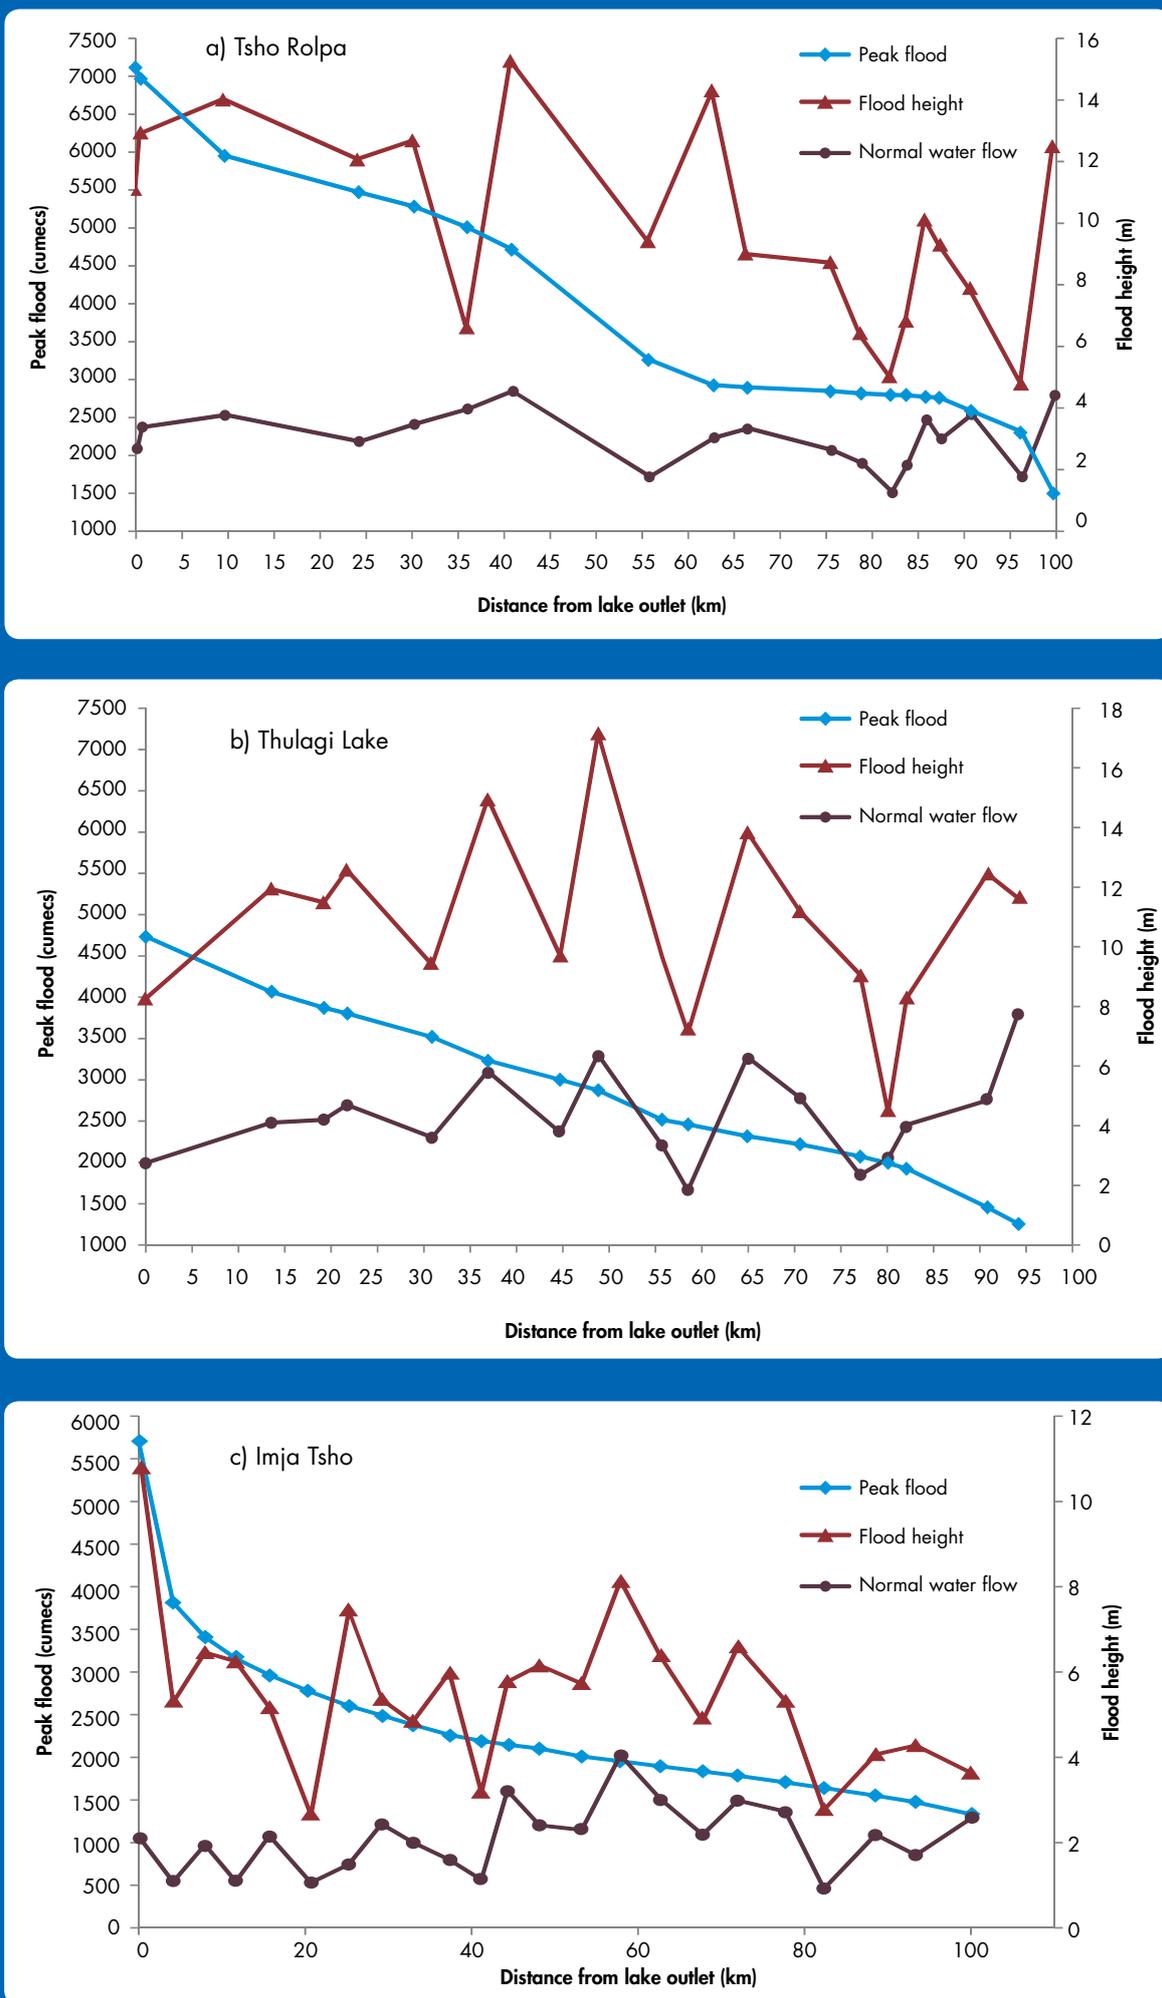
Figure 8.4: Peak flood and flood height of the three lakes

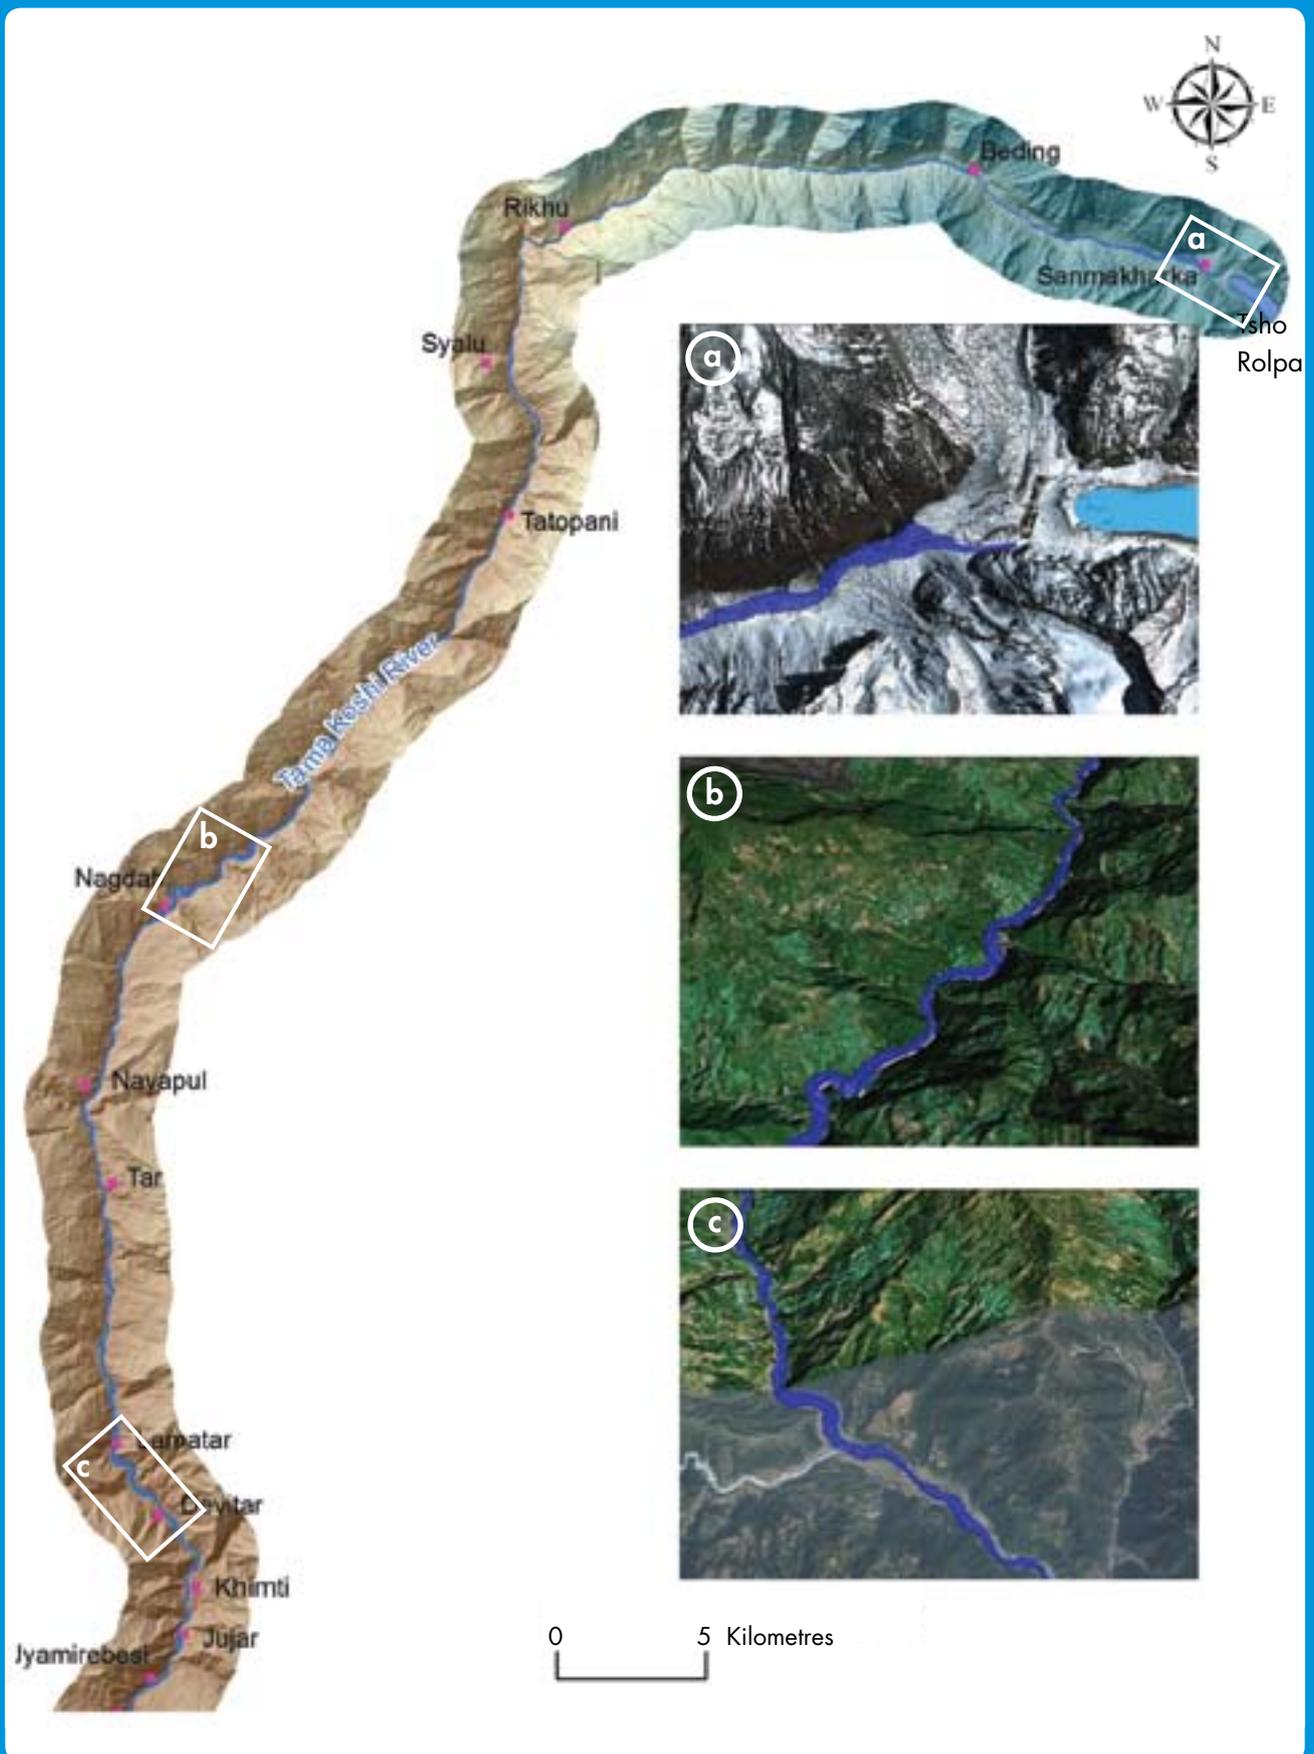
Figure 8.5: Modelled flood inundation map along the Tama Koshi valley, downstream from Tsho Rolpa

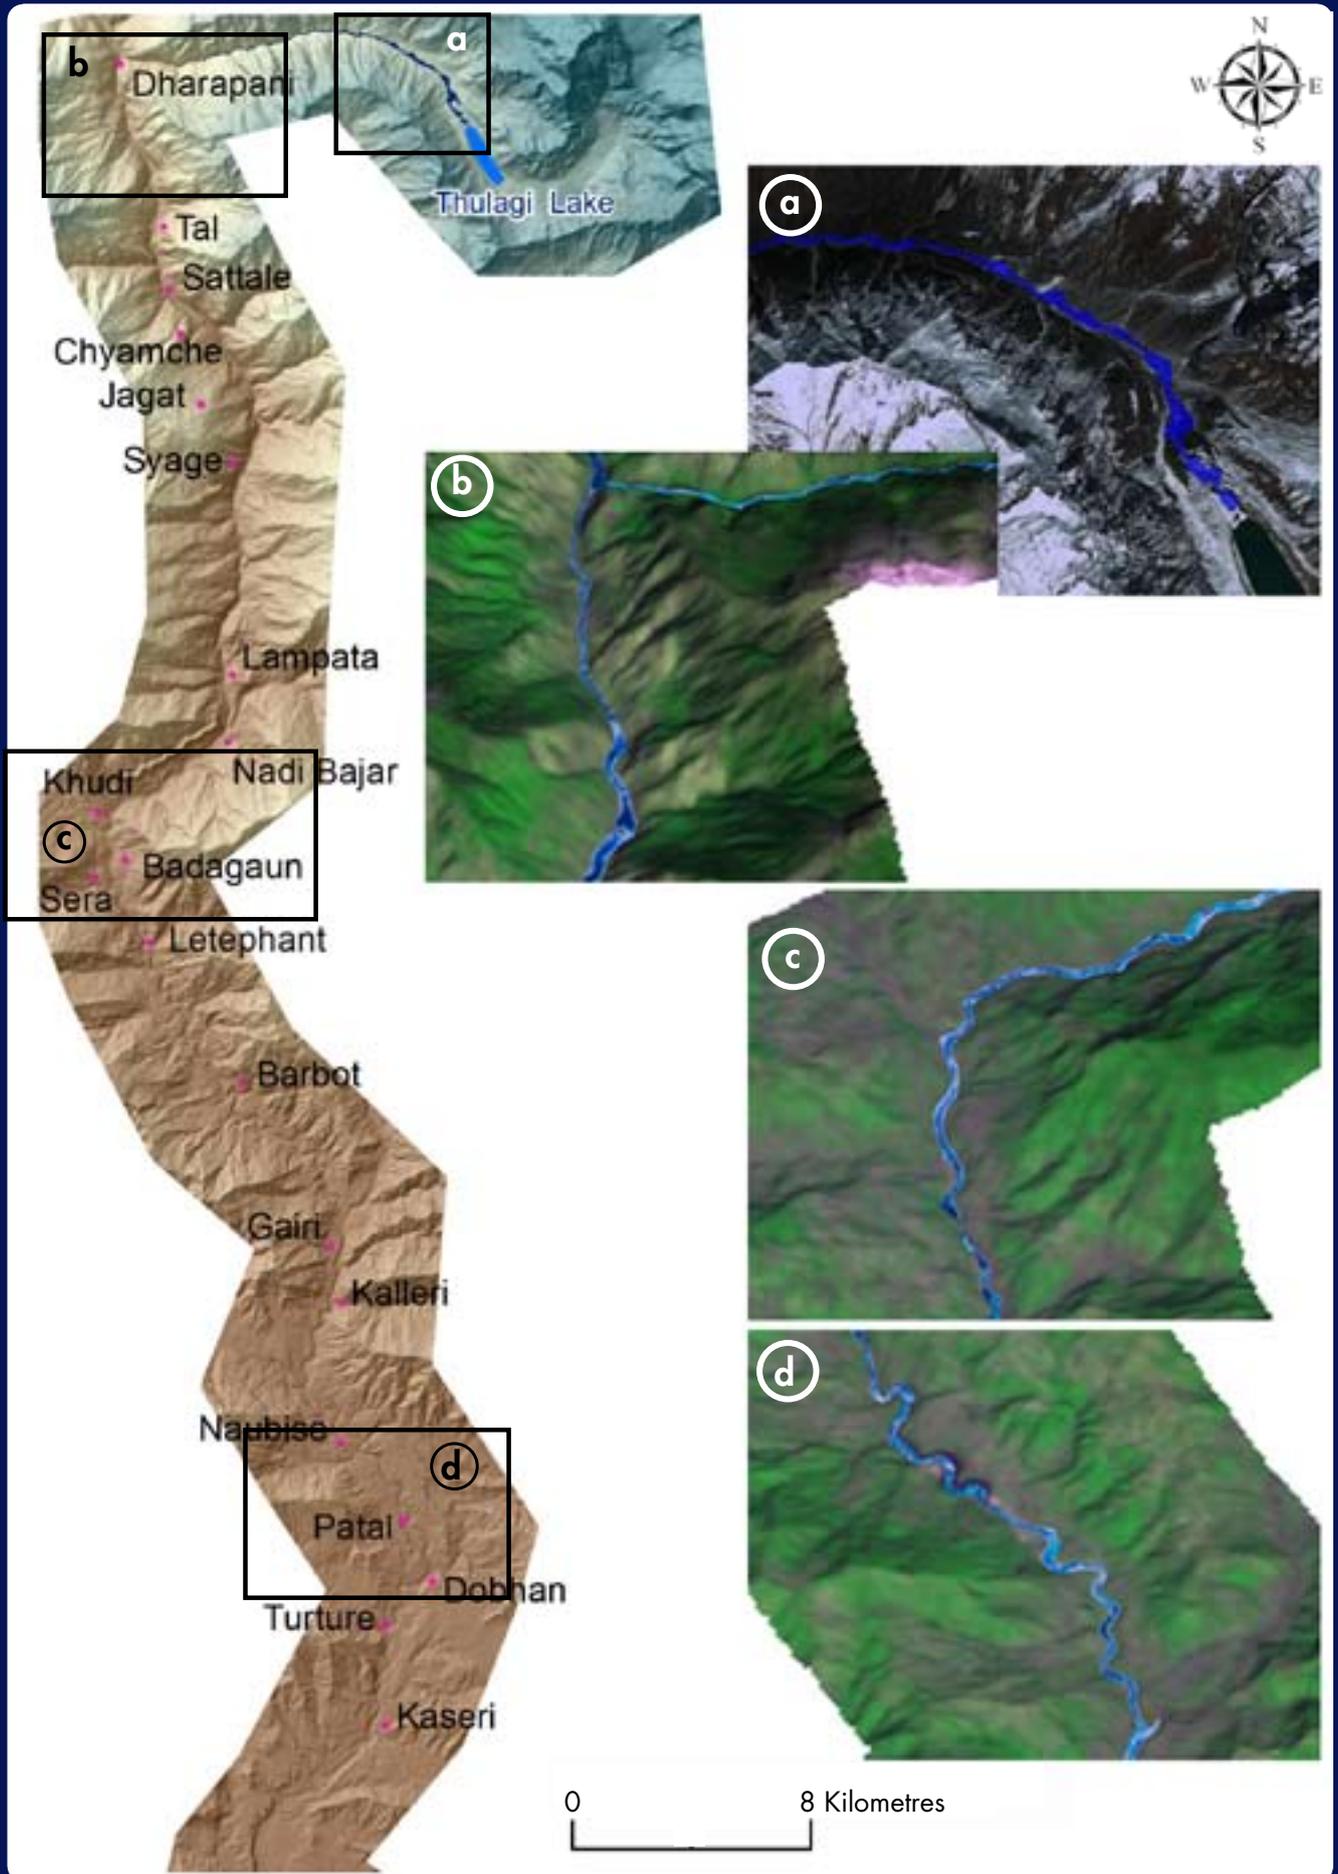
Figure 8.6: Modelled flood inundation map along the Marsyangdi valley, downstream from Thulagi Lake

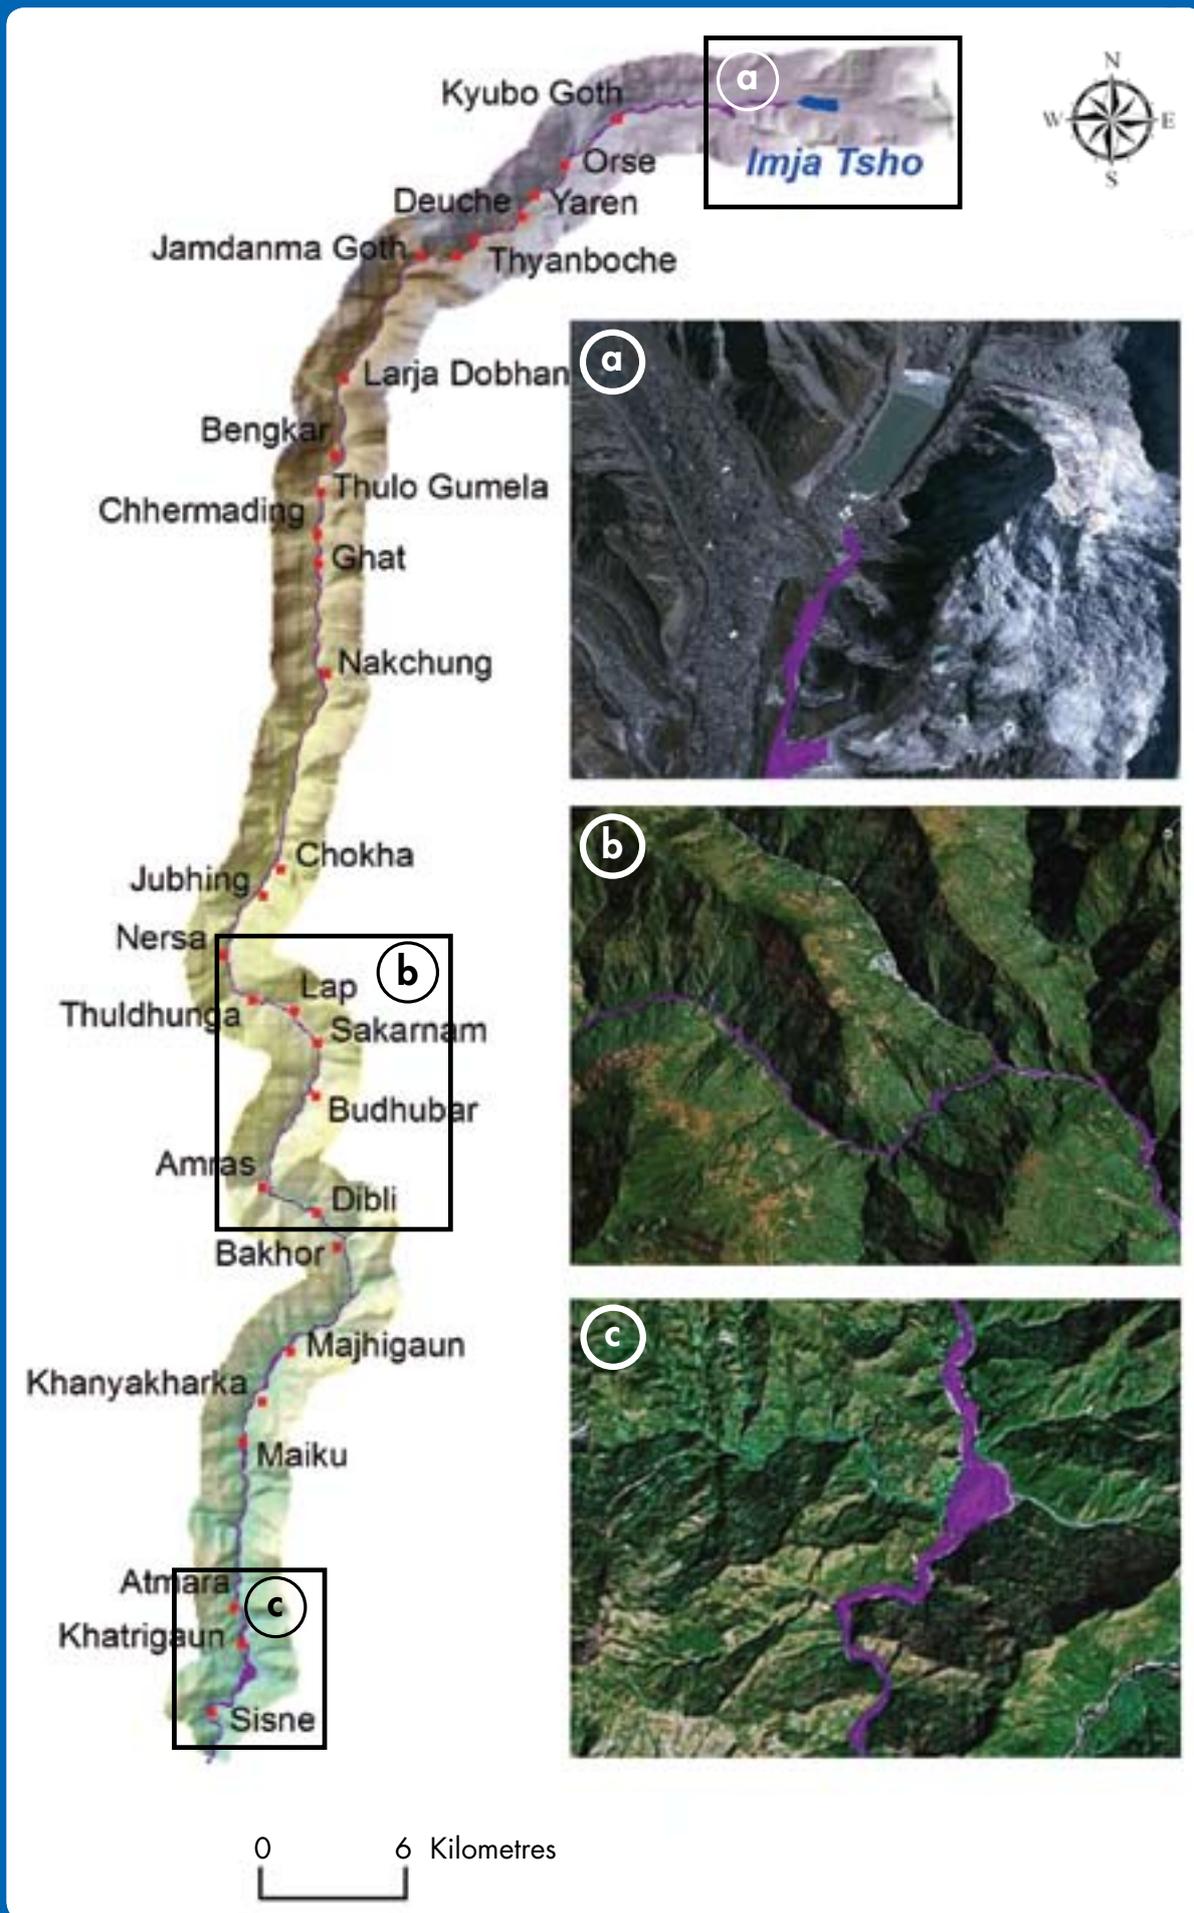
Figure 8.7: Modelled flood inundation map along Dudh Koshi valley downstream of Imja Tsho

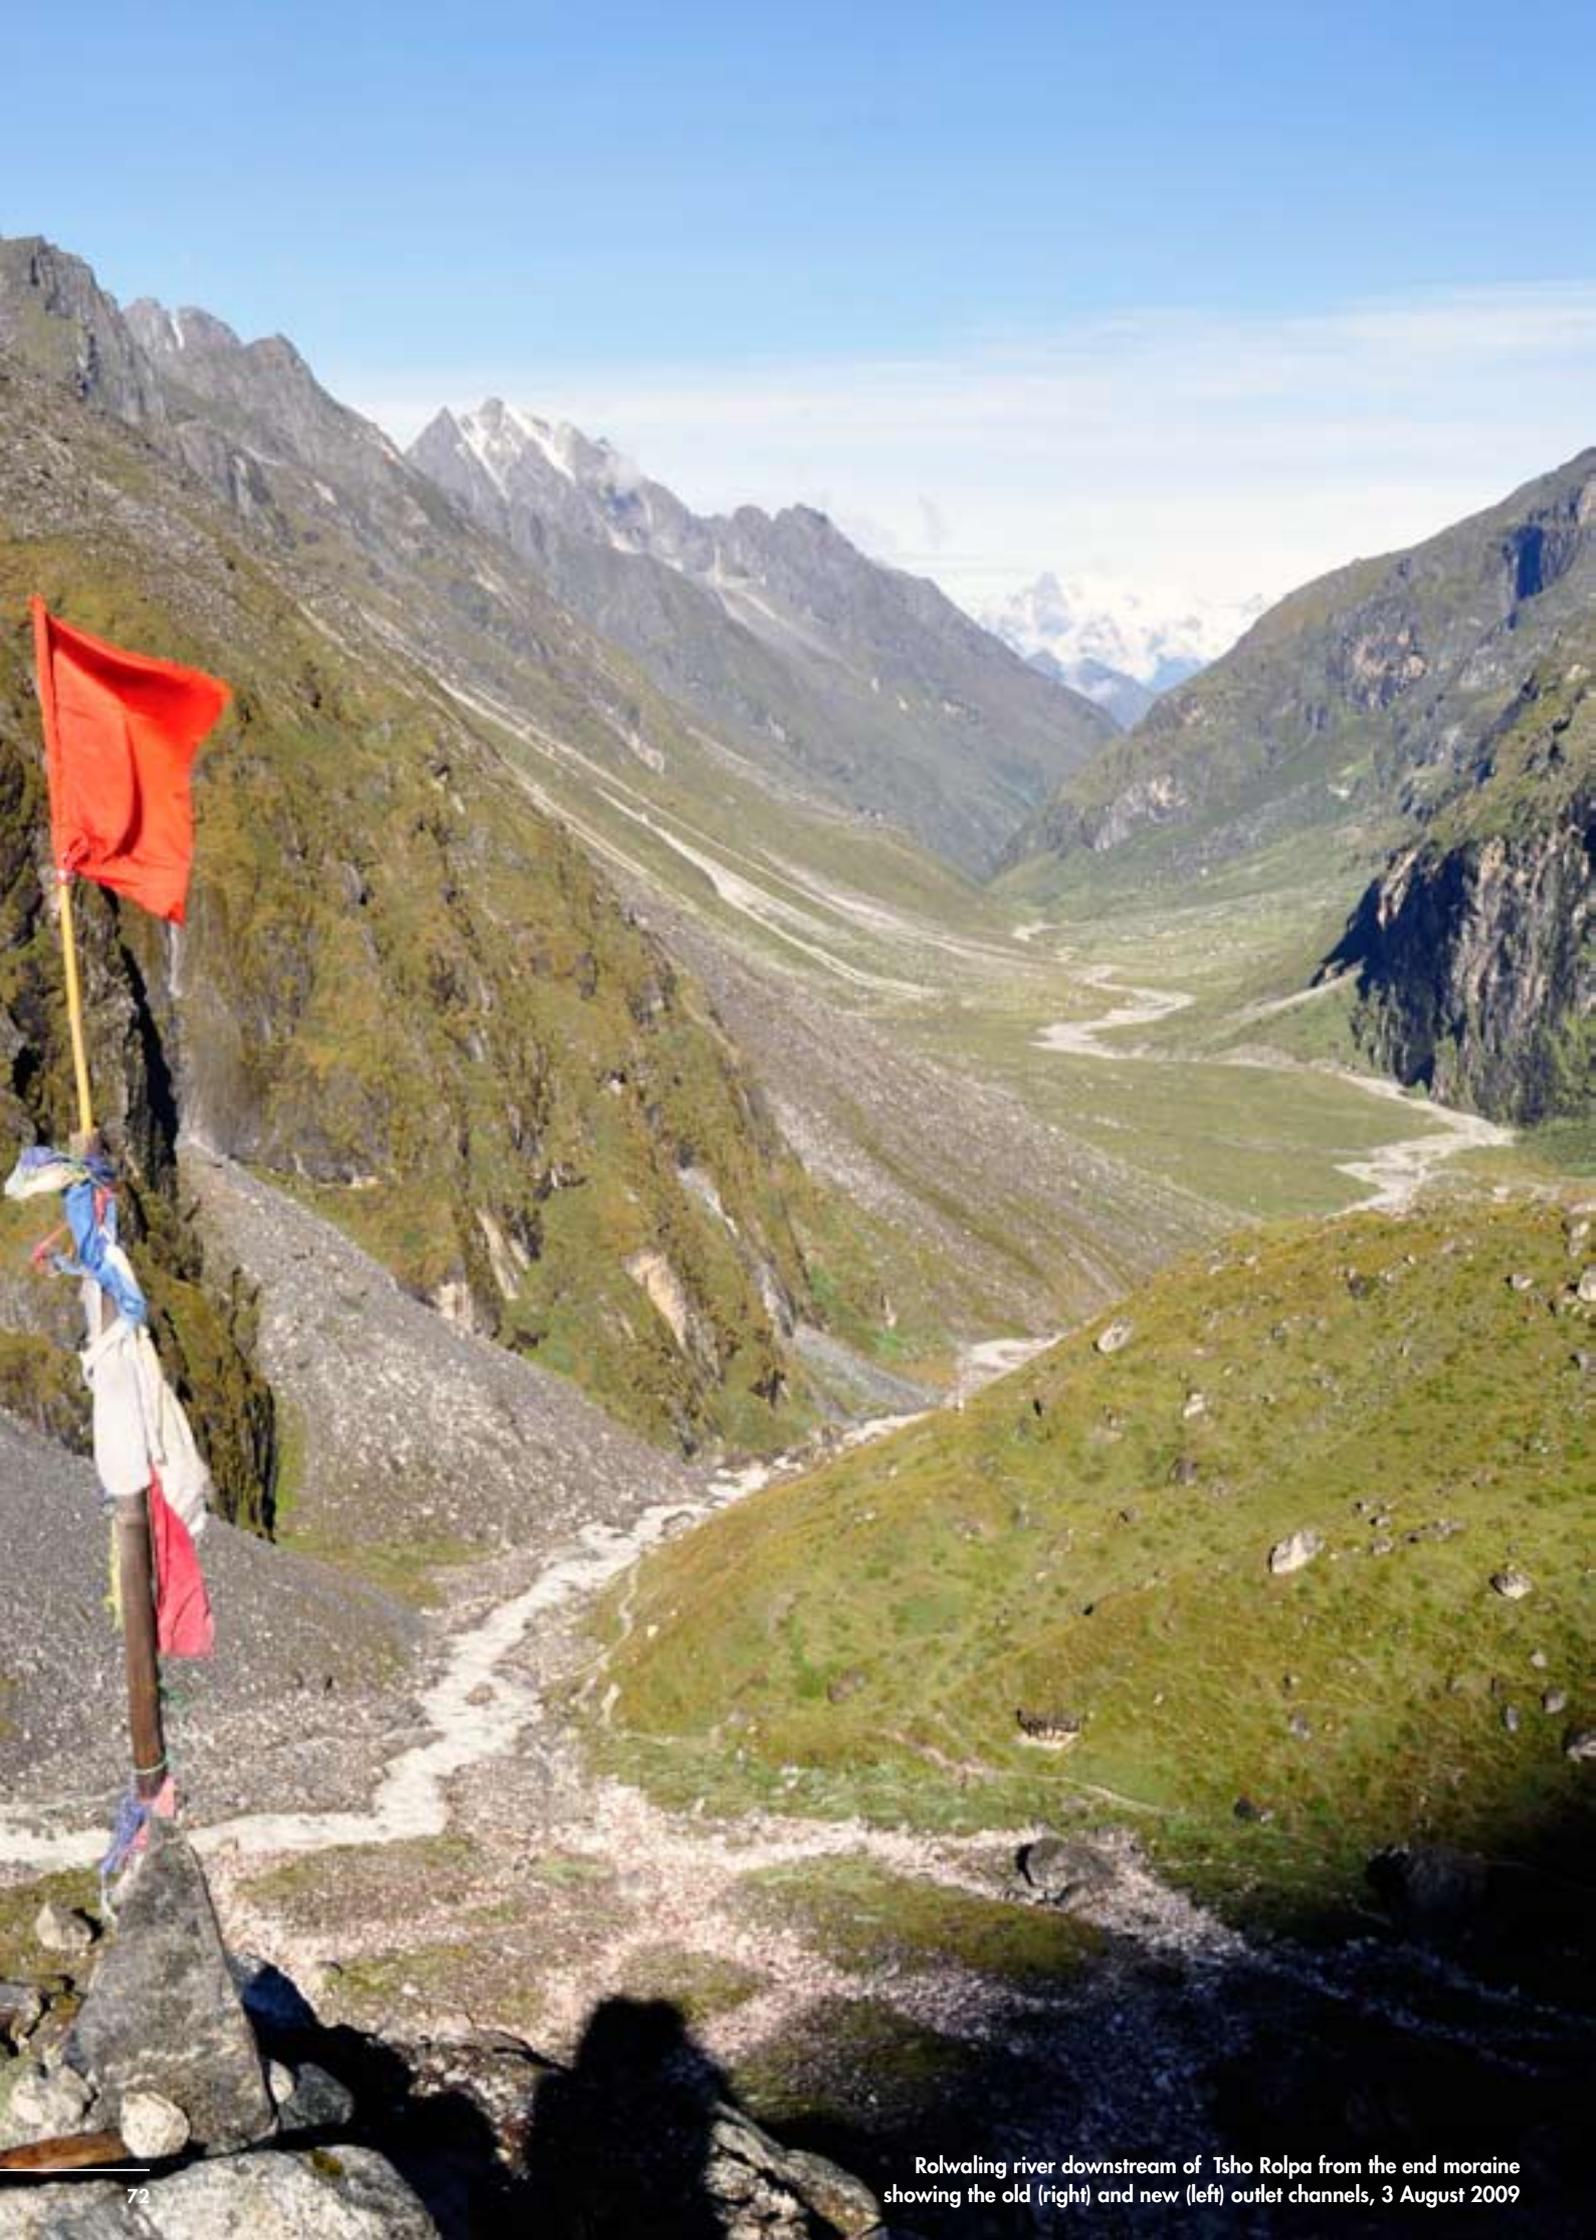
Rolwaling river downstream of Tsho Rolpa from the end moraine showing the old (right) and new (left) outlet channels, 3 August 2009

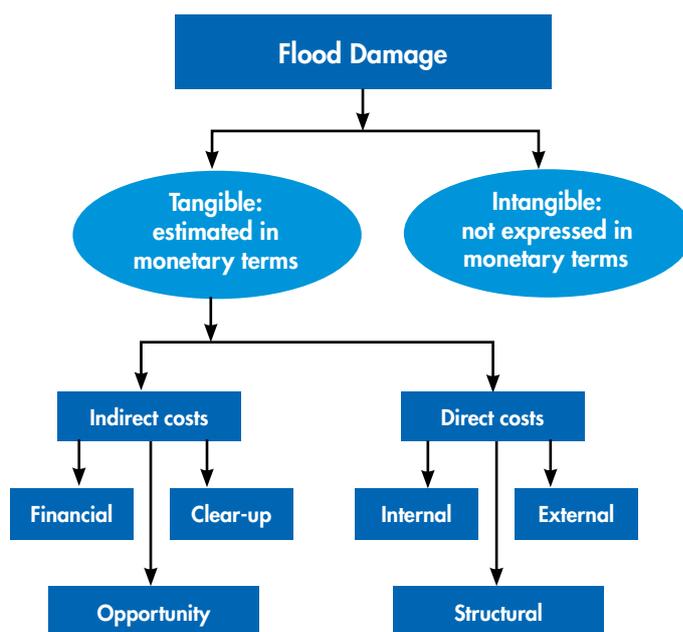
Figure 9.1: Types of flood damage
