Managing Flood Risk in Guyana

The Conservancy Adaptation Project
2008-2013

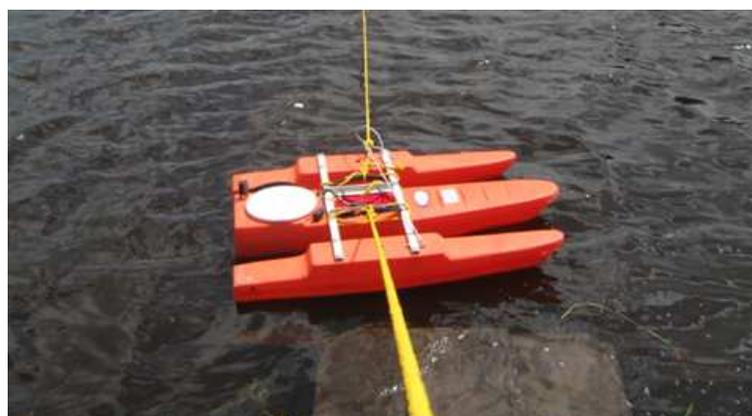
D

Discharge (the volume of water flowing in a channel during a given time interval) can be measured using a boat-mounted Acoustic Doppler Current Profiler (ACDP) (see **Figure D**), which is manually pulled across the width of the river

to collect channel profiles and to measure discharge. The ADCP transducer works by emitting 'pings' of sound at constant frequency into the water, which bounce off suspended particles or the riverbed back to the device. The travelling time of the sound and the change of pitch (variable due to the Doppler effect) gives an estimate of distance from which velocity, and hence discharge can be calculated. By collecting discharge measurements at a particular location, at low,

ADCP (above), example river velocity profile (below) and the sound-emitting ADCP transducers (top right)

medium and high water levels, a relationship can be developed so that discharge can be calculated for any river level.

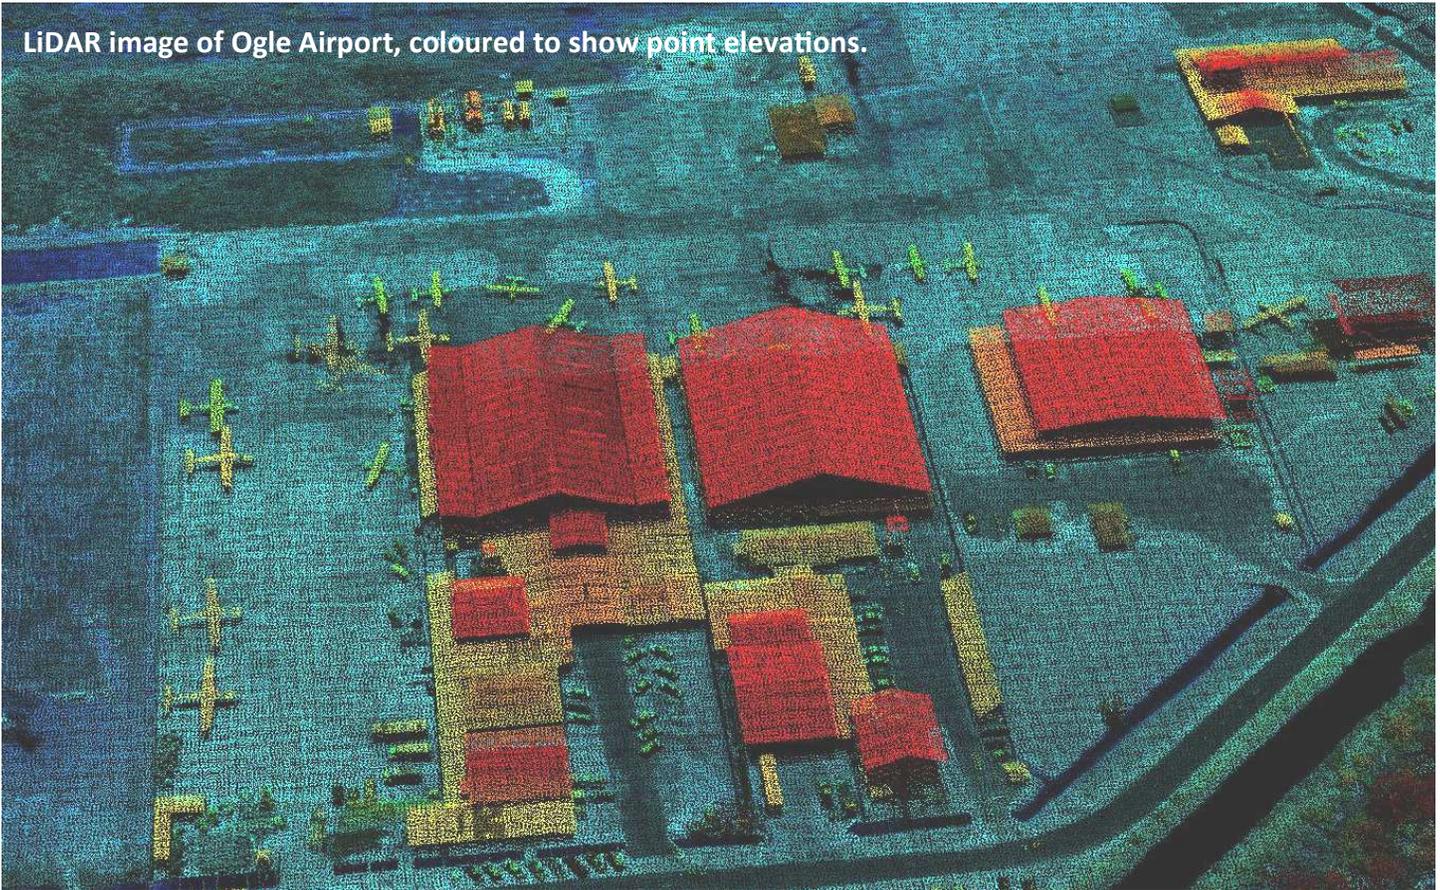
LiDAR (Light Detection And Ranging) is an airborne laser mapping and altimetry system which produces accurate and spatially geo-referenced land elevation data. It works by sending a laser light signal to the ground and measuring how long the pulse takes to return. Data collection usually involves an aircraft-

mounted Global Positioning System (GPS) receiver (for keeping track of the aircraft location), an Inertial Measurement Unit (INS) (for keeping track of aircraft rotation) and a laser range-finder (which includes the laser source and detector, the scanning mechanism and the timing and processing system).

Aircraft-mounted LiDAR system

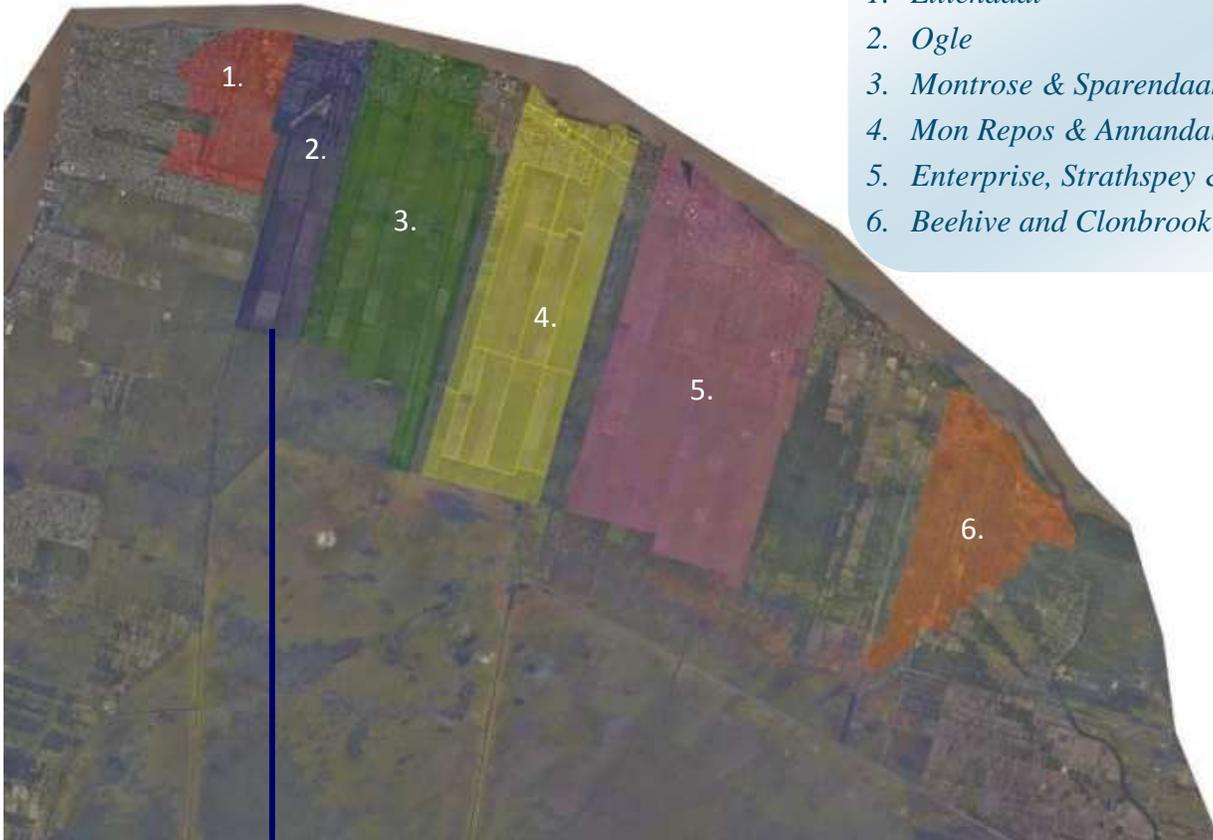
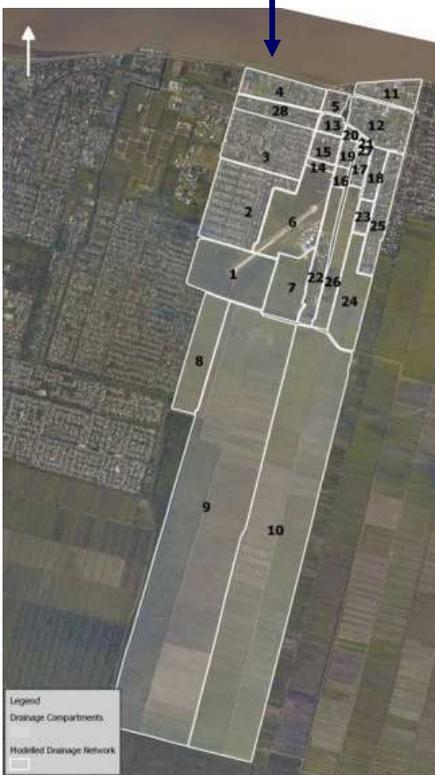
Conceptually, the coastal drainage system, particularly in urban areas, can be considered to comprise a number of discrete drainage compartments,

bounded by roads and other embankments that are connected through a series of drains to the primary drainage network. The modeling therefore prioritised the modeling of the main drainage network above the secondary and tertiary drainage systems.

Schematic of Ogle drainage system model (lower centre), drainage compartments (lower left) and primary and secondary drains with their associated catchment areas (lower right) .

Walkover surveys and LiDAR surveys were used to identify the complex network of drains, inter-linkages, flow directions and other characteristics of the drainage regime needed for building the models. Six models were set-up, one for each drainage area, however as canal water levels have not been recorded or monitored, the models are necessarily uncalibrated.
