Technical Notes

Analysis of the Results of the Network Seismic Risk and Vulnerability Functions Evaluation Performed by the Costa Rican Institute of Aqueducts and Sewers

RESULTS OF SEISMIC RISK ASSESSMENT FOR WATER AND SANITATION INFRASTRUCTURE IN COSTA RICA

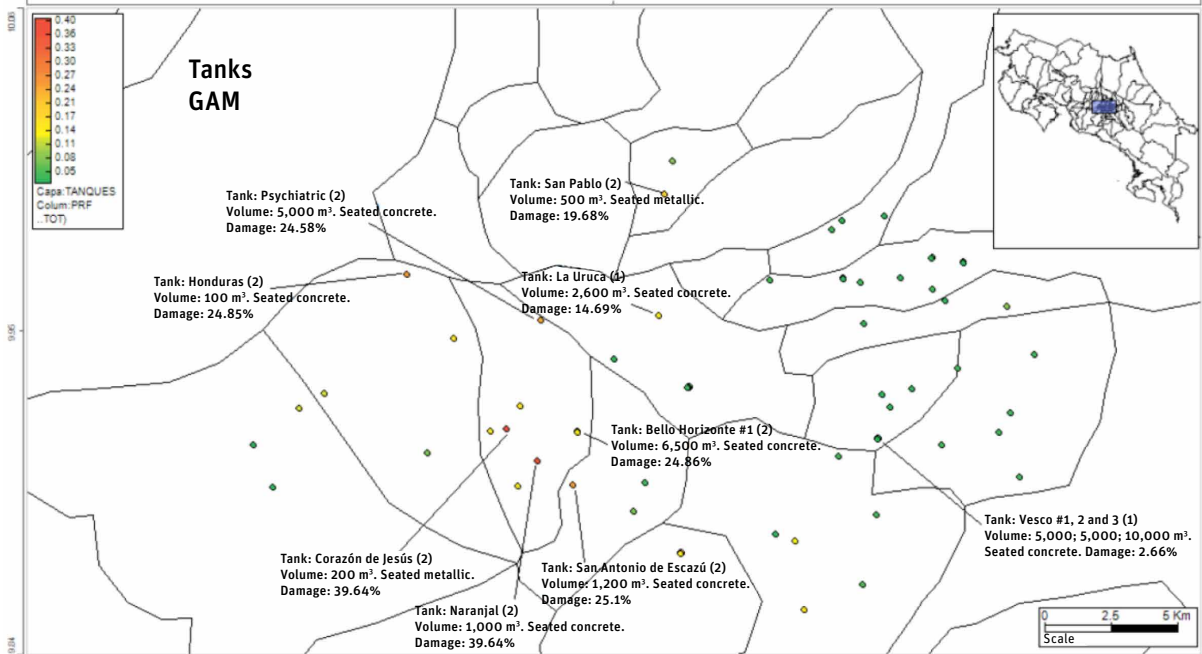
Figure 1 Tank location

It is noted that both reinforced concrete tanks and metal ones have very high ALE values, and there is also certain proximity between them (see Figure 1).

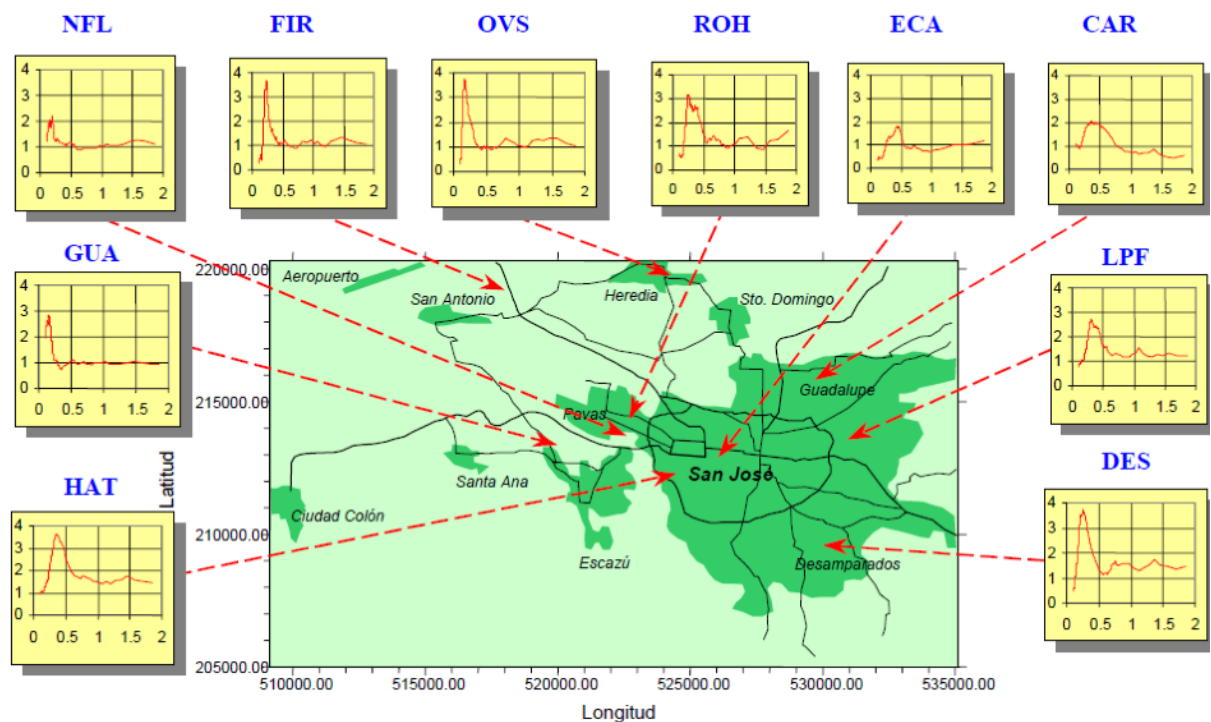
Figure 10 Amplification functions in different parts of the Greater Metropolitan Area of San José. The acronyms identify the place where the evaluation was conducted, while the abscissa corresponds to structural periods and the ordinates to intensity amplification factors.

According to these studies, the amplification caused by the presence of soil varies a little under 4 (Figure 10). The value of this amplification depends on the type and depth of the soil deposit, and the structural vibration period of the element being analyzed, in this case the water tanks or reservoirs. To determine how soil type contributes to risk estimates, an assessment of the ALE was made without regard to amplification acceleration caused by local effects and then compared with the original assessment (only for tanks within the Greater Metropolitan Area). The results indicated that the increase in the ALEs were due to the inclusion of the site effect in the original study which in some cases was nearly 7 times.

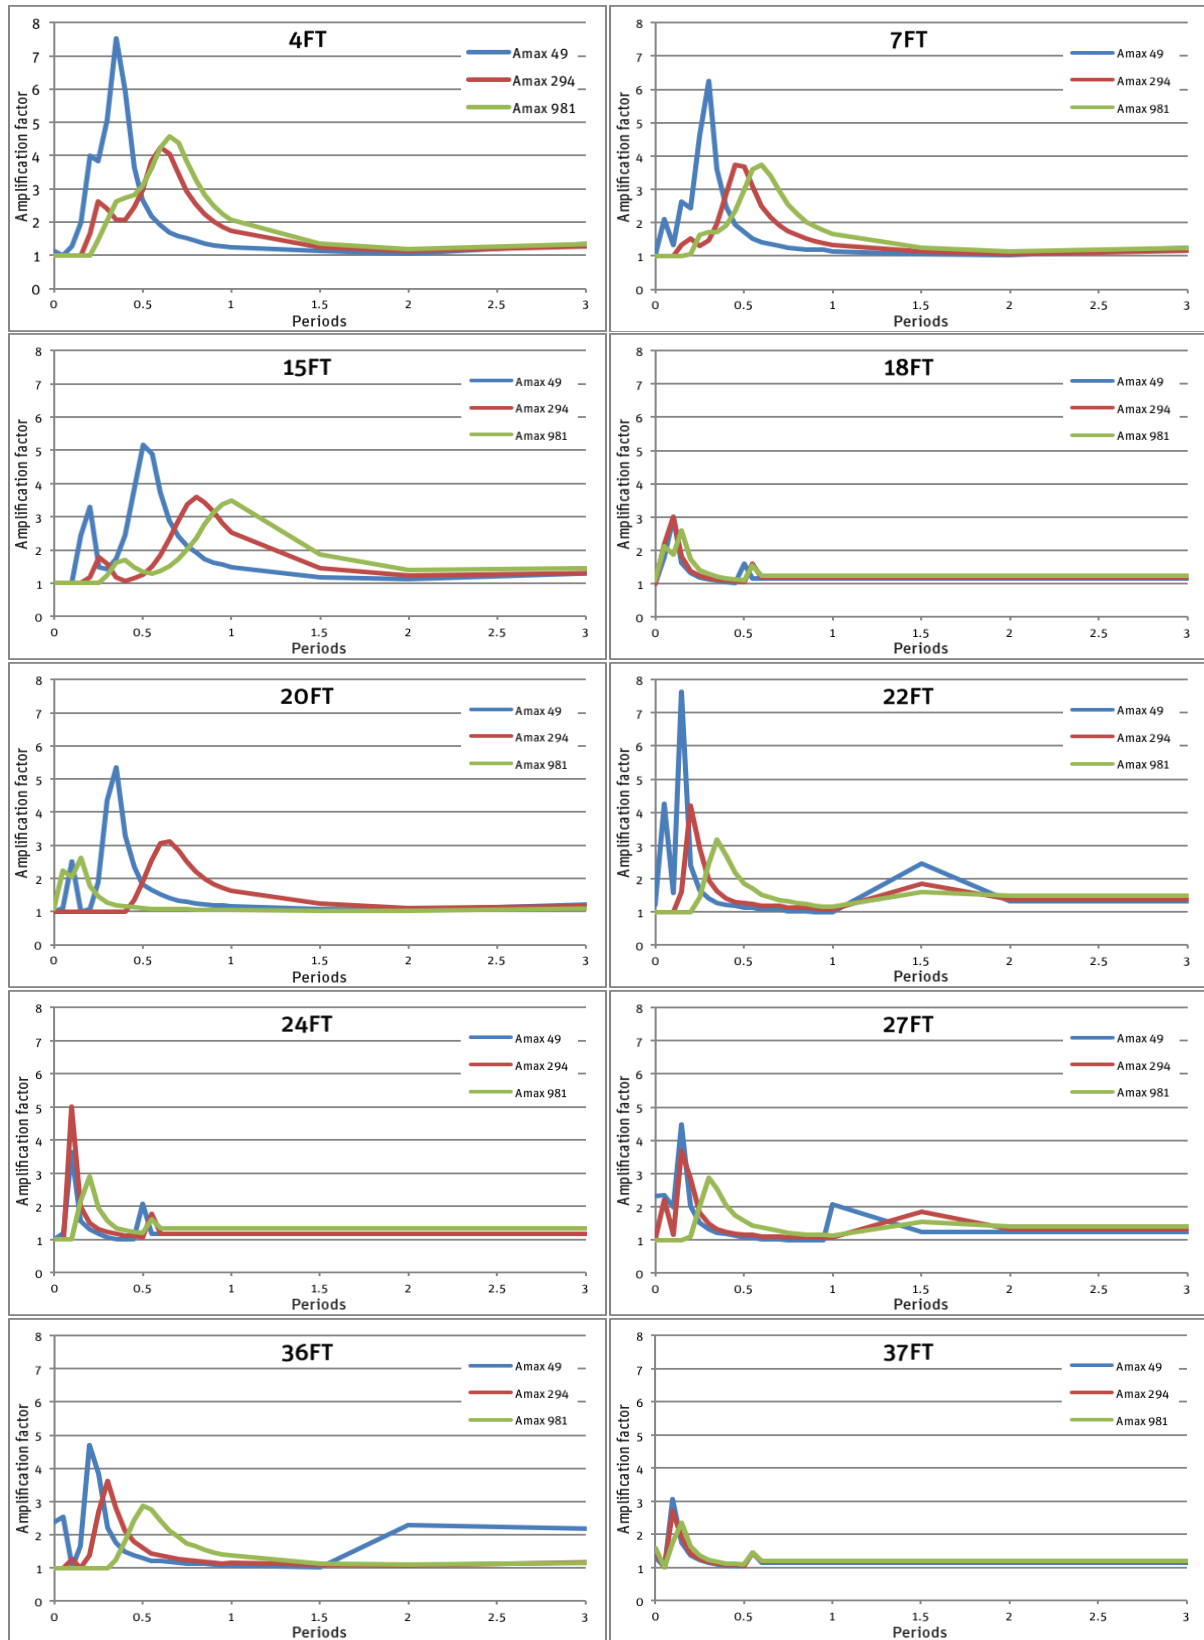
Figure 11 Amplification functions for different soil types, structural period and Intensity (Part 1)

Figures 11 and 12 show the amplification values depending on the structural period for different levels of ground acceleration determined by the ERN study consulting team.

We can see that the maximum amplifications due to the ground are around 7.5 (4FT); however, the vulnerability functions used for tanks use peak ground acceleration (PGA) as a measure of intensity, i.e., the corresponding amplification is period 0, which uses a maximum value of about 2.4 for 27FT and 36FT soils. This means that the amplifications caused by soil type during the acceleration suffered by tanks (up to 2.4) are much smaller than the increases in expected damage (up to 7). It should be noted that the increase in the values of expected damage is not generally proportional to increases in acceleration, and, depending on the vulnerability curve type of the tank, small increases in acceleration can lead to further increases in the expected damage, and hence, local effects may explain an increase in ALE, but not necessarily explain increases as high as those presented in this case.

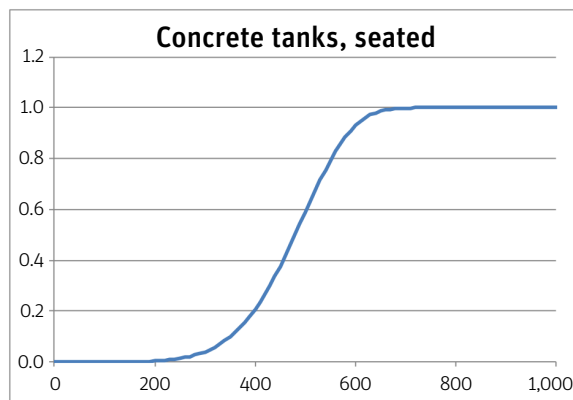
Figure 13 Typical form of a vulnerability function, where the abscissa corresponds to peak ground acceleration (PGA) and the ordinates to the expected damage percentage.

Then, in order for small increases in the value of acceleration (about 2.4) to produce large increases in expected losses, unamplified loss values should be significantly smaller than the values of amplified losses. This can occur, as shown in Figure 13, if the unamplified intensity is less than about 200 Gal, in which case, the expected value of damage is very close to zero, and when it is amplified, the intensity rises to 500 Gal, associated to an expected loss value of about 50%. This highly disproportionate behavior is characteristic of some ductile structural systems, where the occurrence of a catastrophic and sudden failure is possible. This does not seem to be the case with tank structures, where the internal forces that develop in the tank often tend to be bending moments and axial tensile forces (and in very few cases, compression).

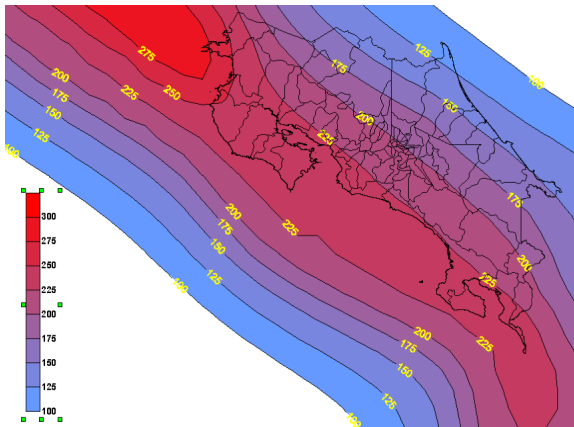
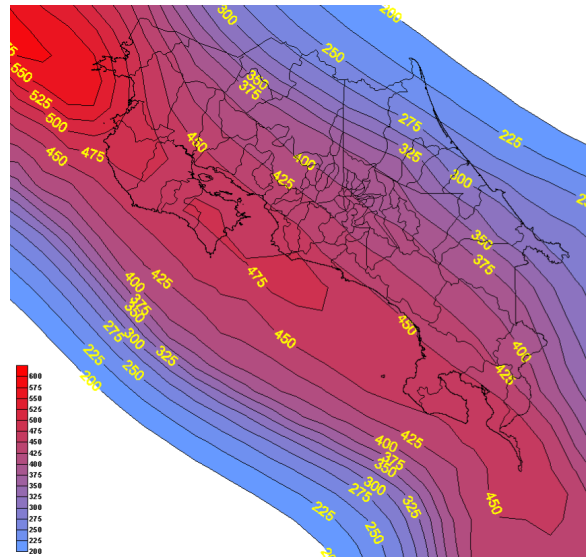
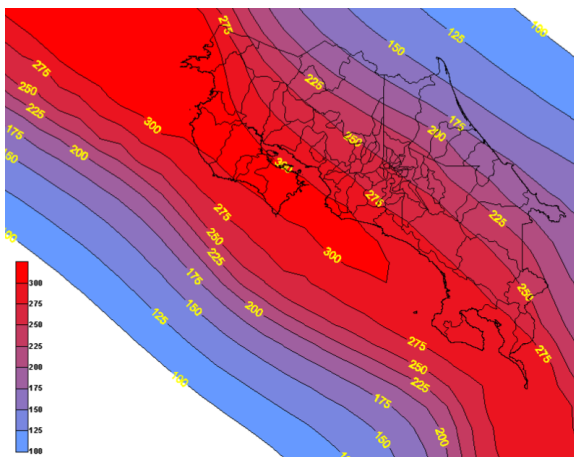
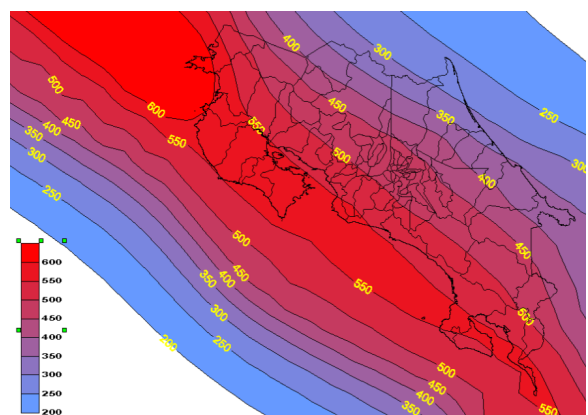
PGA values in San José are approximately 200 Gal for a return period of 50 years, 250 Gal for a return period of 100 years, 400 Gal for a return period of 500 years, and 475 Gal for a period return of 1,000 years.

From the above charts, it can be seen that the intensity levels, at least for PGA, are in the same order as the threat in other regions where there have been similar risk studies, such as Peru, despite the fact that no studies have observed such high ALE levels in tanks.

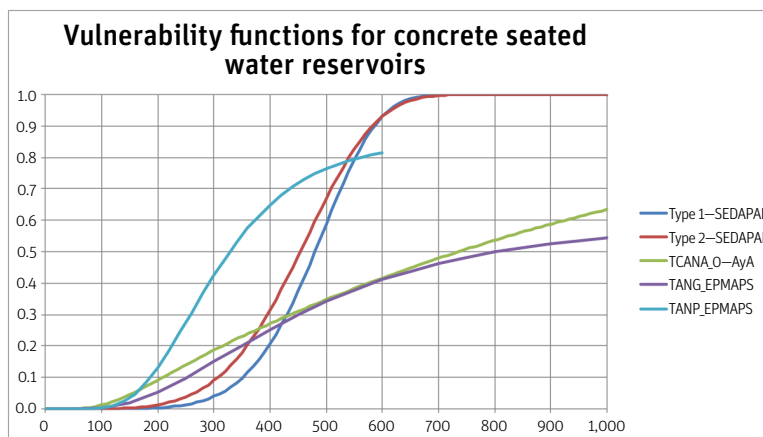
Figure 20 Vulnerability function, where the abscissa corresponds to peak ground acceleration (PGA) (0–1,000 Gal) and the ordinates to the expected damage percentage

In addition to this study by AyA, there are the results and vulnerability functions included in the studies undertaken by the SEDAPAL, which is the Lima Drinking Water and Sewerage Services, and by the Public Metropolitan Water Supply and Sanitation Company (EPMAPS) of Quito. The vulnerability functions of the seated storage tank elements employed in each of these studies were analyzed. It should be stated that although this analysis is illustrative, comparing vulnerability functions should not be done directly without taking into consideration the specific technical aspects of each country or region, as well as local design and construction regulations, which are aspects related to the construction practices prevalent in each country, in addition to threat levels, among others.

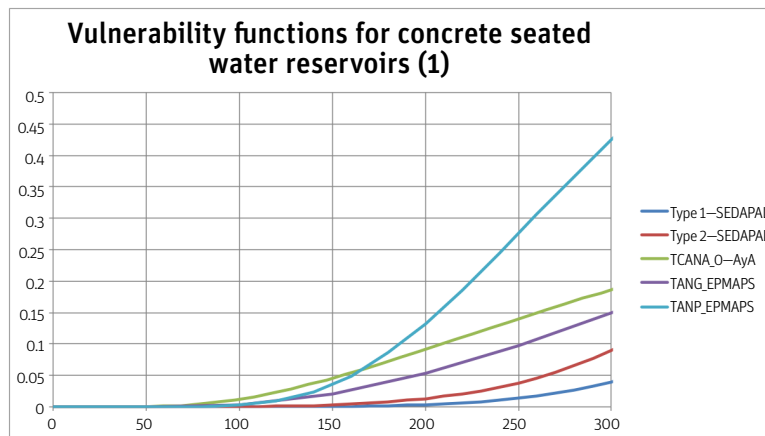
Figure 21 Vulnerability functions, where the abscissa corresponds to peak ground acceleration (PGA) (0-300 Gal) and the ordinates to the expected damage percentage

If the curves for levels of moderate or low intensity are examined in greater detail (Figure 21), this shows that the curve given by AyA generates higher values than the other curves (for the moment, we will leave aside the TANP-EPMAPS curve values). Concerning some of the curves, mainly TYPE 1–SEDAPAL, the loss values for the same intensity are significantly higher using the TCANA_O curve–AyA. Since it is very likely that the calculation of ALE will be strongly influenced by events in this range of intensities, it is to be expected that the AyA results will be greater than those obtained using the other vulnerability functions.

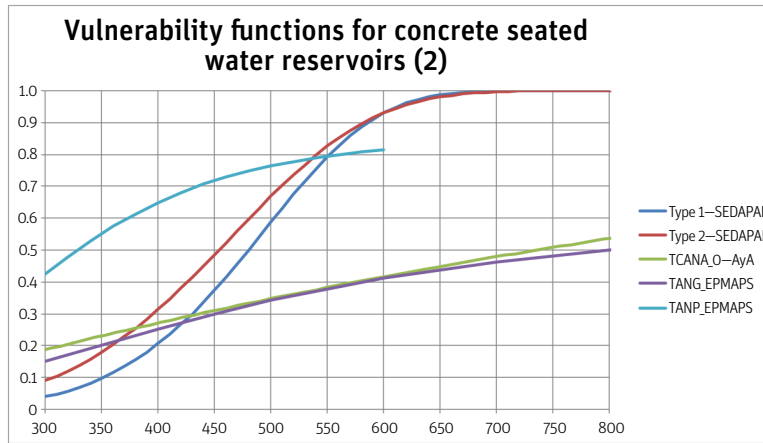
Figure 22 Vulnerability functions, where the abscissa corresponds to peak ground acceleration (PGA) (300-800 Gal) and the ordinates to the expected damage percentage

Now, let us look at the range of highest intensity (Figure 22). It can be seen that in a small initial interval, things remain the same as for low intensities, but suddenly the SEDAPAL curves increase their slope and significantly raise loss values, while the AyA and EPMAPS curves maintain an almost constant slope. Thus, for high intensities, the SEDAPAL vulnerability functions will produce much higher damage values than those of AyA and EPMAPS. This is relevant to the calculation of the ALE, where the interest is usually set on very high losses, associated with very rare events and therefore, very intense ones.

Accordingly, it can be concluded that for SEDAPAL, tanks are elements that work well at low intensities, but that when the intensity is increased slightly, widespread damage can occur violently, while for AyA and EPMAPS, the deterioration is gradual. It is of interest to establish which of the two approaches bears a greater relation with the true and actual behavior of concrete tanks when subjected to ground movements.

Accordingly, it is recommended that new vulnerability functions be obtained, following the procedure employed by AyA but trying to document or better relate the different levels of damage to relative loss values and taking into account the characteristics of seismicity inherent to Costa Rica.
