# Understanding existing school infrastructure – a New Zealand experience

### Seismic activity and risk in New Zealand

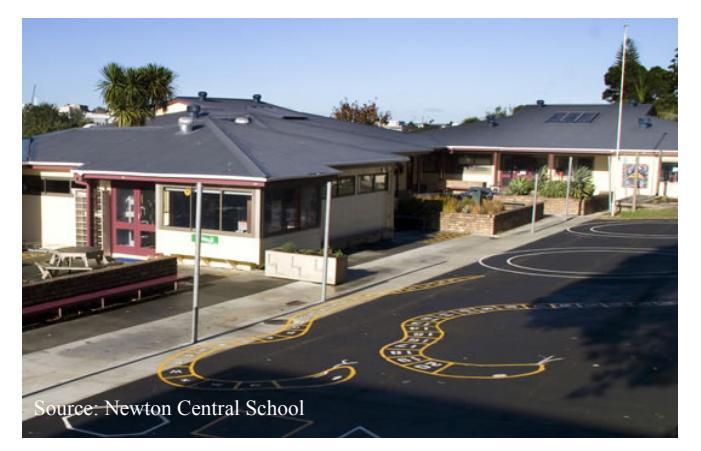
90% of schools in New Zealand are timber frame low rise construction typology which can perform well in an earthquake due to the lightweight and flexible nature of the structure.

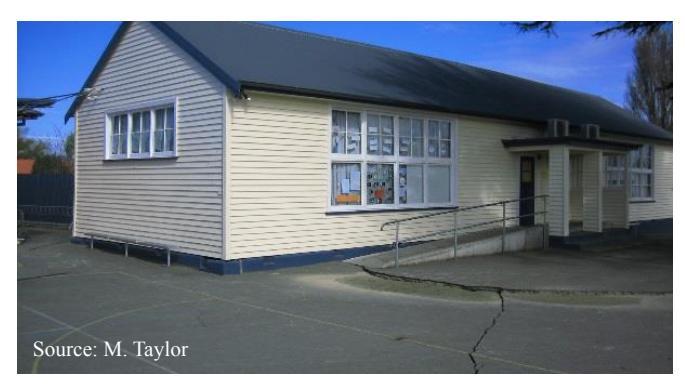
Lightweight timber clad low rise school buildings can often suffer little or no damage during significant earthquake events
