Developing a Schools Infrastructure Inventory in a Small Island Developing State

Country: Tonga

Stakeholders: Ministry of Education, World Bank, Arup

Hazards: Tropical cyclones, Earthquakes, Tsunami, Flooding

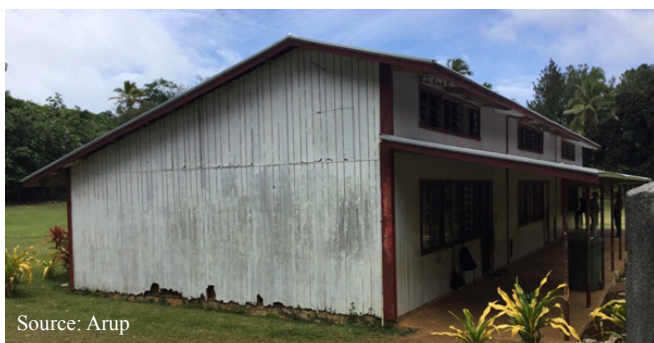
Standard engineered school designs developed in 1982 following Cyclone Isaac have been shown to withstand multiple intense storms, but require urgent maintenance to ensure their long term viability.
