PDNA AT A GLANCE

Republic of Bhutan

Earthquake, September 2009

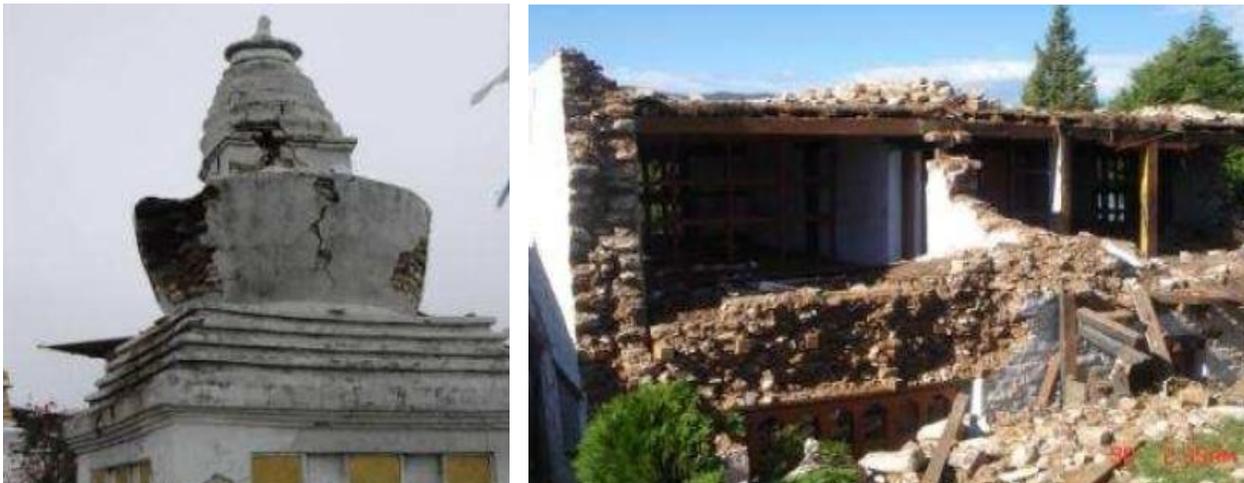
Figure 1: The 2009 earthquake resulted in widespread destruction including many heritage buildings

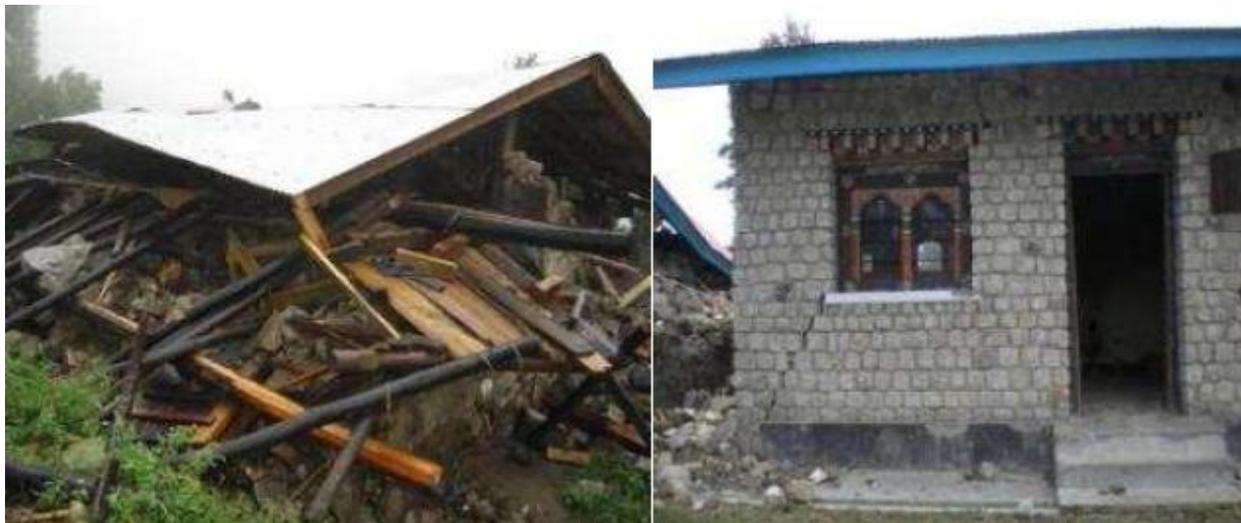
Figure 2: While some buildings could be easily repaired, many others have been completely destroyed

The structural damage in all sectors was categorized into: (1) beyond repair; (2) major repair; (3) partial repair, and (4) minor repair. In case of categories 1 and 2 (i.e. beyond repair and major repair), losses were calculated on the basis of 100 percent of the unit cost given that they will have to be reconstructed entirely. For categories 3 and 4 (i.e. partial repair and minor repair), 25 percent and 10 percent of the unit cost, respectively, was applied for calculating approximate asset losses in the absence of detailed information about each structure.
