# Multi-Hazard Risk Assessment for the Schools Sector in Mozambique

1230818-002

Client	Project	Reference	Pages
World Bank/GFDRR	1230818-002	1230818-002-ZKS-0008	89

Safe schools, earthquakes, coastal flooding, river flooding, cyclones, landslides, risk assessment, retrofitting options, awareness raising

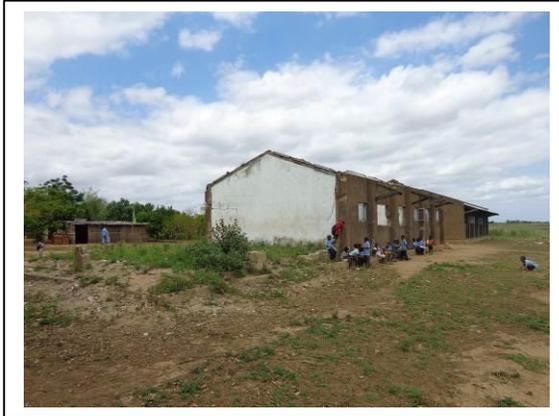
If so, inform about hazard intensities, related losses (US\$) and repair timescale: one of the classroom blocks lost the cover sheets and the truss and occurred a demolition of the walls of one of the classroom during last cyclone.

Observation: Damaged classroom block

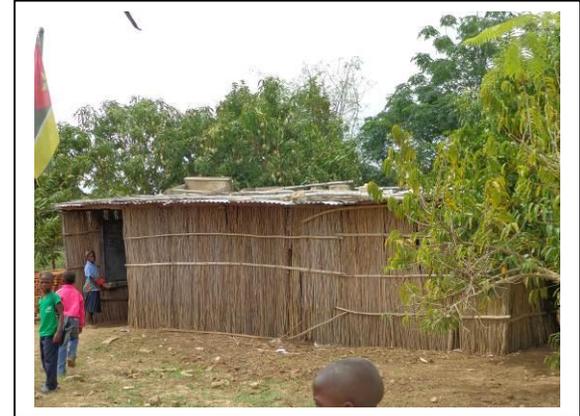
Observation: Classroom made by local material

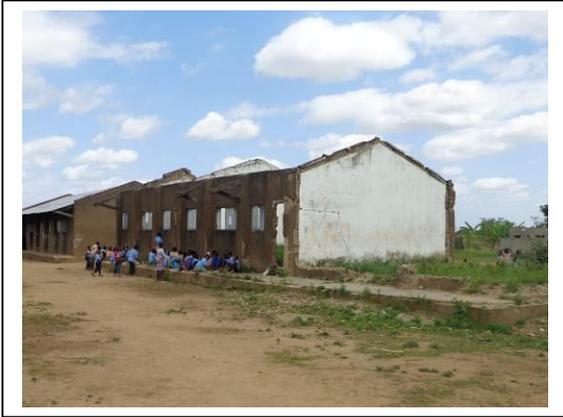
Observation: damaged classroom block

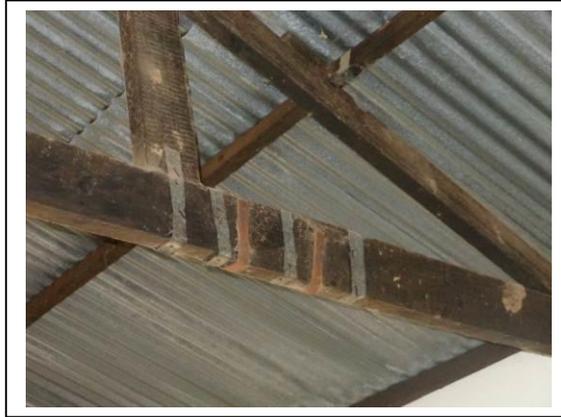
Observation: wood truss

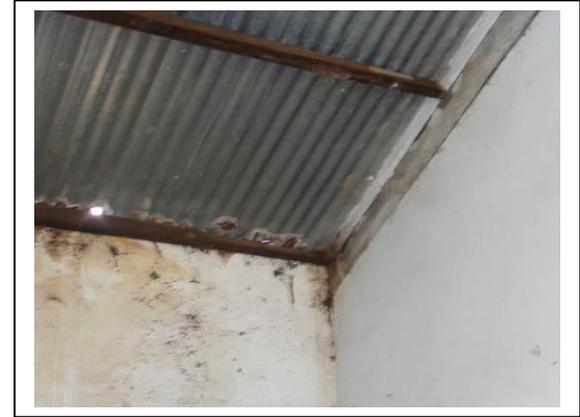
Observation: cover sheets.

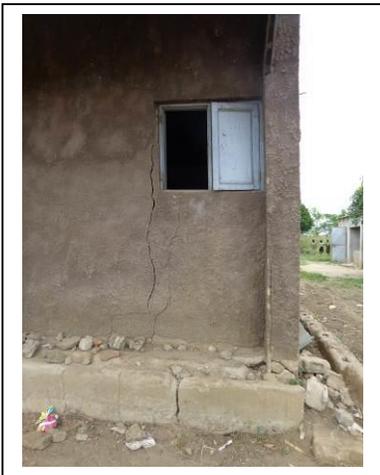
Observation: cracks in the classroom block 1

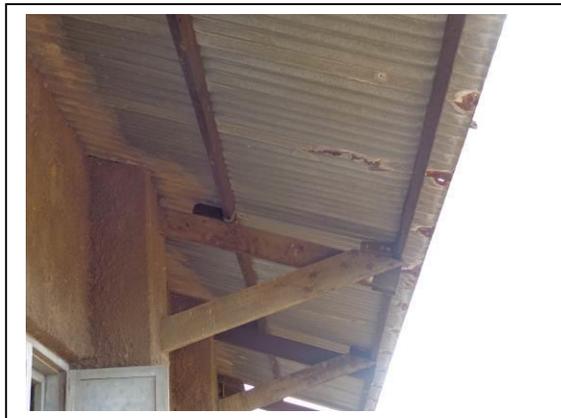
Observation: Cover sheets on the veranda

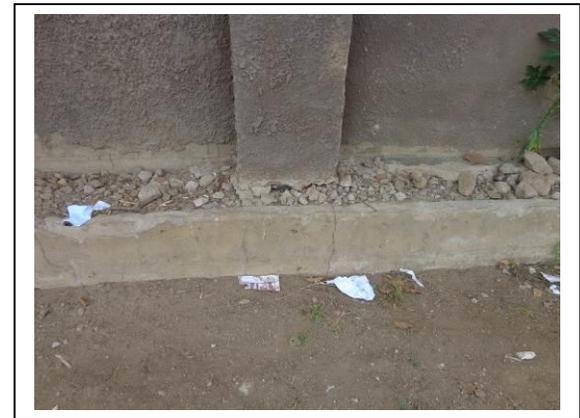
Observation: Cracks on the foundation protection wall

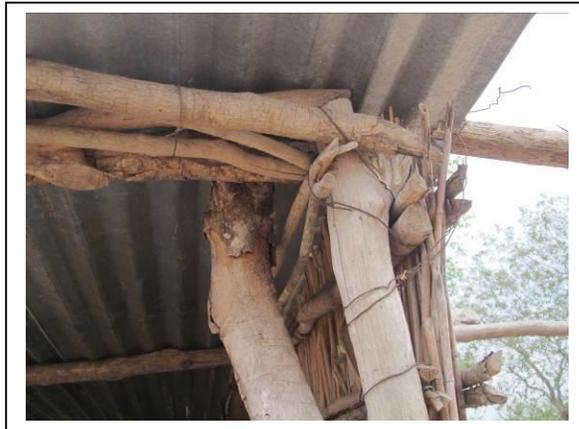
Observation: Connection Detail

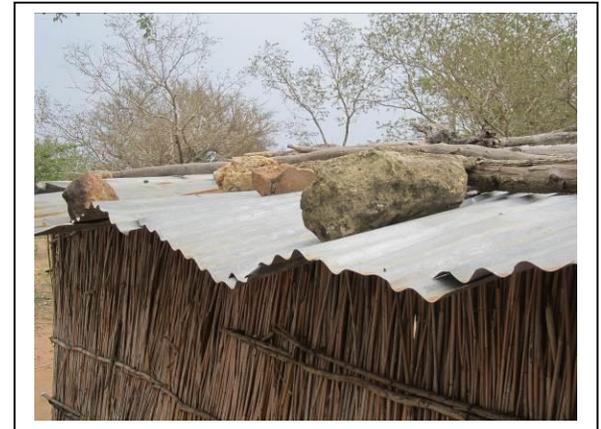
Observation: Detail of the roof

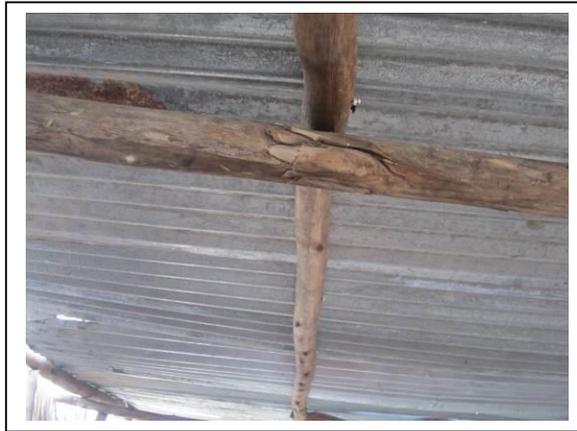
Observation: Fixing detail

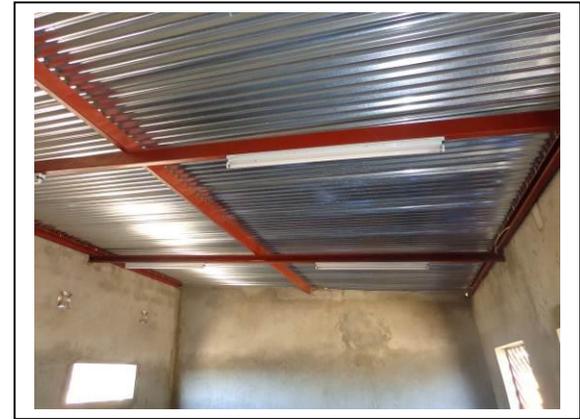
Obser: roof steel structure to upgrade (no enough slope)

In general the school is in good conditions. The roof structure of one of the buildings should be revised.

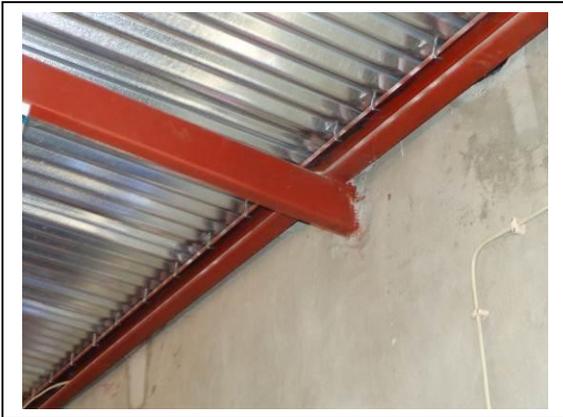
Observation: Detail of roof steel structure to upgrade

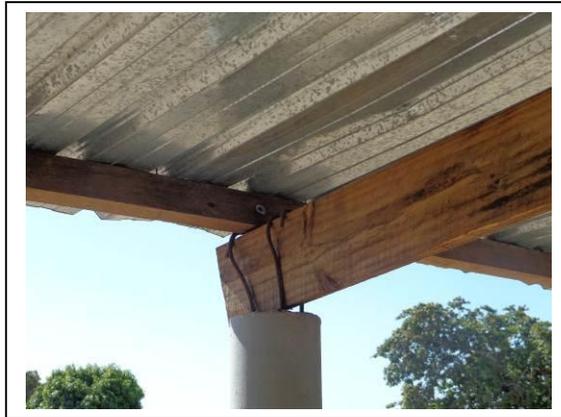
Observation: Detail of wood beam fixing

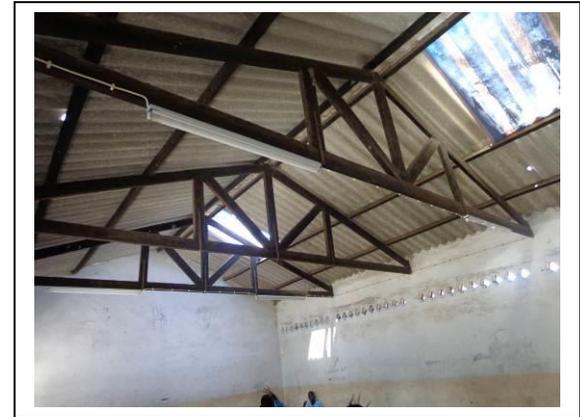
Observation: wood roof structure

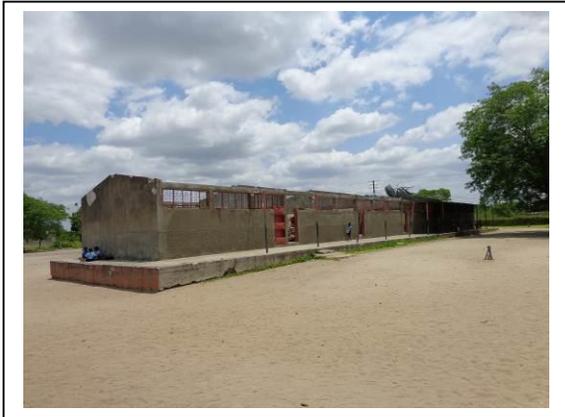
If so, inform about hazard intensities, related losses (US\$) and repair timescale: one of the classroom block lost the roof structure and cover sheets during the last cyclone.

Observation: Classroom damaged

Only one building need the replacement of the roof structures and the cover sheets. Replace of the steel structure and the cover sheets

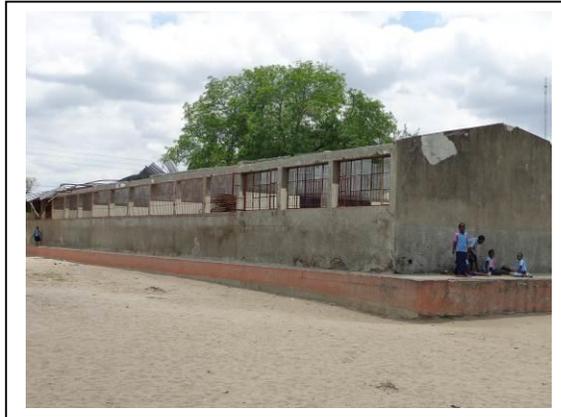
Observation: Classroom damaged

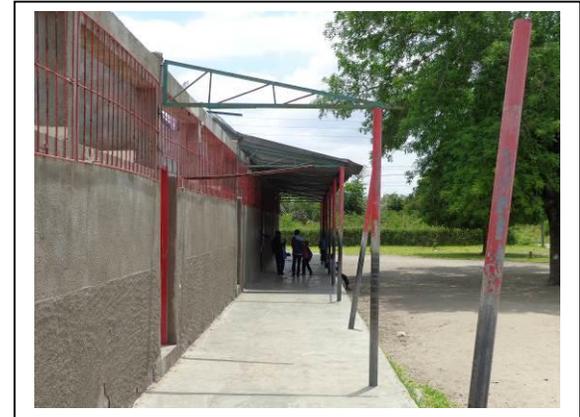
Observation: Classroom damaged

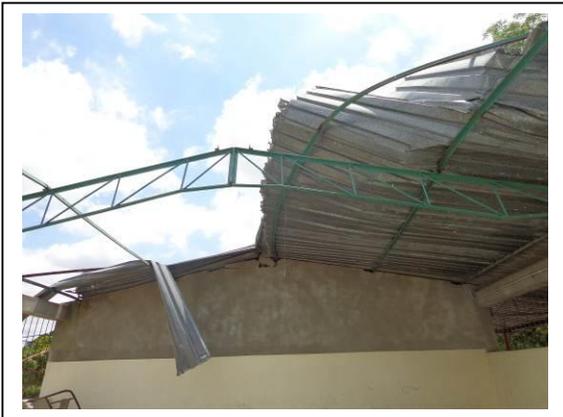
Observation: Classroom damaged steel structure

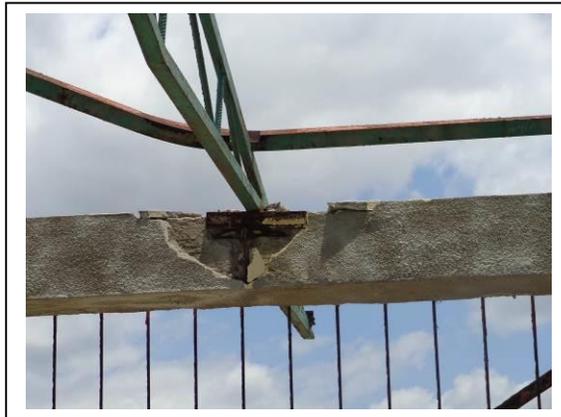
Observation: Classroom damaged steel structure

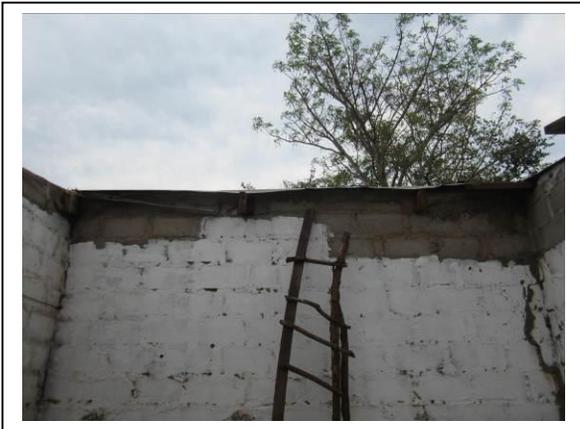
If so, inform about hazard intensities, related losses (US\$) and repair timescale: There is a building transformed into classrooms, with the roof destroyed by a strong wind. It was replaced by the community. There is no cost recording.

Observation: Room without cover

Some classes have lessons under a big tree next to the classroom building. Replacement of the second building roof. The main building has a solid metallic roof structure

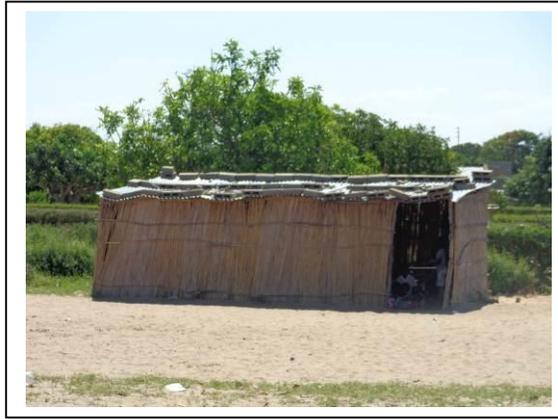
Due to the poor condition of the school, no upgrading actions have been considered. The school has no conditions to resist to any hazard. A new school must be build according the "proyecto de escuelas seguras".

Observation: Classroom 2

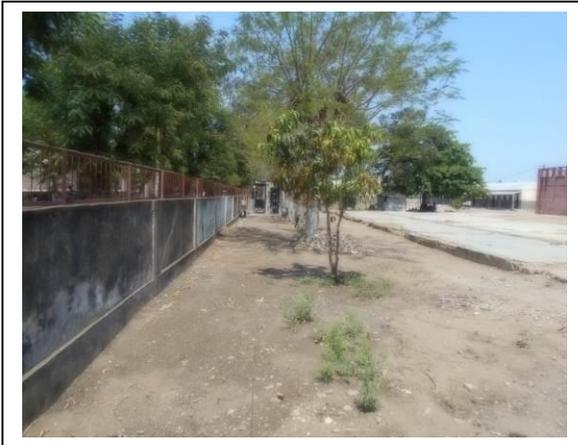
Windows, doors and water supply network, operate with deficiency after suffering the damages caused by the floods. The roof of the old buildings is asbestos cement and needs to be replaced. After the floods of 1977 the administrative building was completely destroyed. The fence has also suffered constant falls whenever there has been a flood

Observation: Fence

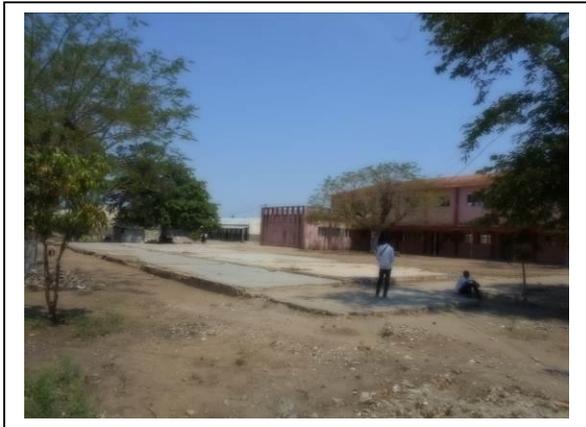
Observation: Floor traces of the old administrative building destroyed by 1979 and 2000 floods

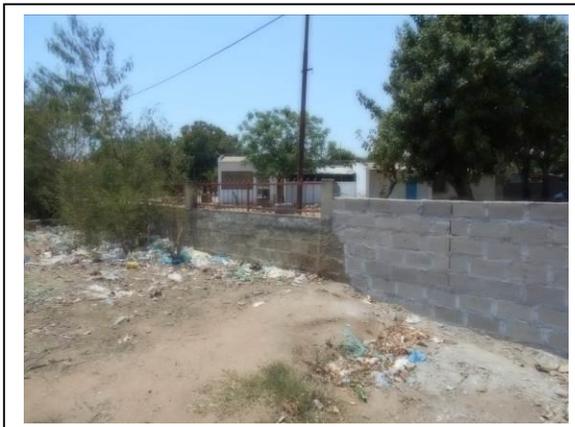
Observation: Sealing wall reconstructed after the destruction by the 2013 floods

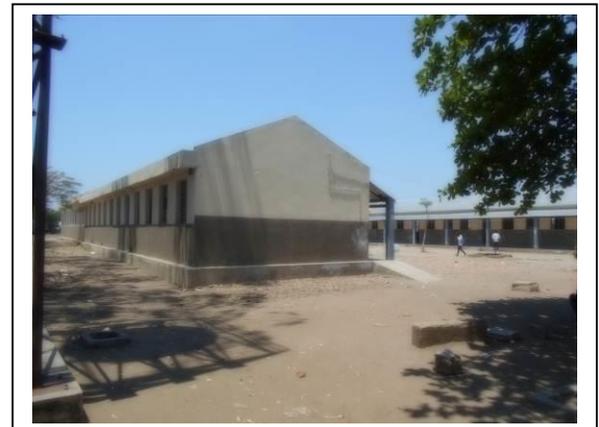
Observation: Concrete rain gutter erected to protect the bottom of roof sheet

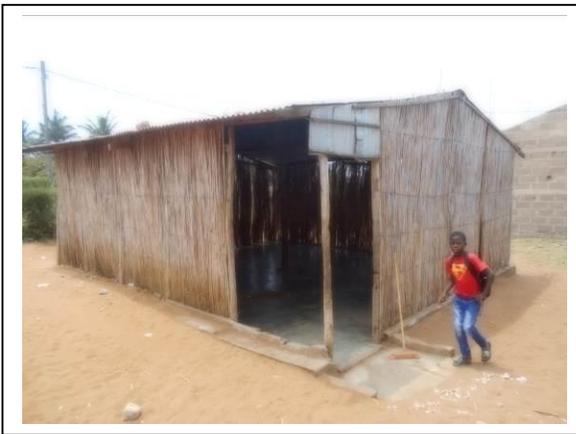
Observation: Non-conventional building classroom

Non Conventional blocks were erected after the last cyclone. They have no conditions to resist to a new cyclone. For the conventional buildings remove the existing roof sheet. Repair the roof structure based on the Safe Schools Catálogo - Ciclones. Install new roof sheets. For the non-conventional buildings, due to the poor construction, no upgrading is recommended.

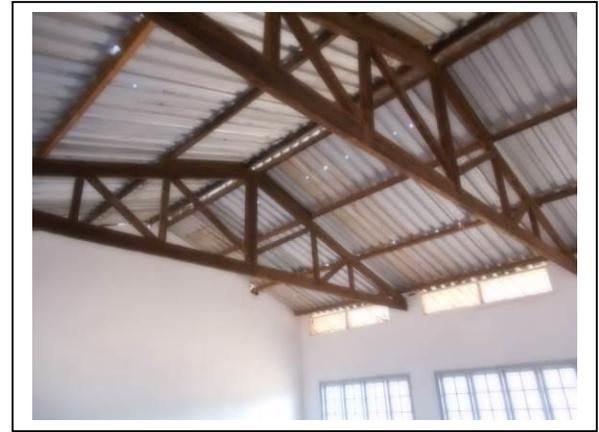
Observation: Roof structure in one of the classroom blocks

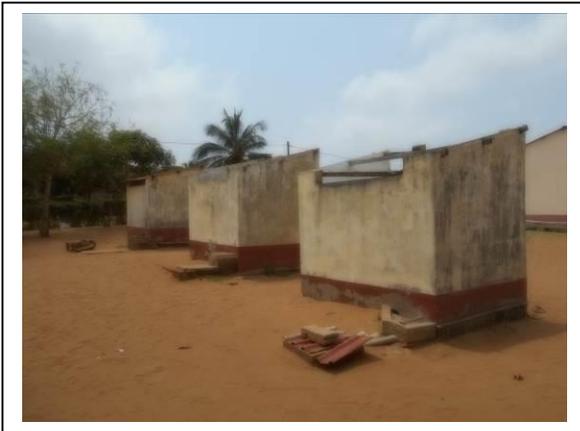
Observation: No sheet roofs in health facilities

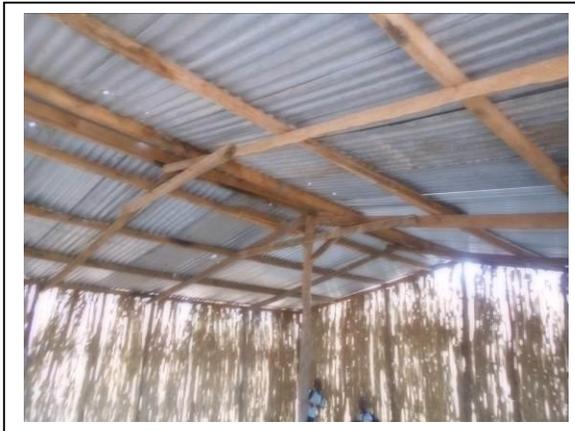
Observation: Roof in the non-conventional classroom

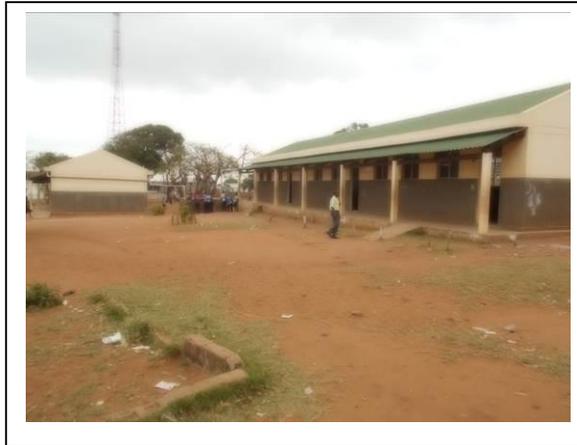
Observation: The two blocks of classroom rehabilitated after hit by the cyclone

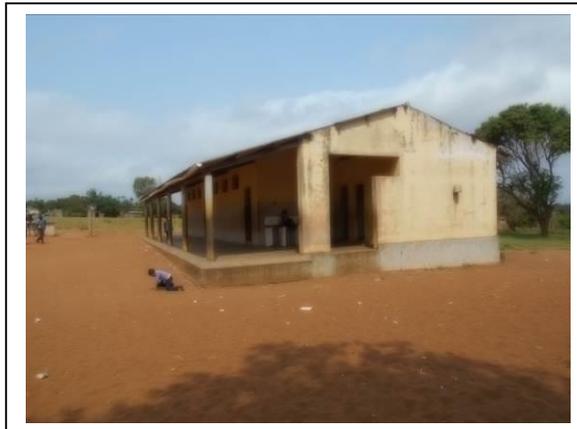
Observation: Old classroom block still in operation, but in an advanced state of degradation

School has 9 conventional classrooms and 10 non-conventional classrooms. Requalify the roof of conventional buildings as per the safe school project. Two of the classroom blocks have recently been repaired using the solutions for cyclone-resistant, especially by introducing concrete gutters at the extremity/bottom of the roof sheet avoiding the wind. Construct new blocks of classrooms to replace existing non-conventional classrooms.

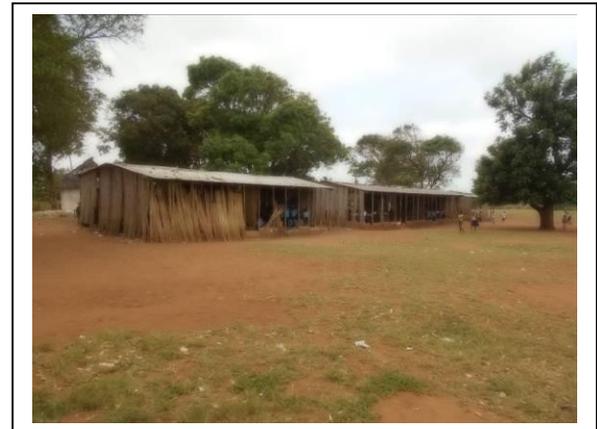
Observation: Non-conventional building classrooms

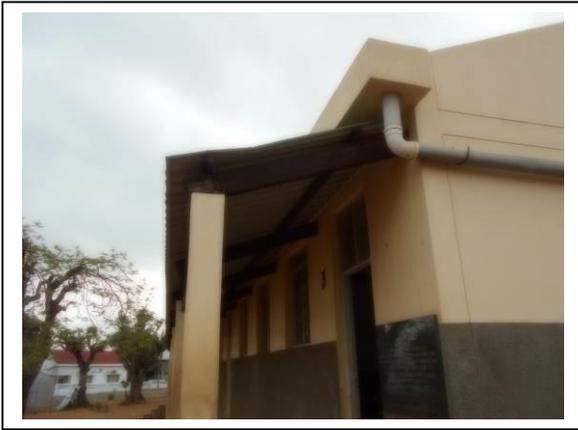
Observation: Detail of gutter constructed to collect rainwater and also to protect the roof sheet from winds

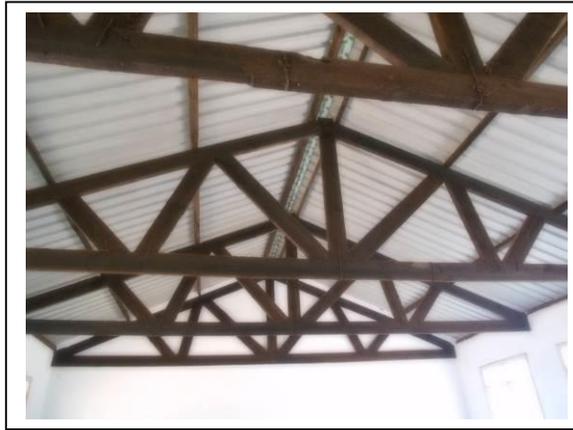
Observation: Reinforced roof structure to support the action of wind

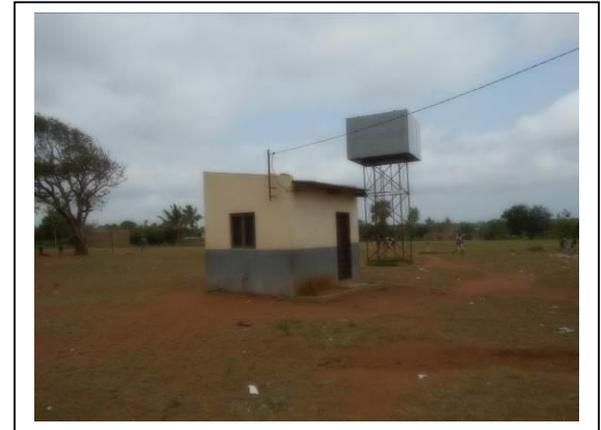
Observation: High deposit/hole for water supply, not in use

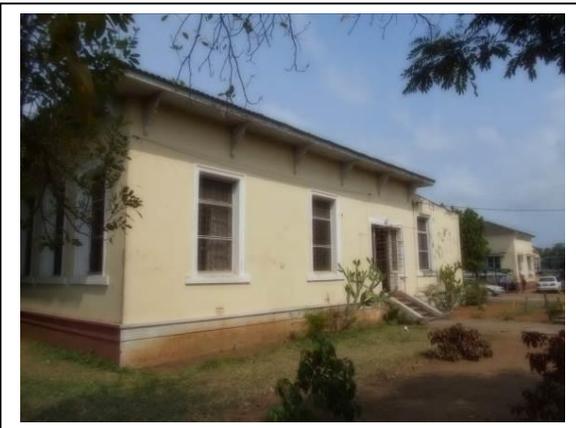
Observation: overview of the two main blocks

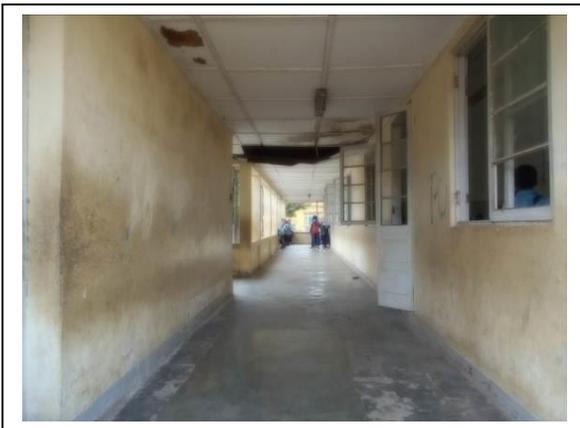
Observation: Corridor with ceiling in advanced  
state of degradation

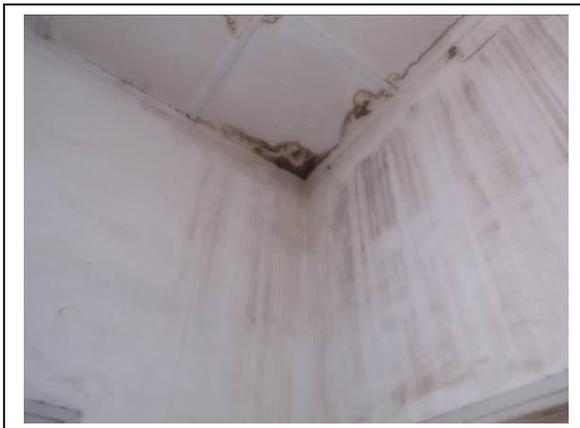
Observation: water leaking on ceiling.

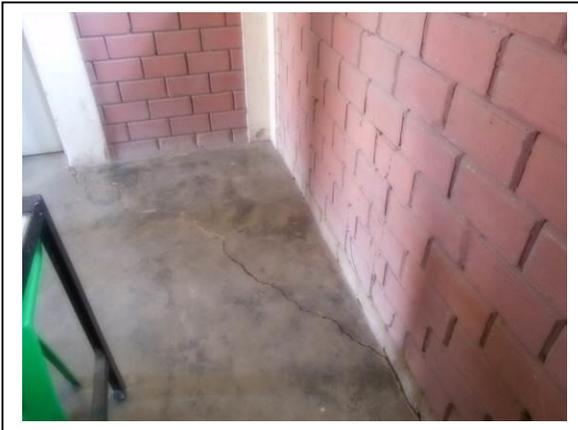
Observation: cracks in the pavement

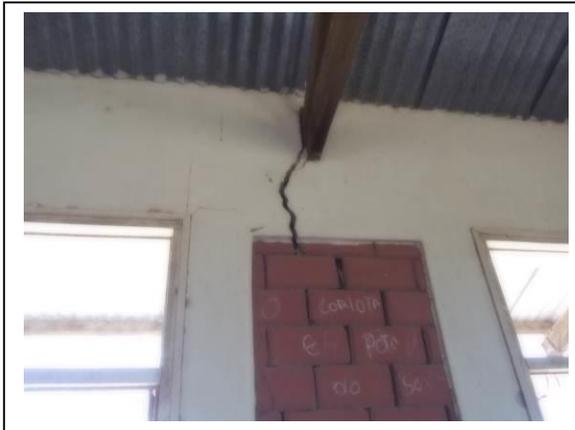
Observation: Cracks i wall/truss support

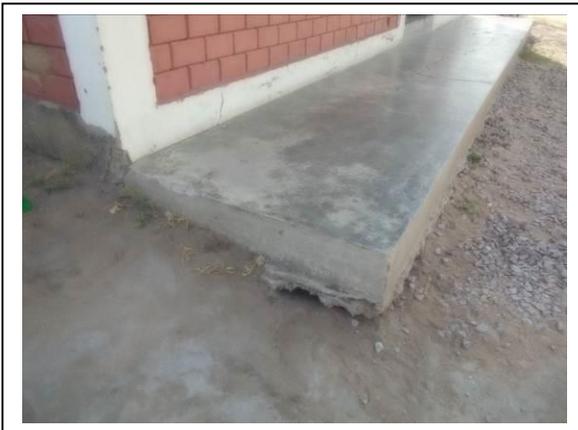
Observation: Erosion in the foundations of the walk around the building

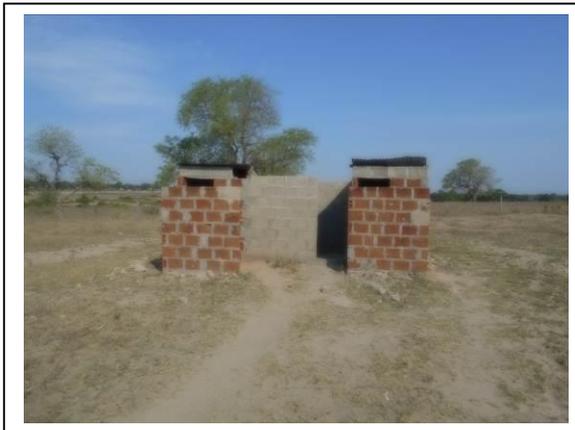
Observation: State of sanitary facilities

The "hydroform" type blocks are in bad condition. The proposal is to demolish existing buildings and build new buildings based on projects - safe schools. Due to the poor conditions, we do not propose any upgrading on the current conditions.

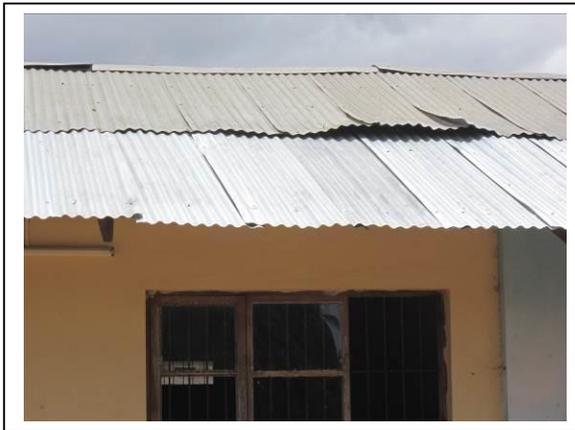
Observation: Roof sheet after cyclone

There is one colonial building with ceiling. The roof have no conditions to resist to a new cyclone or strong wind. Remove the existing roof sheet. Repair the roof structure based on the Safe Schools Catalog - Cyclones. Install new roof sheets. There are 2 buildings in good conditions.

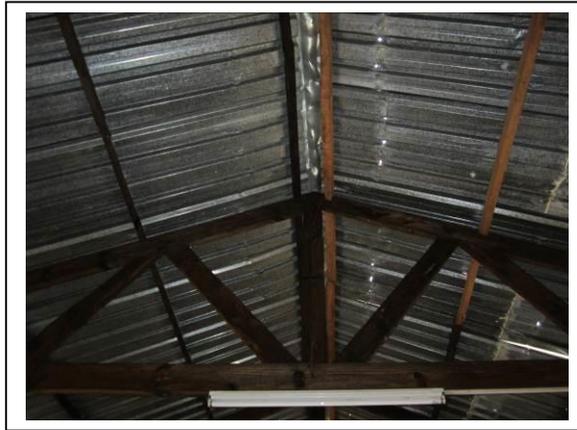
Observation: Detail of the roof structure

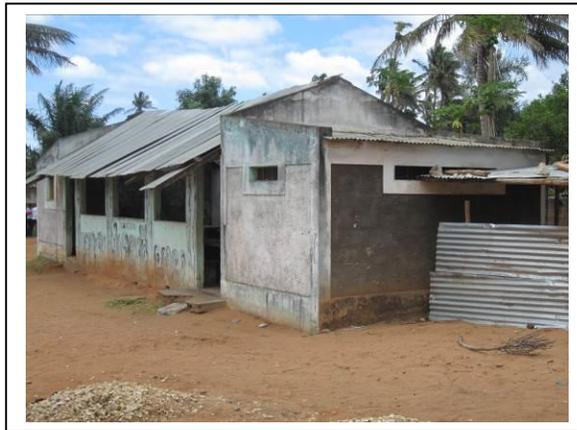
Observation: Obsolete building

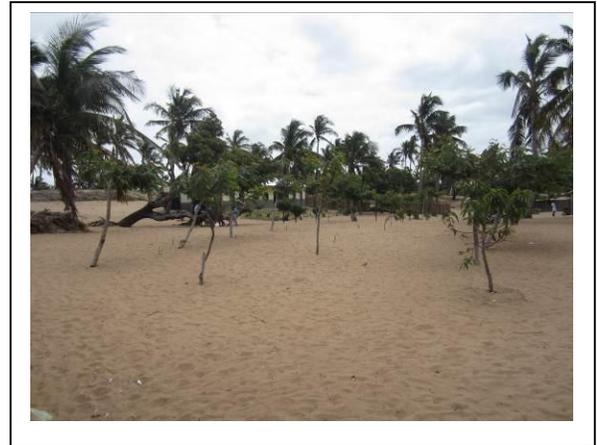
Observation: View of schoolyard

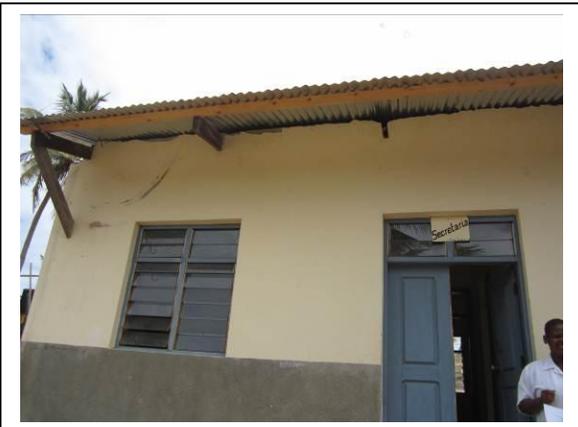
Observation: Cracking between wall and roof structure

The roof structure has no conditions to resist to a new cyclone. Difficult access by vehicle. For the conventional buildings remove the existing roof sheet. Repair the roof structure based on the Safe Schools Catalog - Cyclones. Install new roof sheets. For the non-conventional buildings, due to the poor construction, no upgrading is recommended.

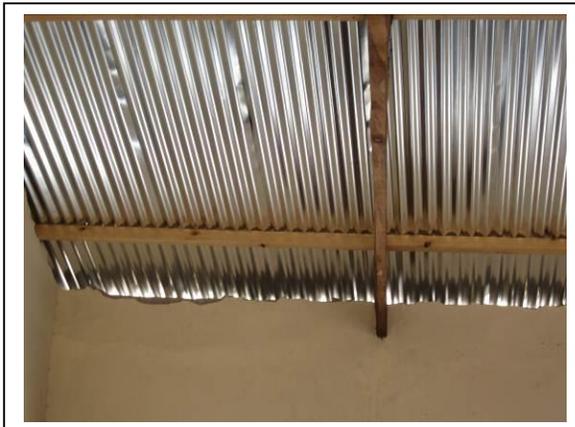
Observation: Purlin detail in Director office

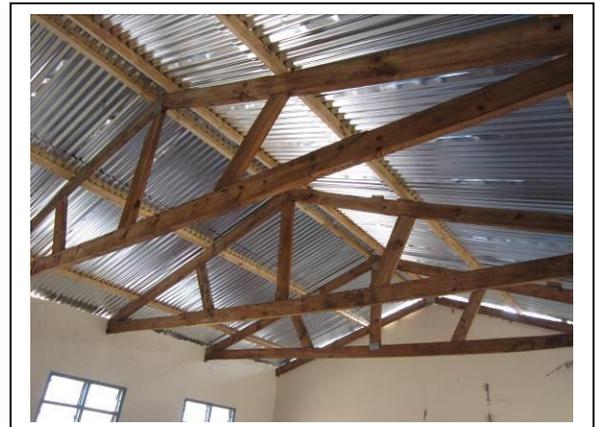
Observation: Roof in the conventional classroom

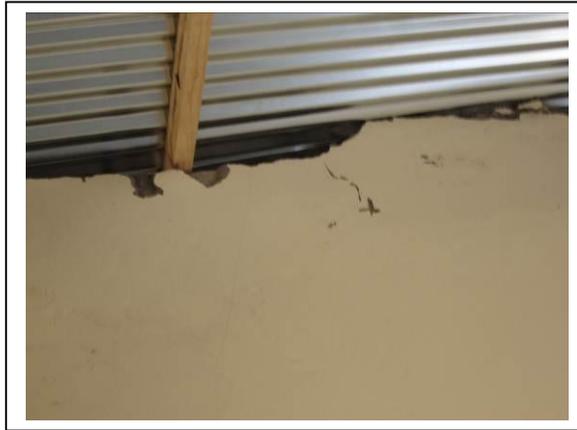
Observation: Cracks between wall and roof

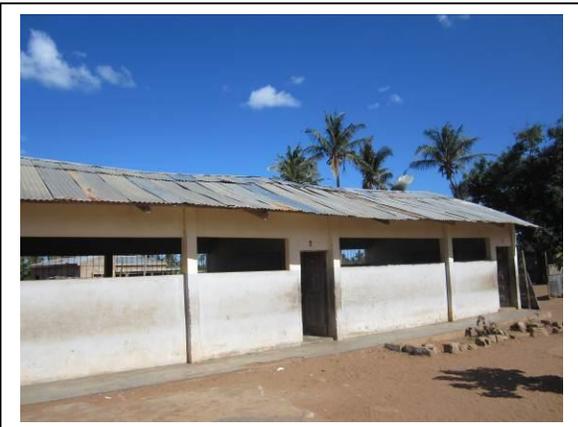
Observation: Damaged roof

The school has 10 classrooms built with non – conventional material. The main buildings have fixing problems in the roof structure. Remove roof sheet of the conventional buildings. Repair the roof structure following the Safe Schools Catalogo - Cyclones. Fix new roof sheets. For the non-conventional buildings, new constructions are recommended.

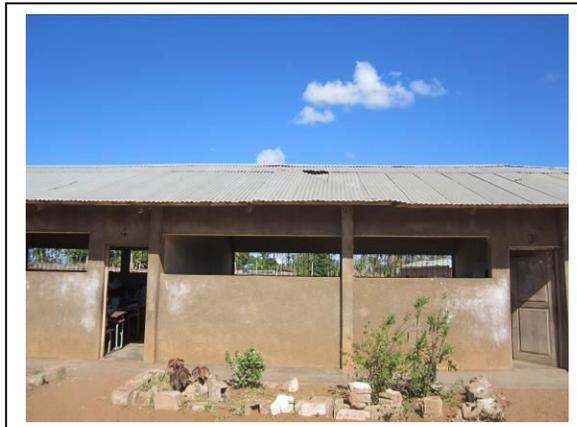
Observation: Roof of the classrooms

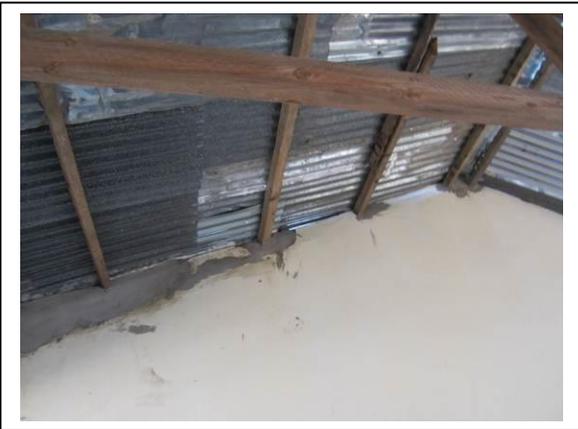
Observation: Cracking repaired

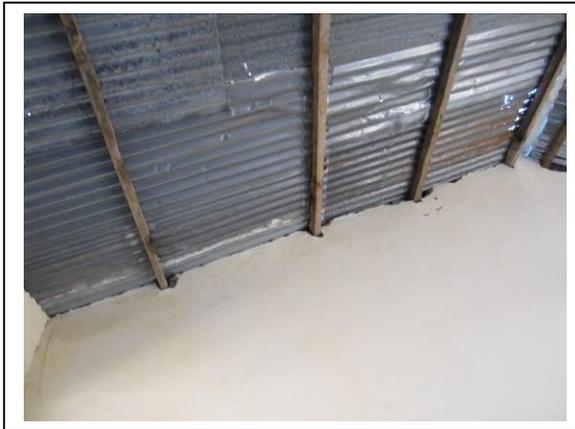
Observation: Cracking between the wall and roof

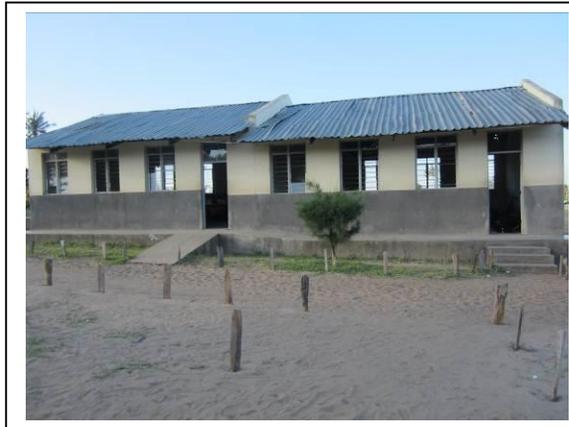
The school reused the same damaged cover plates. The roof is not correctly fixed. For the conventional buildings remove the existing roof sheet. Repair the roof structure based on the Safe Schools Catalog - Cyclones. Install new roof sheets.

Observation: View of the roof sheet

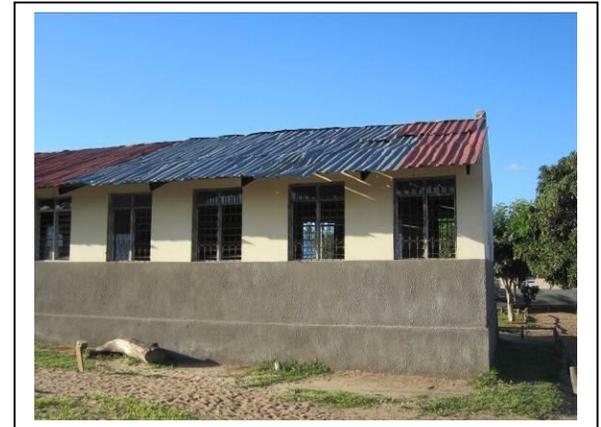
Observation: View of the roof sheet

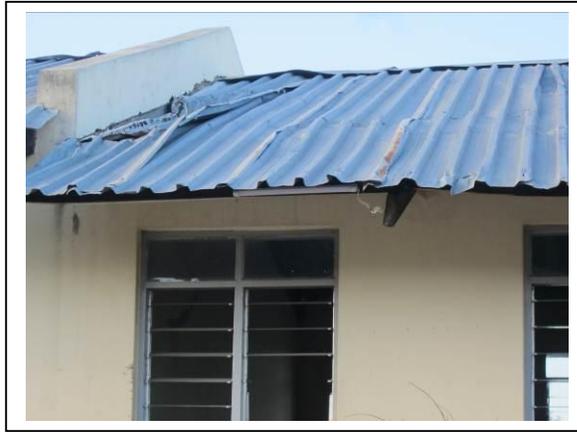
Observation: View of the roof sheet

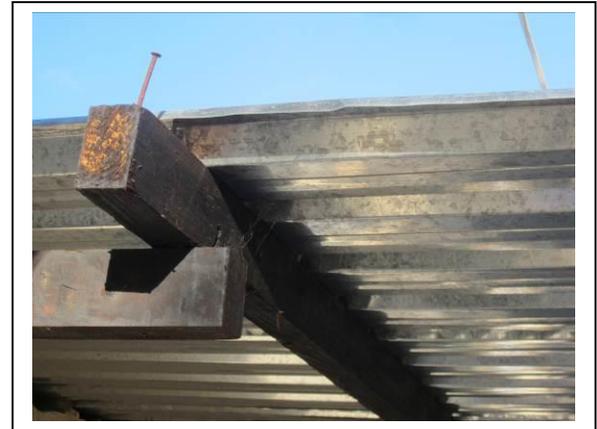
Observation: Detail of roof sheet connection

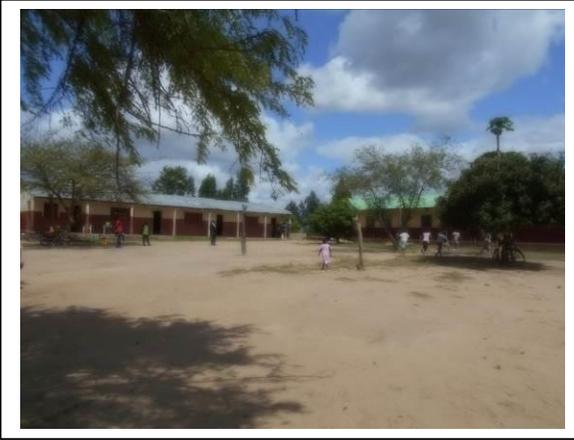
Observation: School grounds

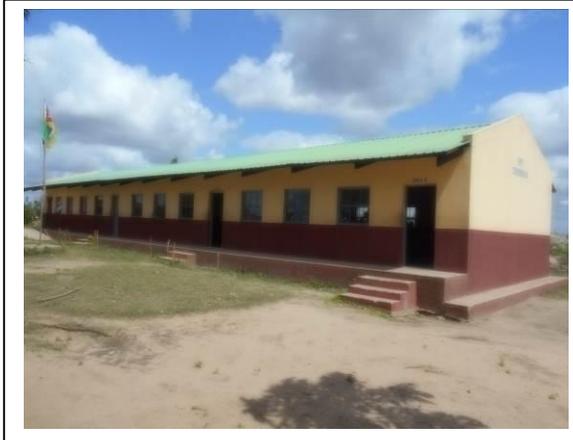
Observation: New administrative and classroom block

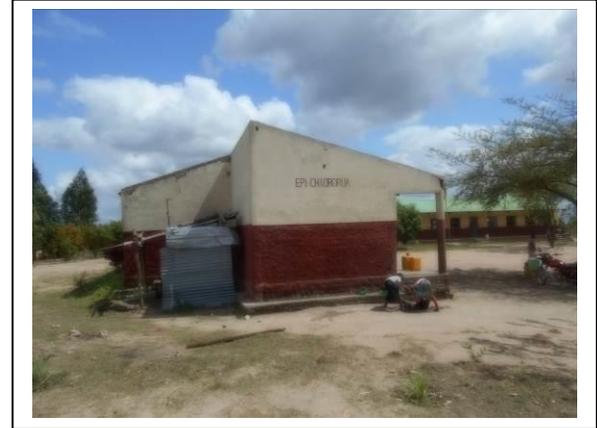
Observation: Old classroom block

For the old conventional buildings remove the existing roof sheet. Repair the roof structure based on the Safe Schools Catalog - Cyclones. For the new conventional buildings, repair the roof structure based on the Safe Schools Catalog – Cyclones.

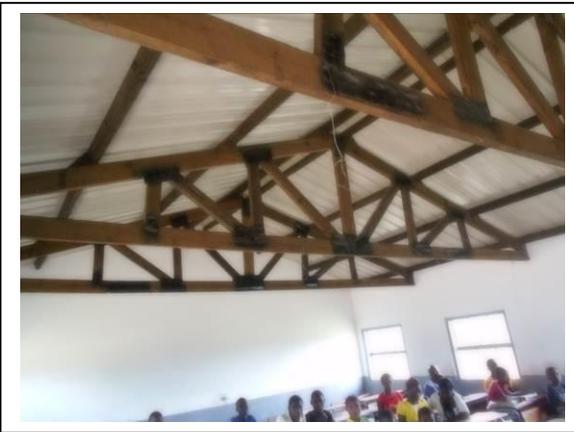
Observation: Roof structure of the new classroom block

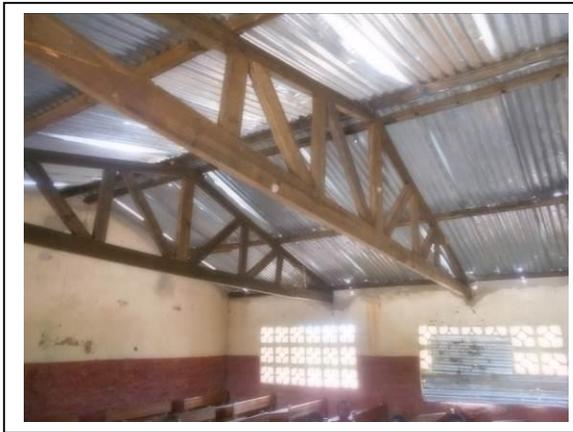
Observation: Roof structure of the old classroom block

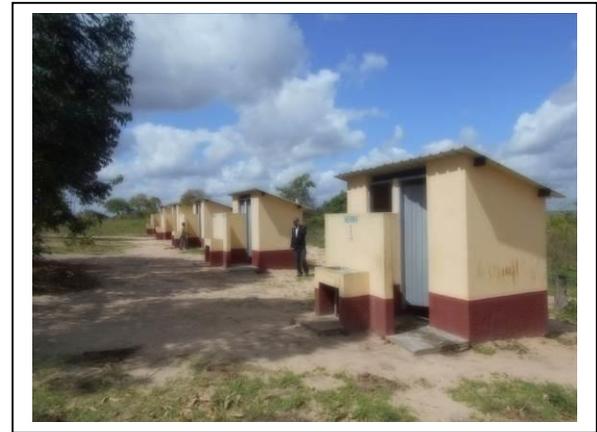
Observation: sanitary facilities

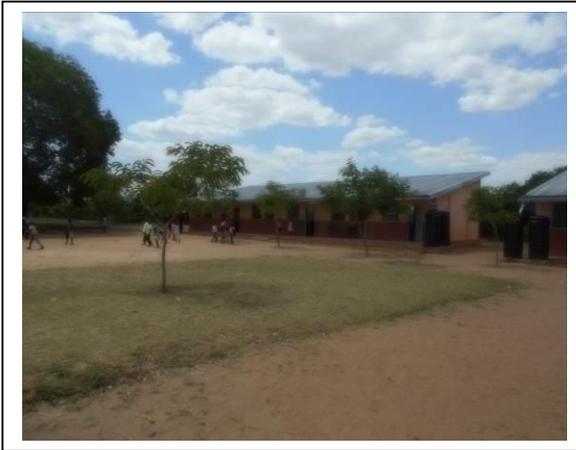
Observation: School grounds

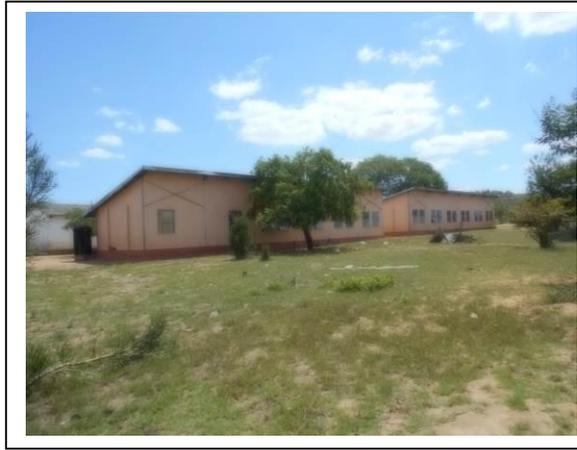
Observation: posterior view of two new blocks school

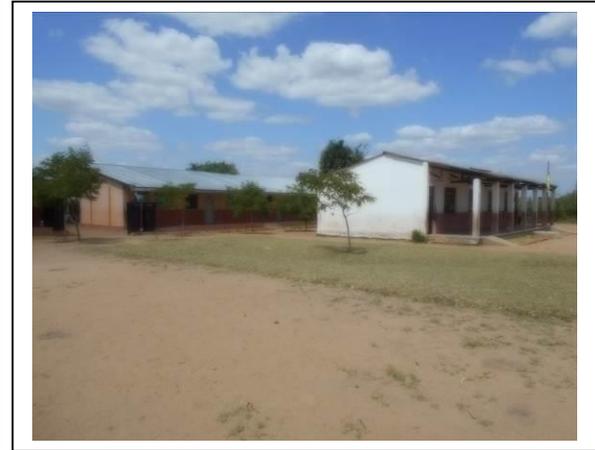
Observation: view of school blocks (old and new)

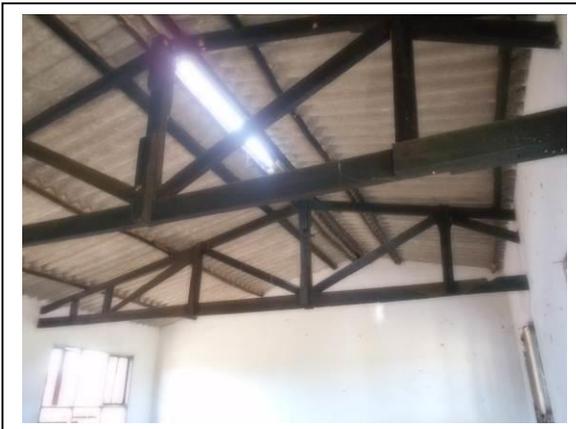
Observation: cover in fiber cement sheets.

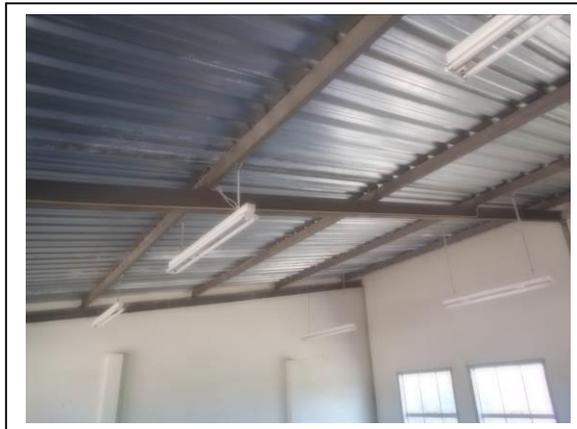
Observation: corrugated sheets in new building

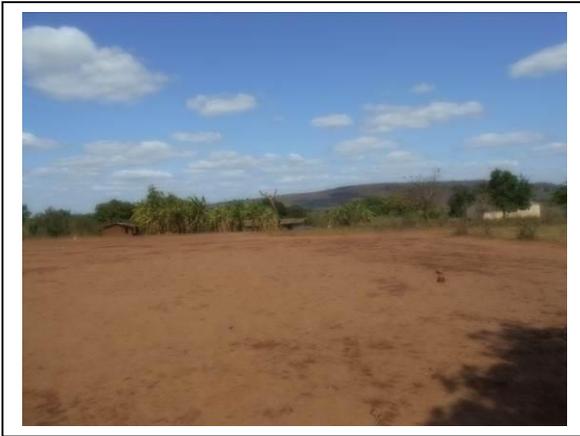
Observation: school access area

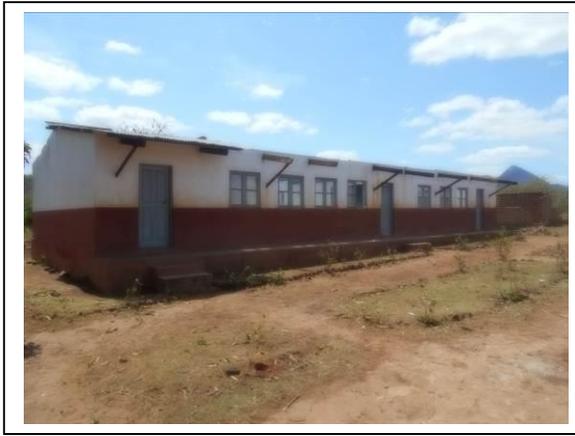
If so, inform about hazard intensities, related losses (US\$) and repair timescale: Main building destroyed by the action of the cyclone has not yet been repaired. Students have lessons in the non-conventional construction building.

Observation: Administrative and classroom block with roof destroyed by a Cyclone

The entire roof of the main building should be replaced by a new one. Non-Conventional blocks were erected after the last cyclone. They have no conditions to resist to a new cyclone. For the conventional buildings remove the existing roof sheet. Repair the roof structure based on the Safe Schools Catálogo - Ciclones. Install new roof sheets. For the non-conventional buildings, due to the poor construction, no upgrading is recommended.

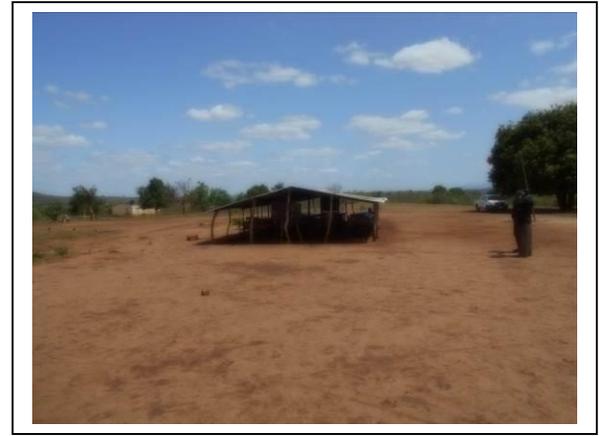
Observation: School grounds

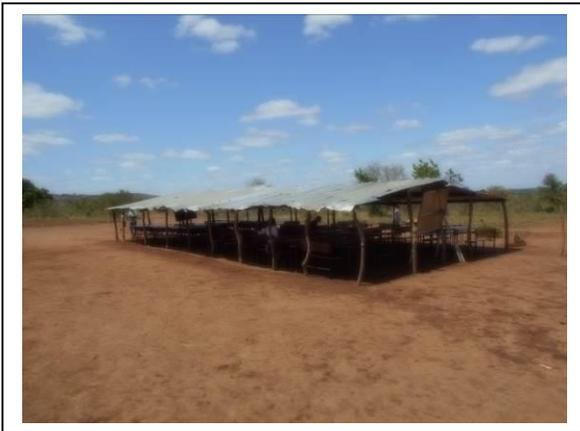
Observation: Non-conventional construction classroom

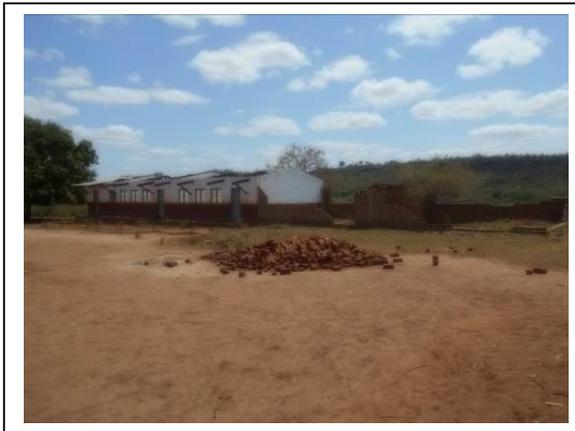
Observation: construction by community of a classroom block next to the main building

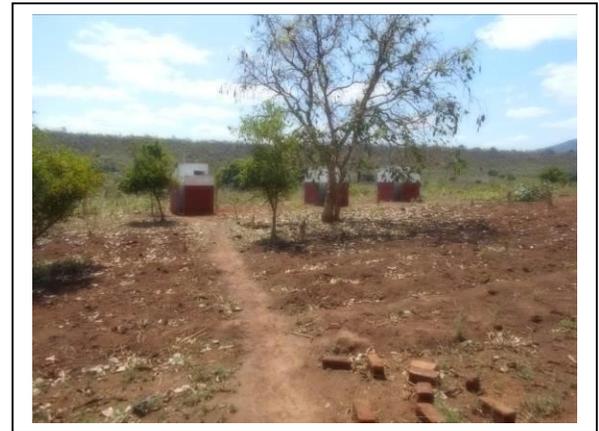
Observation: Sanitary facilities

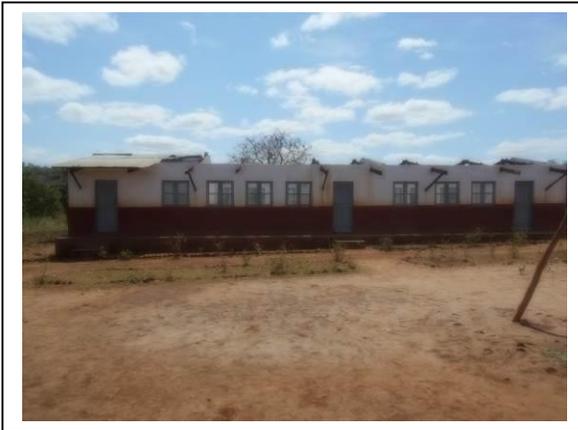
Observation: front view of main building

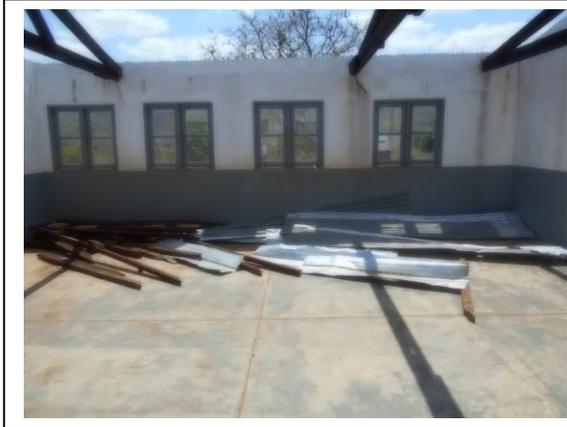
Observation: One of the classrooms after cyclone

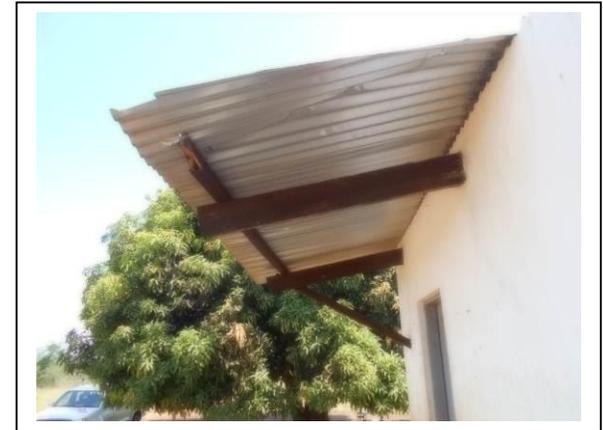
Observation: Roof sheets on the veranda, after cyclone

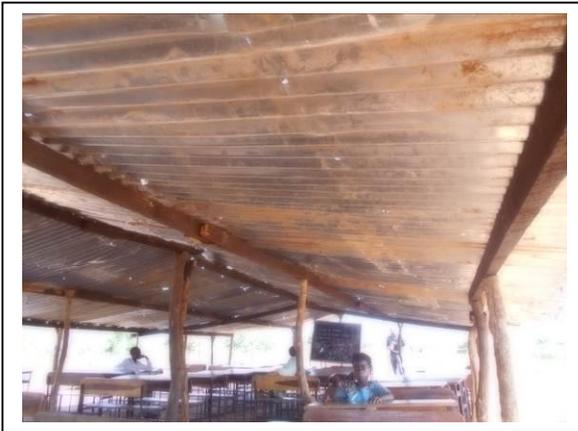
Observation: Inside non-conventional building classrooms

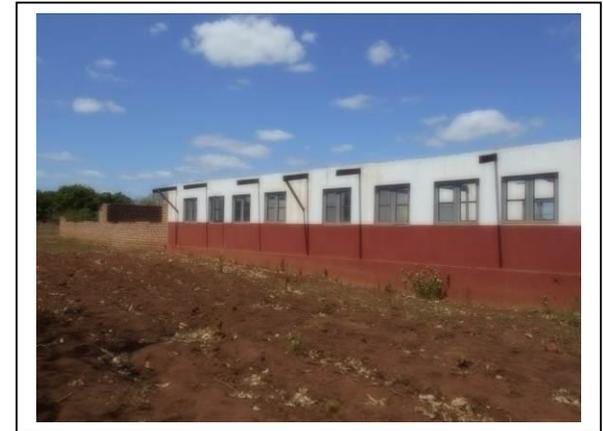
Observation: rear view of the main building

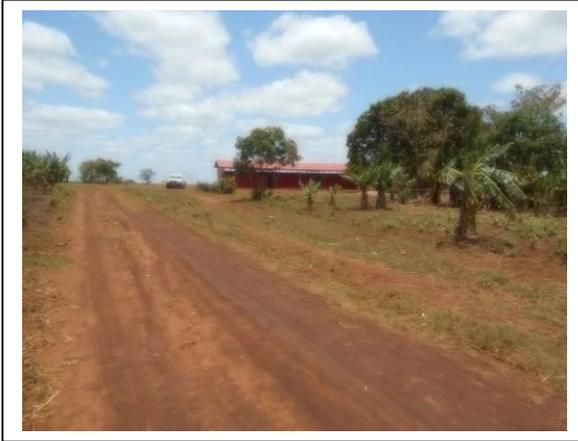
Observation: Road access to school

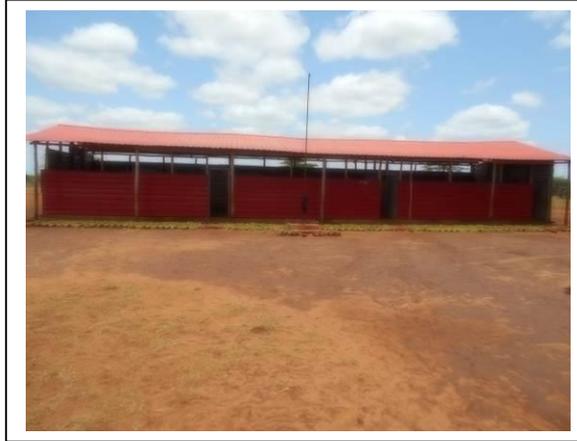
Observation: Classrooms block

Existing buildings cannot be considered safe. They should be destroyed at any hazard condition. We would propose to be constructed new buildings. Construct new building to replace the existing ones.
