# Multi-Hazard Risk Assessment for the Schools Sector in Mozambique

1230818-002

Client	Project	Reference	Pages
World Bank/GFDRR	1230818-002	1230818-002-ZKS-0008	89

Safe schools, earthquakes, coastal flooding, river flooding, cyclones, landslides, risk assessment, retrofitting options, awareness raising

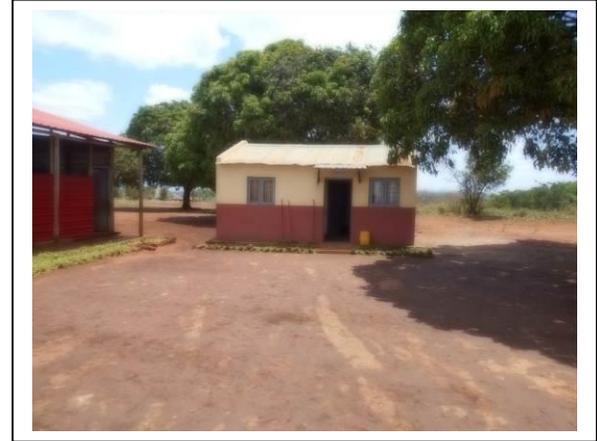
Observation: Administrative block

Existing buildings cannot be considered safe. They should be destroyed at any hazard condition. We would propose to be constructed new buildings. Construct new building to replace the existing ones.

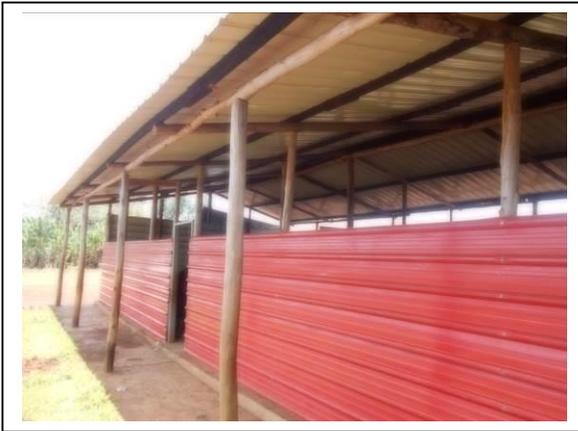
Observation: Structure, roof sheet and walls sheet of classroom block

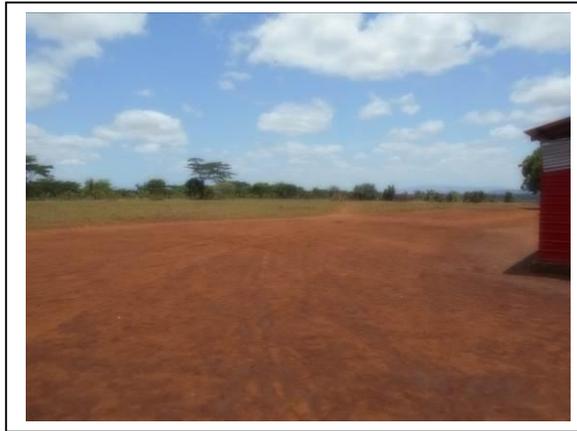
Observation: School grounds

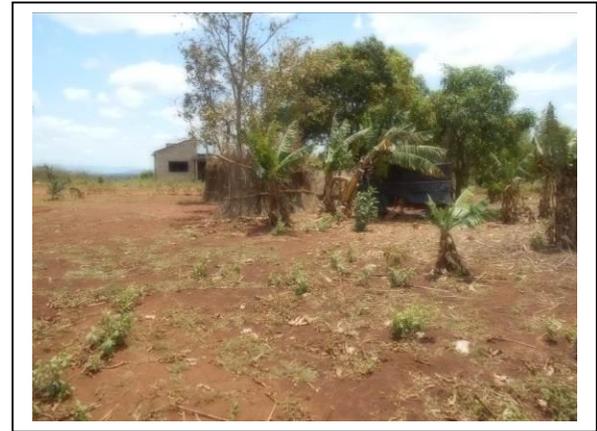
Observation: Sanitary facilities

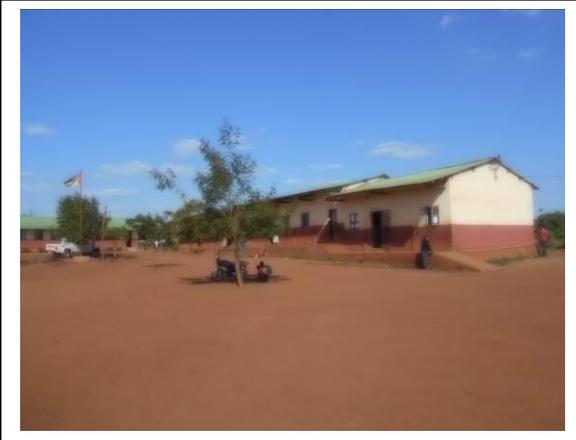
Observation: Front view of the main school block

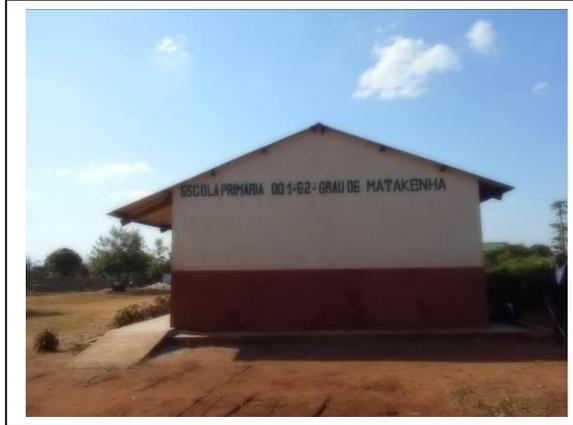
Observation: side view of classroom block

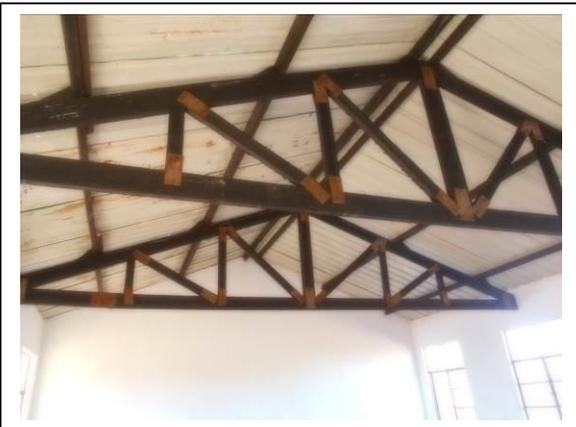
Observation: Roof structure of the classroom block

Work is being carried out on the construction of another block of classrooms, financed by FASE project. Repair the roof structure based on the Safe Schools Catalog - Cyclones. Install new roof sheets.

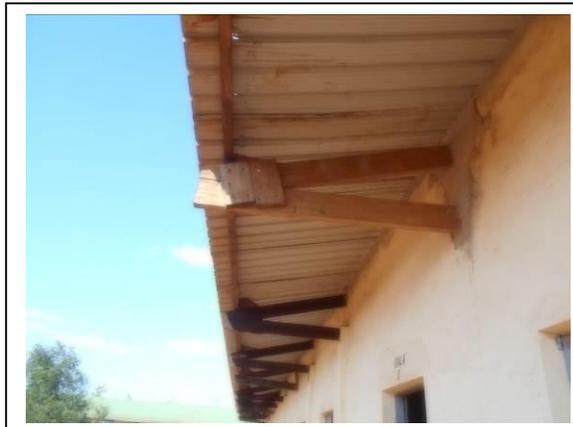
Observation: Poor repair of the roof structure

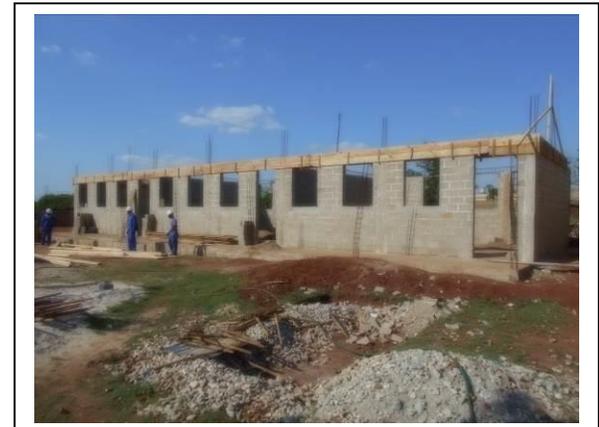
Observation: Construction of a new classroom block

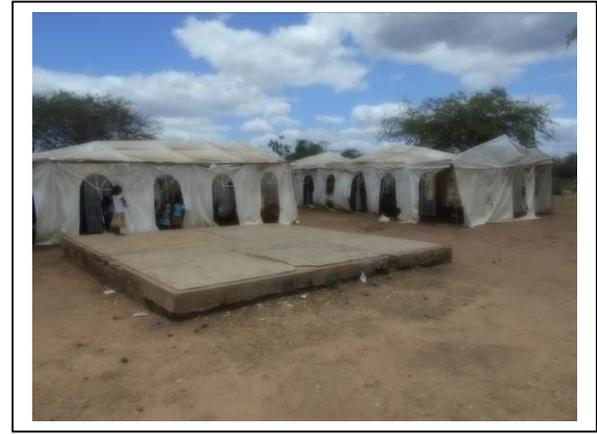
If so, inform about hazard intensities, related losses (US\$) and repair timescale: After the destruction of the initial school blocks, UNICEF donated two tents that are currently used as classrooms

Observation: Tents/classrooms

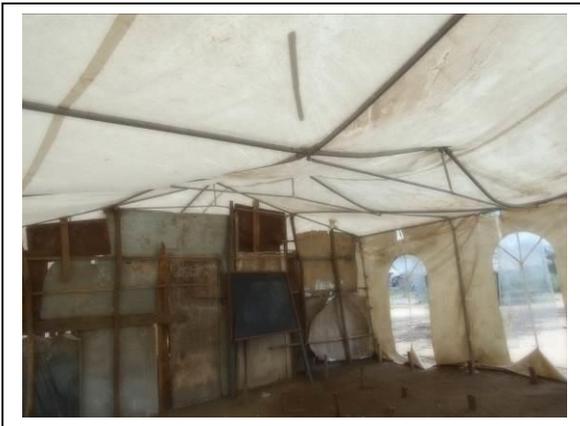
Observation: Inside one tent/classroom

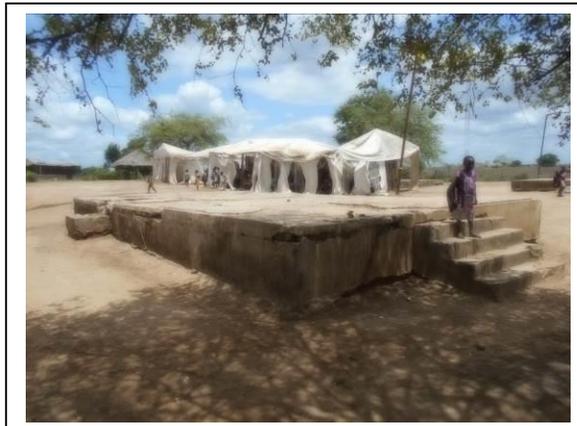
Observation: Flooring base of a destroyed school block

The school currently operates in the CFM campus. A new school is being planned by local authorities to be erected. Construct a new building to replace the existing one

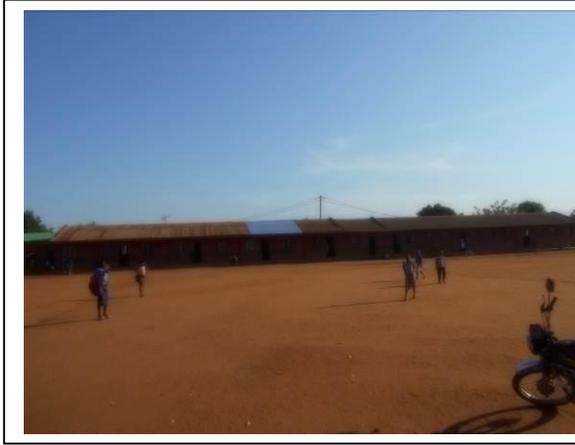
Observation: View of the largest classroom block

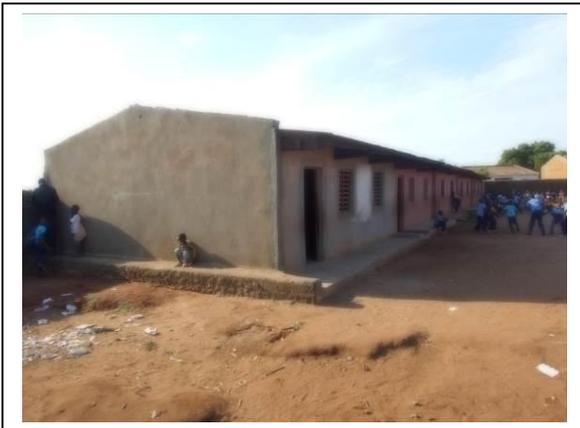
Observation: extending one classroom block with new room

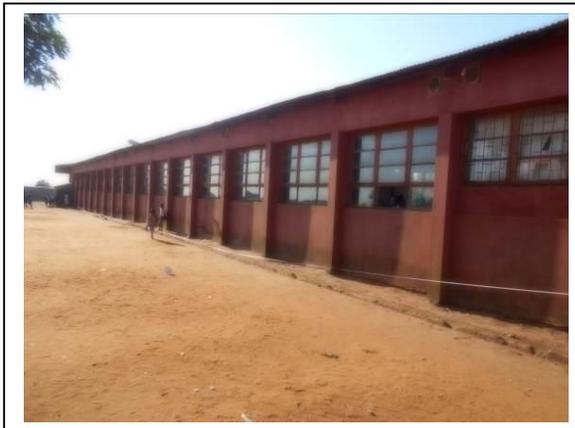
Observation: structure that appears robust in one of the classroom blocks

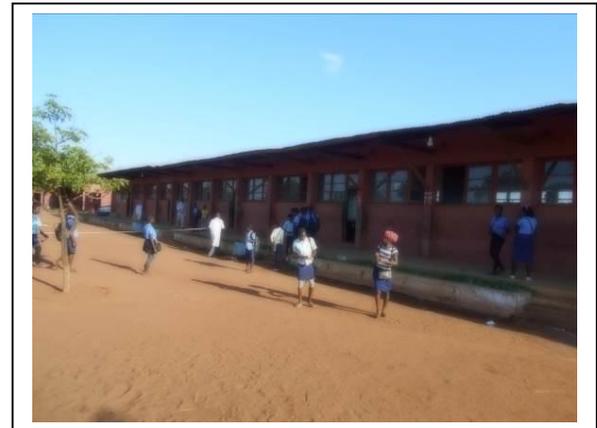
Observation: Poor roof structure on the veranda

The number of buildings was growing as the needs of the school, and the construction techniques were changing from building to building. Repair the roof structure based on the Safe Schools Catalog - Cyclones. Install new roof sheets.

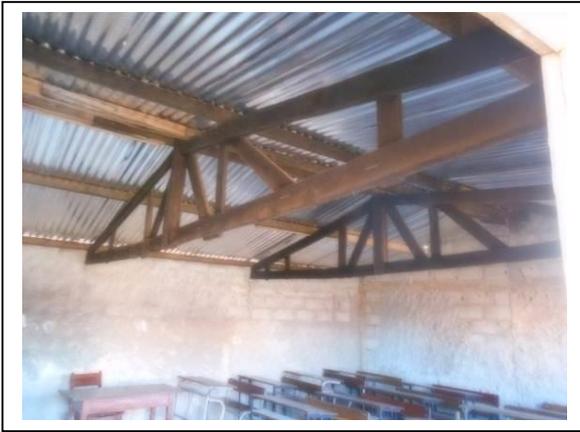
Observation: cover structure with Zinc Sheets

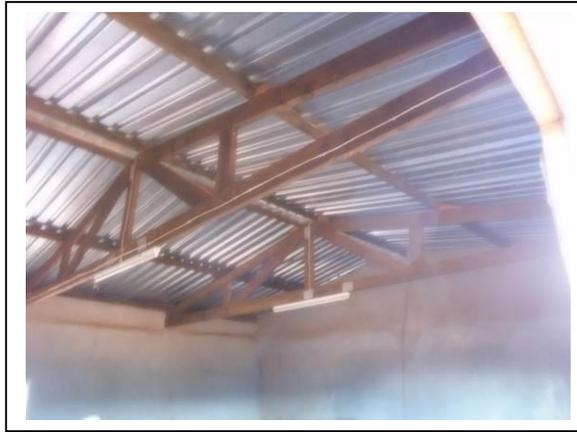
Observation: cover structure with IBR sheet

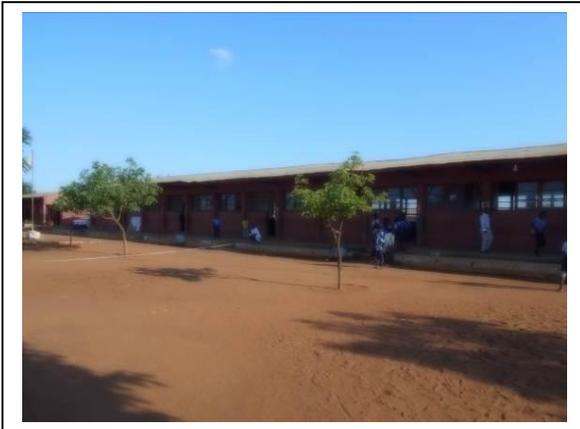
Observation: General view of a classroom block

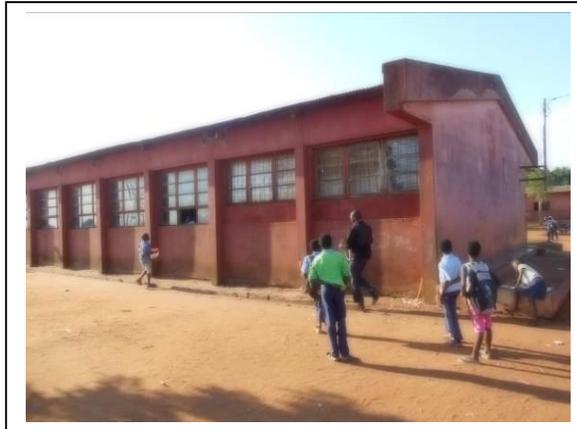
Observation: Gable wall that apparently protects the roof
